ACCIDENT

Aircraft Type and Registration:	1) Boeing 777-240(LR), AP-BGY 2) DHC-8-402 Dash 8, G-JEDR
No & Type of Engines:	1) 2 General Electric GE90-110B turbofan engines 2) 2 Pratt & Whitney Canada PW150A turboprop engines
Year of Manufacture:	1) 2005 2) 2003
Date & Time (UTC):	15 February 2007 at 1220 hrs
Location:	Manchester Airport
Type of Flight:	1) Commercial Air Transport (Passenger) 2) Commercial Air Transport (Passenger)
Persons on Board:	1) Crew - 12 Passengers - 144 2) Crew - 6 Passengers - 37
Injuries:	1) Crew - None Passengers - None 2) Crew - None Passengers -None
Nature of Damage:	1) Minor scratches on right wingtip 2) Damage to the rudder
Commander's Licence:	1) Airline Transport Pilot's Licence 2) Airline Transport Pilot's Licence
Commander's Age:	1) N/K 2) 46 years
Commander's Flying Experience:	1) 14,000 hours (of which 180 were on type) Last 90 days - N/K Last 28 days - N/K 2) 9,873 hours (of which 2,000 were on type) Last 90 days - 150 hours Last 28 days - 50 hours

Information Source:	AAIB Field Investigation

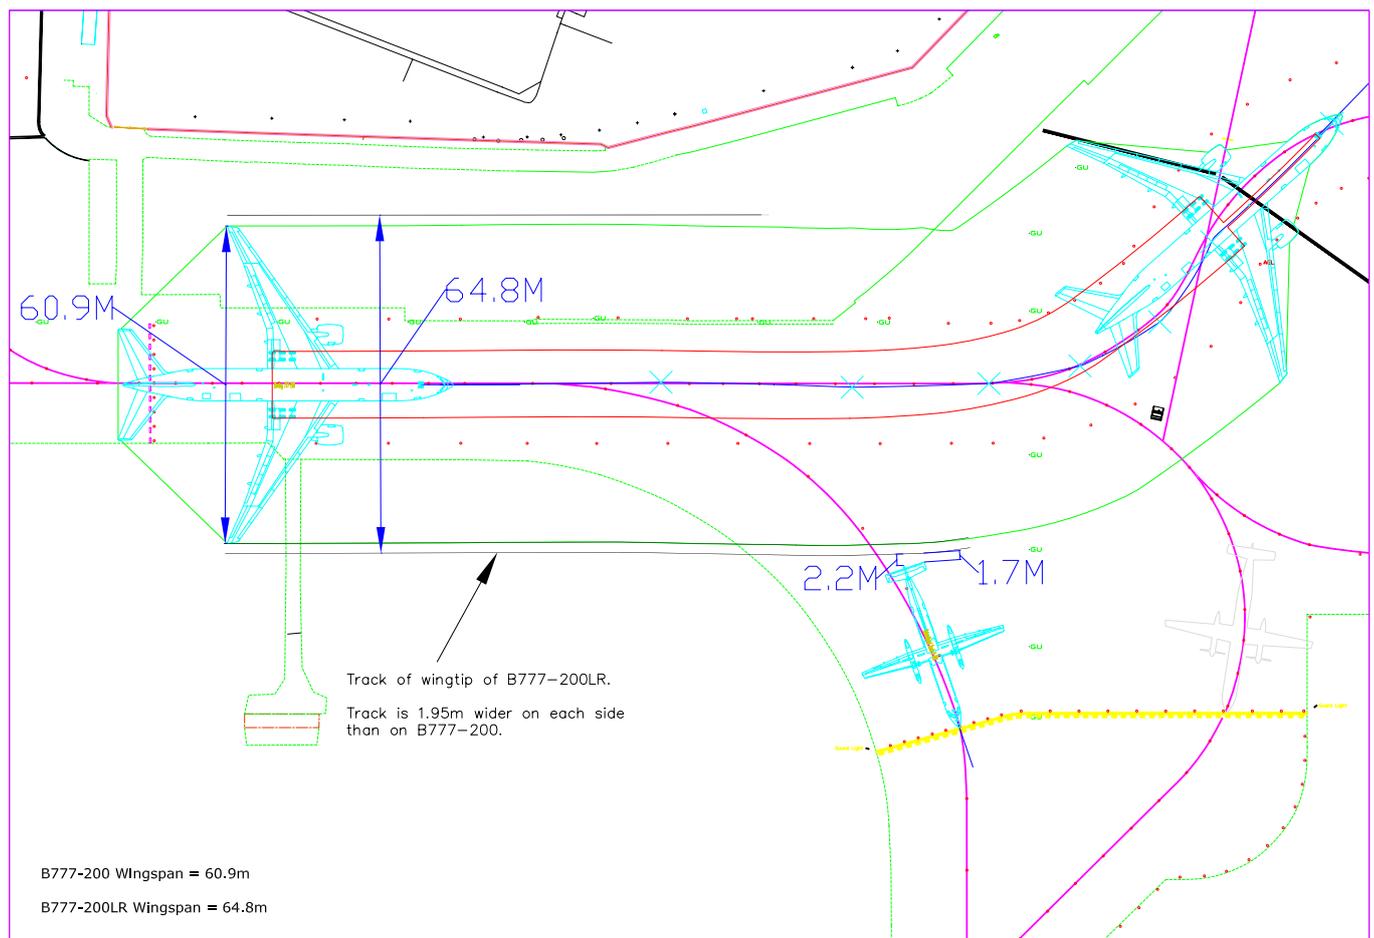
Figure 2

the impact. However, the clearances between the two aircraft were simulated using a computer generated map, based on accurate survey data, on which scale representations of various aircraft types could be displayed (see Figure 2). This indicated that there would be a clearance of 2.0 m between the rudder of a DHC-8-400 (parked with its nose precisely at the stop line at holding point JA1 and on the taxiway centreline) and the right wingtip of a Boeing 777-200LR taxiing behind it along the centreline of Taxiway J. The gap between the wingtip of the B777 and the higher trailing edge of the DHC-8’s left elevator would be less, at 1.4 m.

The trailing edge of G-JEDR's rudder had been struck just below the level of the horizontal stabiliser by AP-BGY's right wingtip. The impact had bent the trailing edge of the rudder at right angles over a length of about 80 cm. The damage was not repairable and the rudder was replaced.

There was little more than superficial scratching to the wingtip and outboard leading edge of AP-BGY's right wing which, after examination, was allowed to continue in service without requiring repairs.
