INCIDENT

| Aircraft Type and Registration: | Boeing 747-436, G-BNLG | |

Synopsis

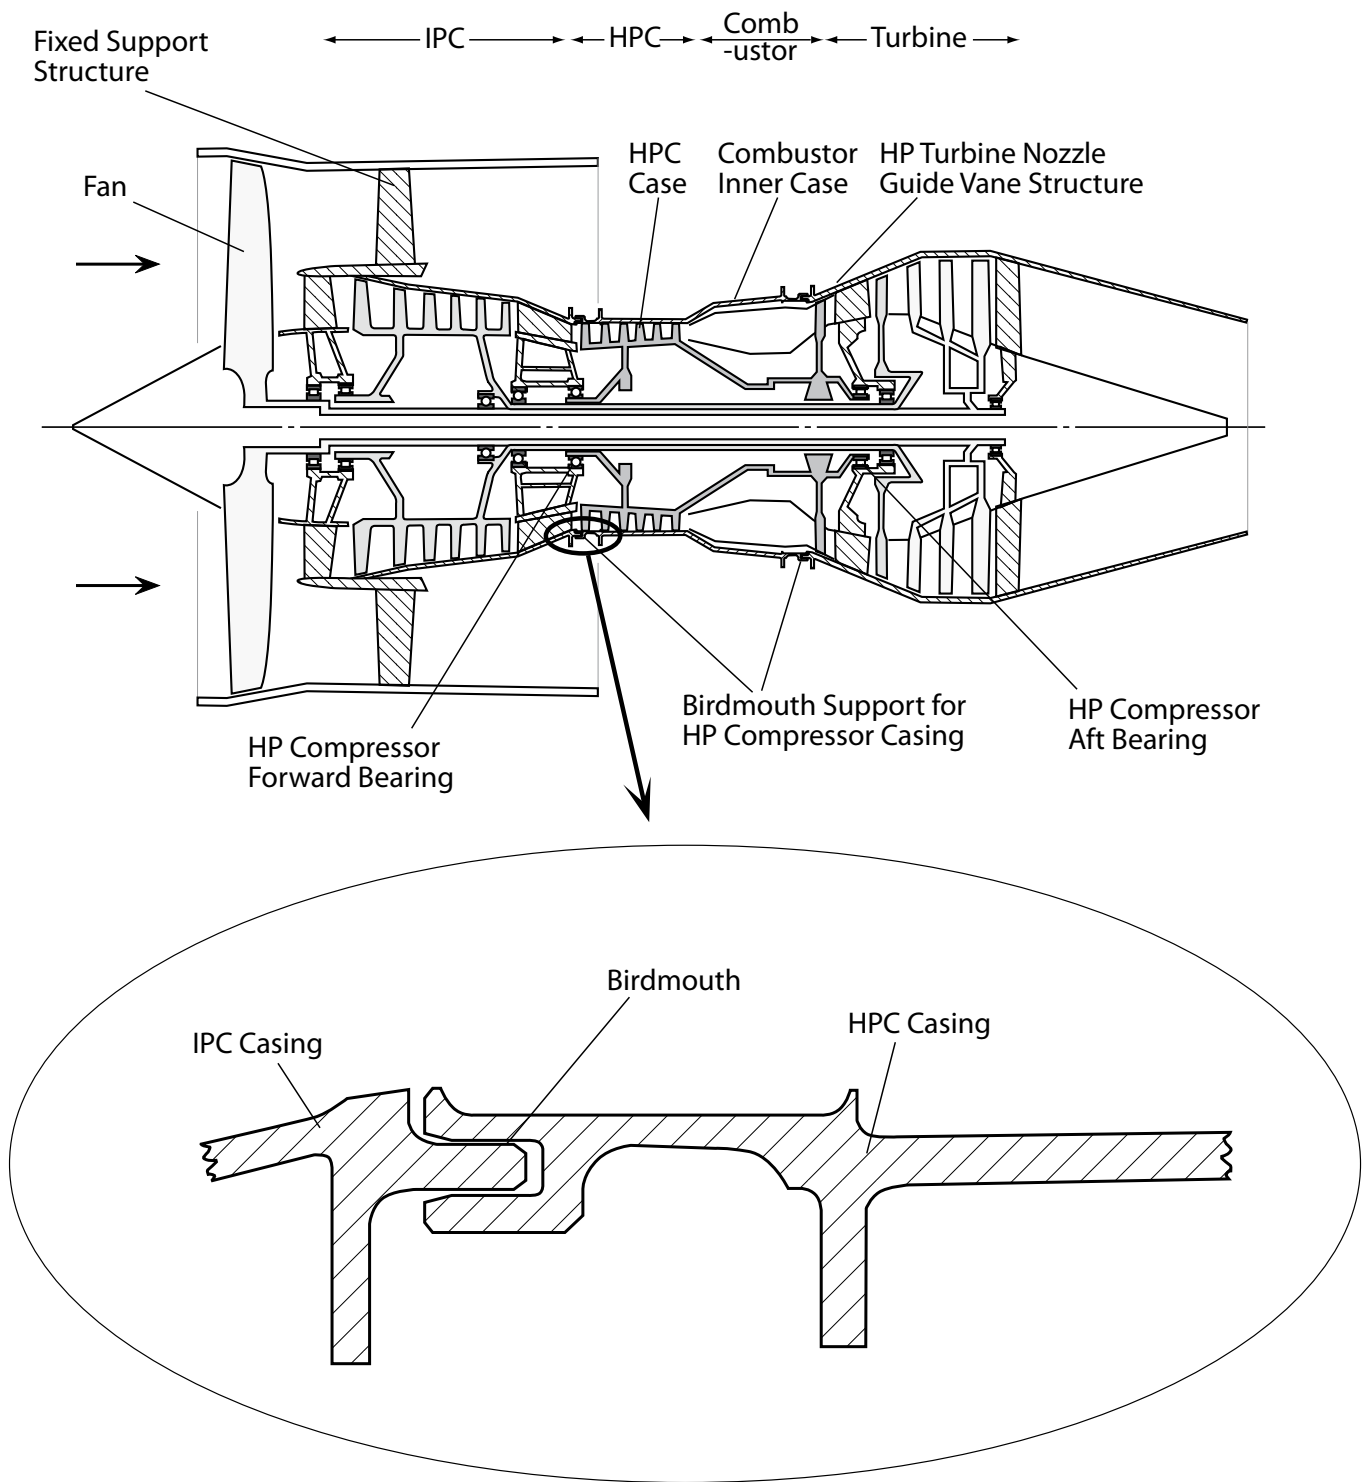
Figure 1
 Engine HP Compressor Support Arrangement

Rotor blade tip clearance can be affected by wear of the HPC casing birdmouth feature. Excessive wear allows the forward end of the HPC casing to displace radially downwards, thereby increasing blade tip clearances over the lower half of the compressor and causing the rotor blades to contact the liner over the upper part and erode, further increasing the lower clearances. Experience has shown that where this has led to a compressor stall and engine surge the HPC tip clearance has increased to around 0.020-0.040 inch, with the engine typically having accumulated in the order of 3,500 cycles. Commonly, where the clearances have become excessive, a stall will occur when power is increased in reverse thrust. Information suggested that this may have been used as an indicator that repair was required. Two previous cases of RB211 in flight shut downs (IFSDs) due to surge resulting from HPC birdmouth wear had been reported, on RB211-524G-T and 524H-T type engines.

It was clear from the evidence found during the investigation that the initial No 2 engine problem had been a surge. The degree of wear found to the front of the HPC casing birdmouth locating ring allowed radial displacement of the front of the HPC casing that would have increased the HPC rotor blade tip clearance and thus eroded the normal compressor stall margin. The further increase in clearance, that was a consequence of the loading and thermal effects when engine power was advanced, was predicted to peak around 50 seconds after setting take-off power. The surge that occurred just after G-BNLG took off was consistent with the effects of a compressor stall induced by the increase in HPC tip clearance from these combined effects.

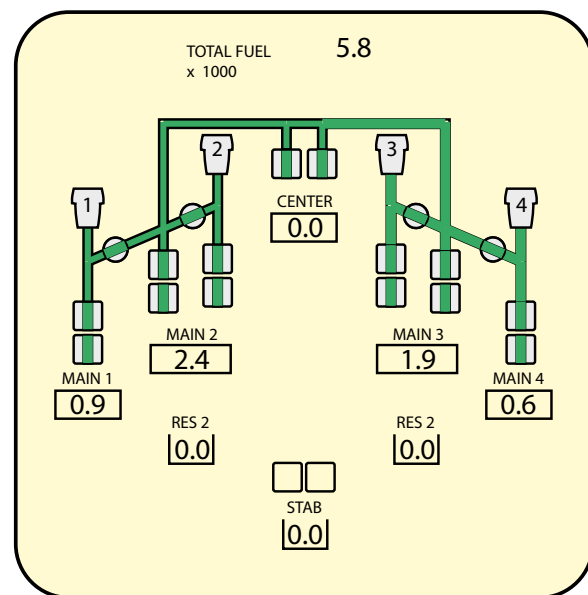
Figure 3

Green line indicates predicted flow.

Fuel quantities shown are approximately those present at G-BNLG's landing.

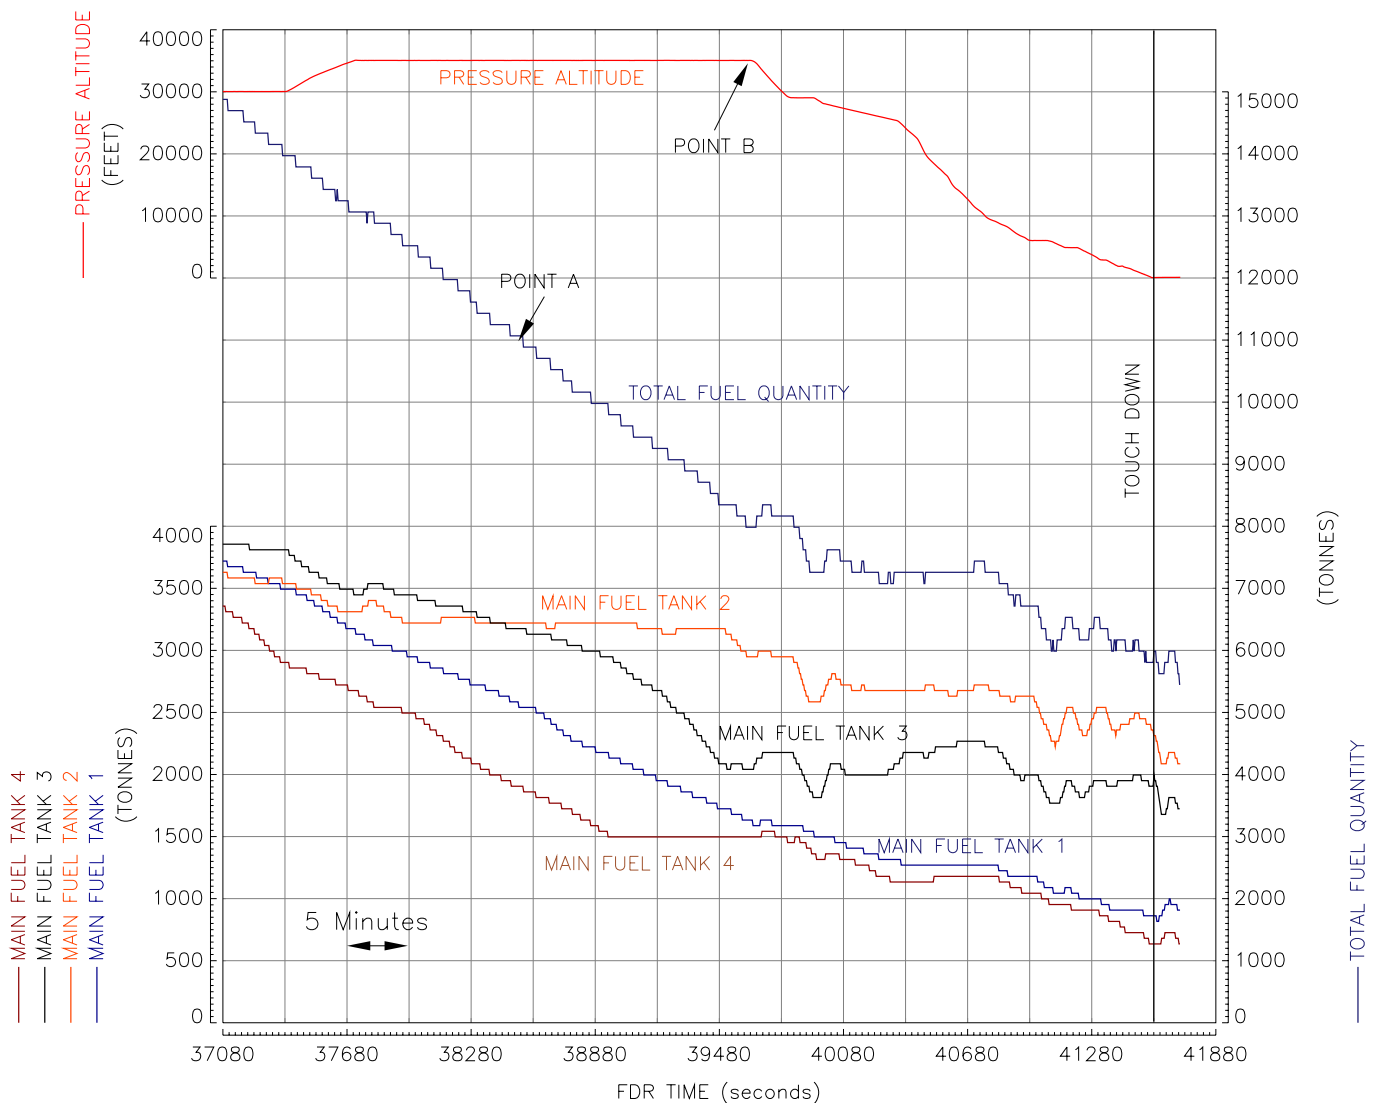
Figure 4
 Salient FDR Parameters
 (Incident to G-BLNG on 20 February 2005)

The main tank fuel quantities prior to the top of descent until the landing are depicted in Figure 4. At 1513 hrs (Figure 4, point A) whilst at FL350, the total fuel quantity was 11 tonnes. The stabiliser, and both reserve fuel tank quantities were at zero with the centre tank at 0.2 tonnes and the main fuel tank quantities for No 1 to No 4 tanks were: 2.6 tonnes, 3.2 tonnes, 3.1 tonnes and 1.9 tonnes respectively. At 1532 hrs (Figure 4, point B), with a total fuel quantity of 8.1 tonnes, a descent to FL290 was initiated; this altitude was maintained until 1537 hrs when the final descent was commenced.

Touchdown occurred at 1604 hrs when the total fuel quantity was 5.8 tonnes. The fuel distribution across the No 1 to No 4 main fuel tanks was: 0.9 tonnes, 2.4 tonnes, 1.9 tonnes and 0.6 tonnes respectively. The FDR stopped recording at 1617 hrs when the aircraft was shutdown.

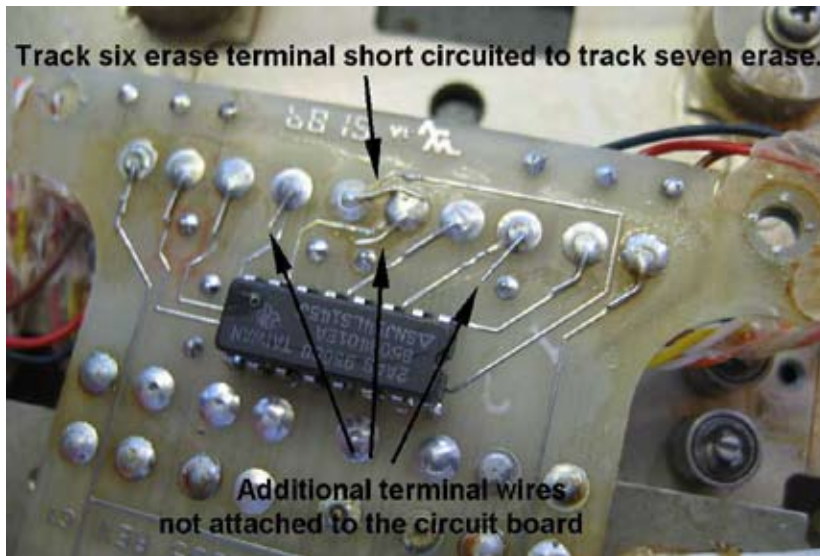
Figure 5 (left)
Faulty distribution board

The fault was traced to the distribution board. The distribution board forms part of the crash protected tape transport assembly. Part of its function is to provide an interconnecting point between the four heads and the FDR's circuitry that was external to the crash protected assembly. A short circuit, between terminals E48 and E49, was found on the underside of the distribution board (see Figure 5). The short circuit was made by a terminal attachment wire, from terminal number E48, becoming

detached from its correct position and becoming soldered to the adjacent terminal, E49. It was also noted that other attachment wires were in close proximity to adjacent circuitry. Figure 6 shows the attachment wires in the correct positions.

September 2002. The operator's annual FDR replay records were inspected and it was found that the erasure fault had not been present prior to the replacement of the heads. Therefore it is considered most likely to have been introduced as a result of this maintenance work. The short circuit was not detectable until the board had been physically removed from the transport assembly. The operator advised that the board would not typically be removed when the heads were replaced as access to the solder terminals was adequate. The history also indicated that after the heads had been changed the unit had been to the workshop on three further occasions and released to service prior to the incident.

Following the discovery of the short circuit fault, the operator's avionics repair facility introduced a change to its testing procedures for the series 980-4100 model of FDR. The change required that a recording test be performed, using the functional tester, that would identify a failure in the erase function.
