INCIDENT

| Aircraft Type and Registration: | Boeing 747-436, G-BNLG |

Synopsis

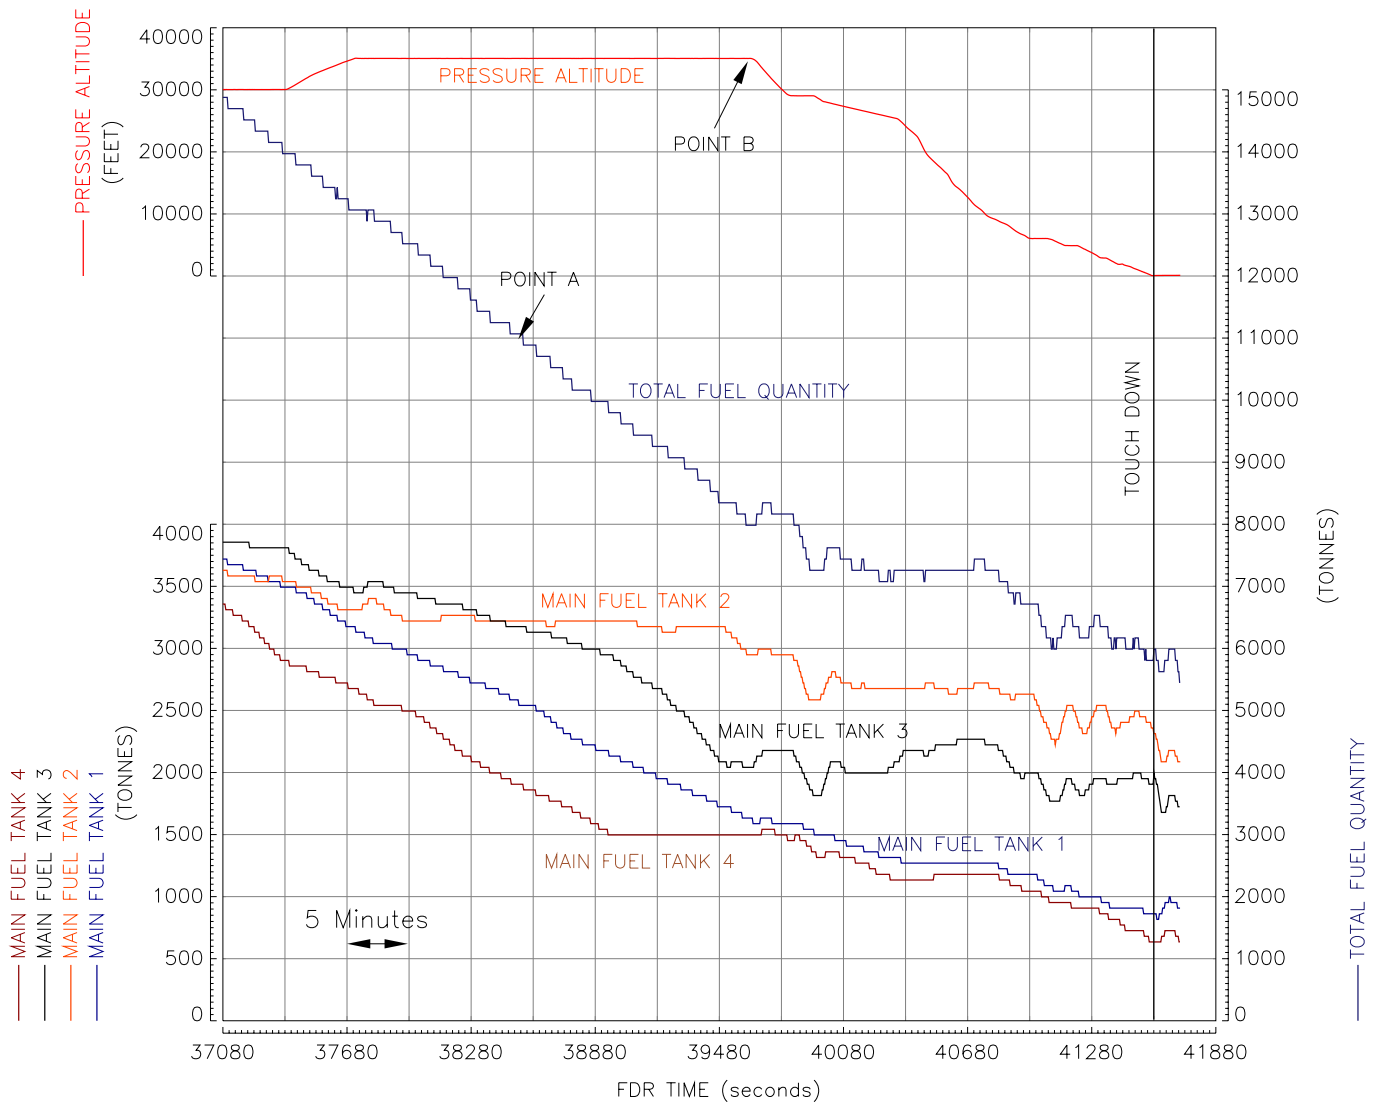
Figure 4
 Salient FDR Parameters
 (Incident to G-BLNG on 20 February 2005)

The main tank fuel quantities prior to the top of descent until the landing are depicted in Figure 4. At 1513 hrs (Figure 4, point A) whilst at FL350, the total fuel quantity was 11 tonnes. The stabiliser, and both reserve fuel tank quantities were at zero with the centre tank at 0.2 tonnes and the main fuel tank quantities for No 1 to No 4 tanks were: 2.6 tonnes, 3.2 tonnes, 3.1 tonnes and 1.9 tonnes respectively. At 1532 hrs (Figure 4, point B), with a total fuel quantity of 8.1 tonnes, a descent to FL290 was initiated; this altitude was maintained until 1537 hrs when the final descent was commenced.

Touchdown occurred at 1604 hrs when the total fuel quantity was 5.8 tonnes. The fuel distribution across the No 1 to No 4 main fuel tanks was: 0.9 tonnes, 2.4 tonnes, 1.9 tonnes and 0.6 tonnes respectively. The FDR stopped recording at 1617 hrs when the aircraft was shutdown.

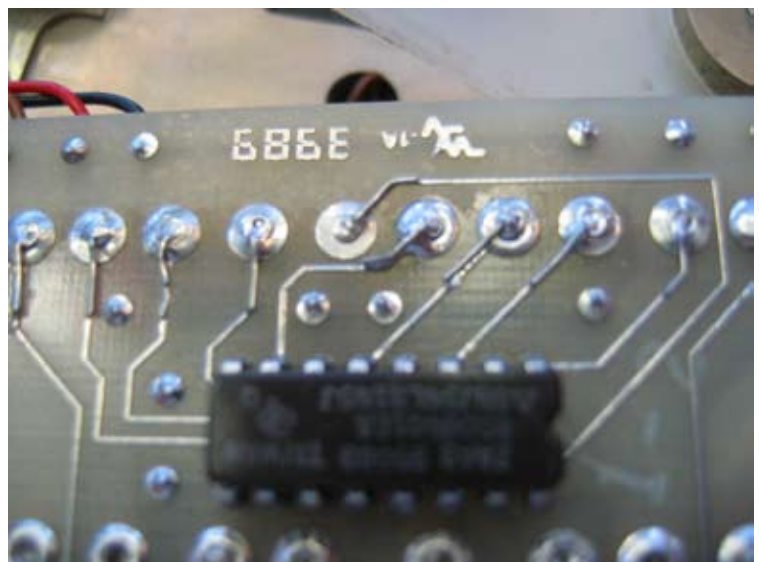
Figure 6 (right)
Correctly configured distribution board
