**INCIDENT**

<b>Aircraft Type and Registration:</b>	Boeing 747-436, G-BNLG
<b>No &amp; Type of Engines:</b>	4 Rolls-Royce RB211-524G turbofan engines
<b>Year of Manufacture:</b>	1989
<b>Date &amp; Time (UTC):</b>	20 February 2005
<b>Location:</b>	En route from Los Angeles International Airport to London (Heathrow) International Airport
<b>Type of Flight:</b>	Public Transport (Passenger)
<b>Persons on Board:</b>	Crew - 18                      Passengers - 352
<b>Injuries:</b>	Crew - None                      Passengers - None
<b>Nature of Damage:</b>	Major damage to No 2 engine
<b>Commander's Licence:</b>	Airline Transport Pilot's Licence
<b>Commander's Age:</b>	48 years
<b>Commander's Flying Experience:</b>	12,680 hours (of which 1,855 were on type) Last 90 days - 212 hours Last 28 days - 75 hours
<b>Information Source:</b>	AAIB Field Investigation

**Synopsis**

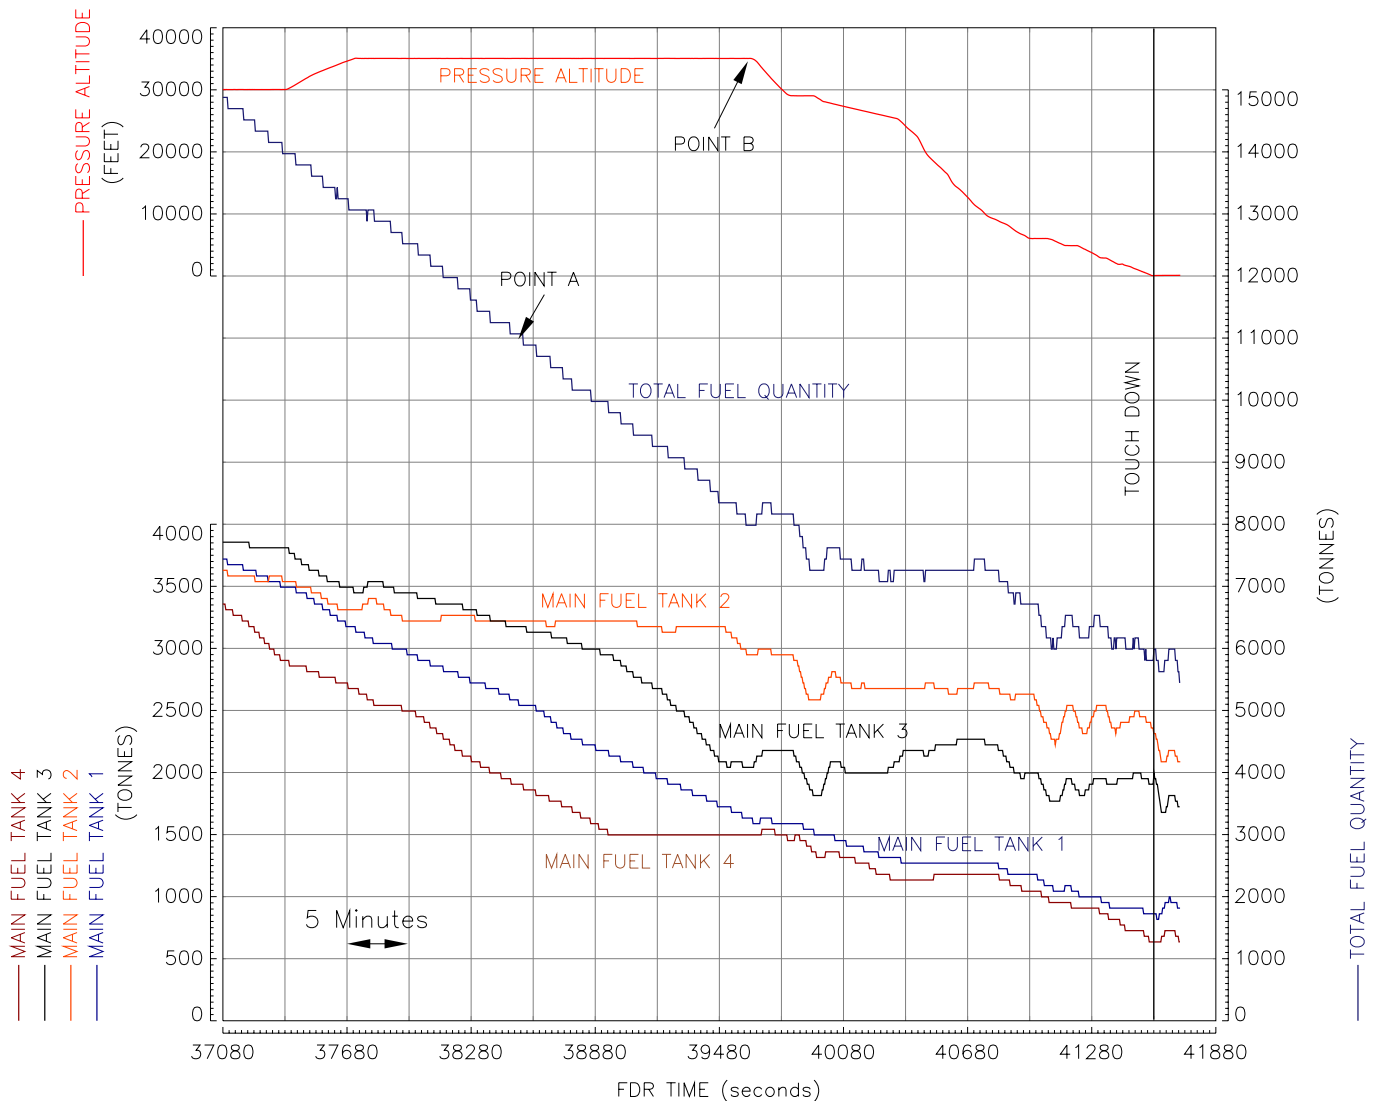
**Figure 4**  
 Salient FDR Parameters  
 (Incident to G-BLNG on 20 February 2005)

The main tank fuel quantities prior to the top of descent until the landing are depicted in Figure 4. At 1513 hrs (Figure 4, point A) whilst at FL350, the total fuel quantity was 11 tonnes. The stabiliser, and both reserve fuel tank quantities were at zero with the centre tank at 0.2 tonnes and the main fuel tank quantities for No 1 to No 4 tanks were: 2.6 tonnes, 3.2 tonnes, 3.1 tonnes and 1.9 tonnes respectively. At 1532 hrs (Figure 4, point B), with a total fuel quantity of 8.1 tonnes, a descent to FL290 was initiated; this altitude was maintained until 1537 hrs when the final descent was commenced.

Touchdown occurred at 1604 hrs when the total fuel quantity was 5.8 tonnes. The fuel distribution across the No 1 to No 4 main fuel tanks was: 0.9 tonnes, 2.4 tonnes, 1.9 tonnes and 0.6 tonnes respectively. The FDR stopped recording at 1617 hrs when the aircraft was shutdown.

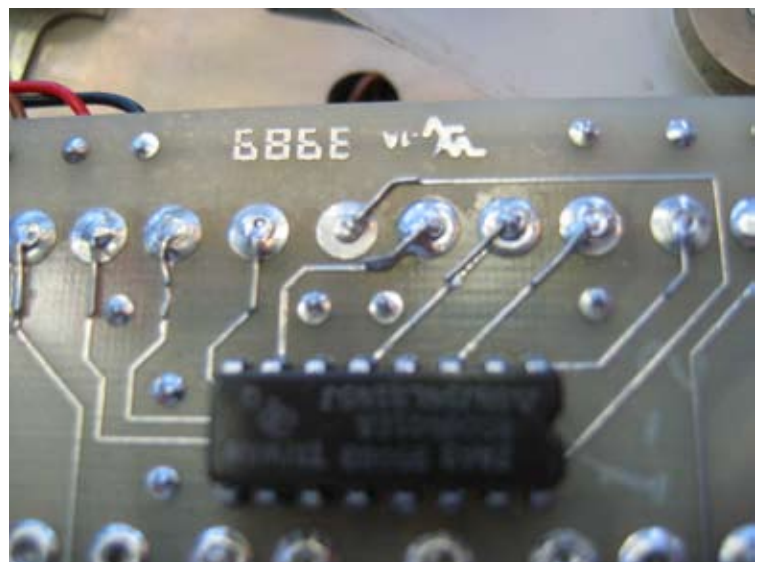
**Figure 6 (right)**  
Correctly configured distribution board
