INCIDENT

Aircraft Type and Registration:	Boeing 747-436, G-BNLG
No & Type of Engines:	4 Rolls-Royce RB211-524G turbofan engines
Year of Manufacture:	1989
Date & Time (UTC):	20 February 2005
Location:	En route from Los Angeles International Airport to London (Heathrow) International Airport
Type of Flight:	Public Transport (Passenger)
Persons on Board:	Crew - 18 Passengers - 352
Injuries:	Crew - None Passengers - None
Nature of Damage:	Major damage to No 2 engine
Commander's Licence:	Airline Transport Pilot's Licence
Commander's Age:	48 years
Commander's Flying Experience:	12,680 hours (of which 1,855 were on type) Last 90 days - 212 hours Last 28 days - 75 hours
Information Source:	AAIB Field Investigation

Synopsis

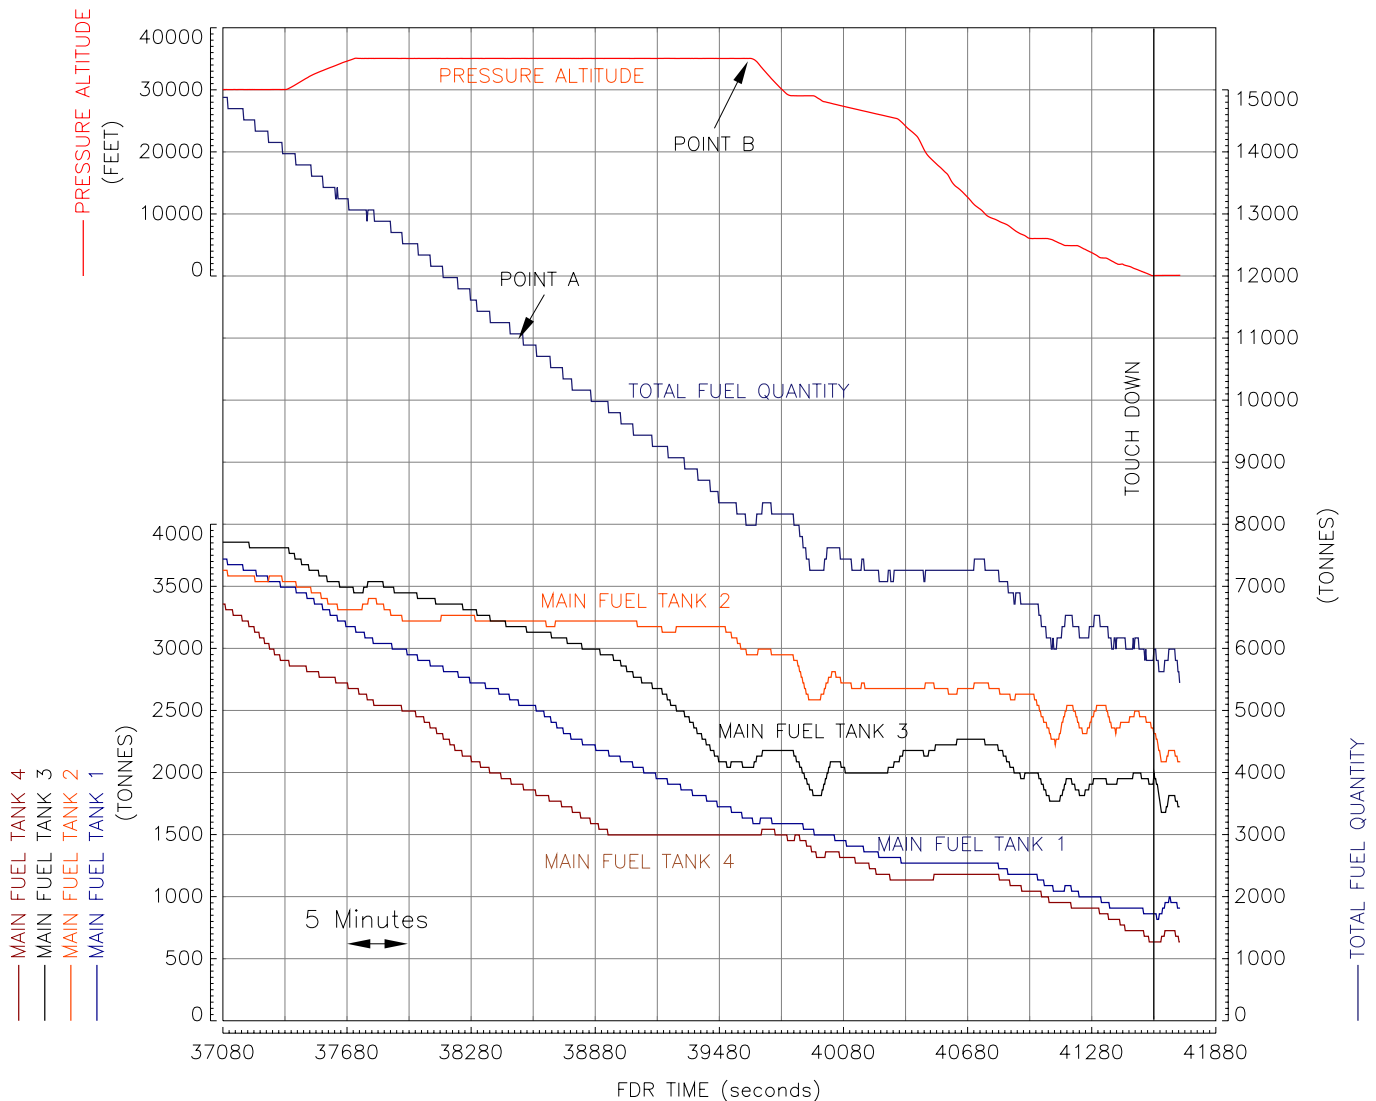
Figure 4
 Salient FDR Parameters
 (Incident to G-BLNG on 20 February 2005)

The main tank fuel quantities prior to the top of descent until the landing are depicted in Figure 4. At 1513 hrs (Figure 4, point A) whilst at FL350, the total fuel quantity was 11 tonnes. The stabiliser, and both reserve fuel tank quantities were at zero with the centre tank at 0.2 tonnes and the main fuel tank quantities for No 1 to No 4 tanks were: 2.6 tonnes, 3.2 tonnes, 3.1 tonnes and 1.9 tonnes respectively. At 1532 hrs (Figure 4, point B), with a total fuel quantity of 8.1 tonnes, a descent to FL290 was initiated; this altitude was maintained until 1537 hrs when the final descent was commenced.

Touchdown occurred at 1604 hrs when the total fuel quantity was 5.8 tonnes. The fuel distribution across the No 1 to No 4 main fuel tanks was: 0.9 tonnes, 2.4 tonnes, 1.9 tonnes and 0.6 tonnes respectively. The FDR stopped recording at 1617 hrs when the aircraft was shutdown.
