Aircraft type and registration: Bölkow Monson B209 G-AZVC
Piper Arrow PA28R G-AYYN (both light single engined fixed wing aircraft)

Date and time (GMT): 19 August 1984 at 1234 hrs

Location: Cobham, Kent

Information Source: AIB Field Investigation

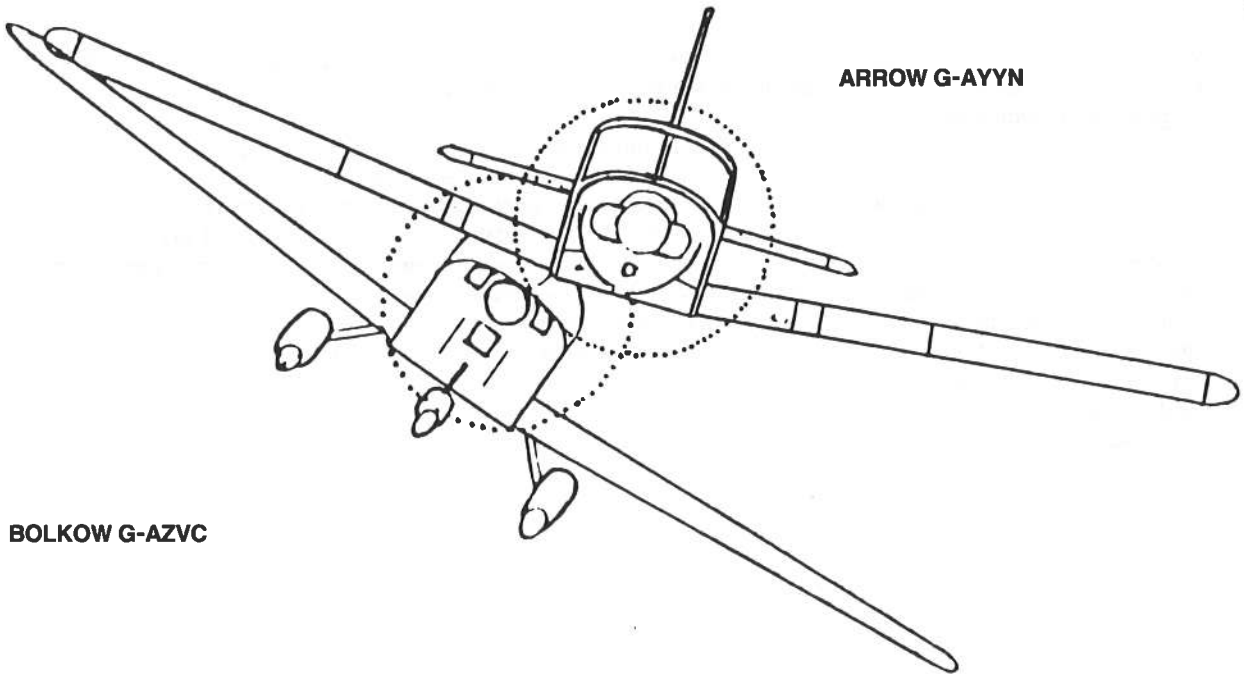
**APPROXIMATE RELATIONSHIP OF THE ARROW AND THE BOLKOW
AT THE POINT OF COLLISION**

The two aircraft were removed to the AIB facility at Farnborough where a detailed engineering investigation took place. As far as can be determined, at the time of collision, both aircraft were structurally intact and all aerodynamic and control surfaces were complete and functional. There was evidence of power on both engines. The collision took place principally between the canopy and propeller of the Monson and the underside of the Arrow. The propeller of the Monson penetrated the cabin floor of the Arrow, suffering severe damage itself and severing rudder, aileron and elevator control cables. The Monson's canopy was shattered in the collision. Black smearmarks on the canopy were identified with contacts on the retracted starboard mainwheel of the Arrow. There was a light contact between the starboard wing tips of both aeroplanes. From the witness marks found on both aircraft it was possible to adduce the approximate relative positions of each aircraft as illustrated in the diagram.

ARROW G-AYYN

BOLKOW G-AZVC
