ACCIDENT

Aircraft Type and Registration:	Avid Speedwing Mk 4 Flyer, G-LORT	
No & Type of Engines:	1 Rotax 582 piston engine	
Year of Manufacture:	1992	
Date & Time (UTC):	10 April 2010 at 1534 hrs	
Location:	Field at Holne, Newton Abbot, Devon	
Type of Flight:	Private	
Persons on Board:	Crew - 1	Passengers - None
Injuries:	Crew - 1 (Serious)	Passengers - N/A
Nature of Damage:	Serious damage to forward fuselage structure and landing gear	
Commander's Licence:	Private Pilot's Licence	
Commander's Age:	59 years	
Commander's Flying Experience:	1,182 hours (of which 14 were on type) Last 90 days - 2 hours Last 28 days - 2 hours	
Information Source:	AAIB Field Investigation

Synopsis

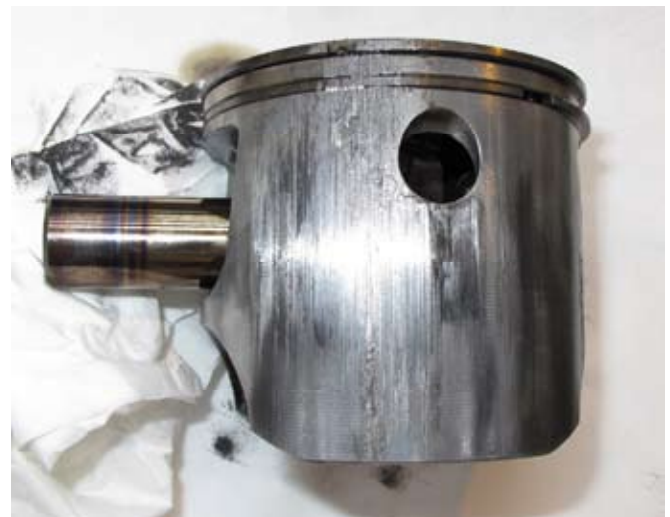
Figure 1

The aircraft was recovered to the AAIB where the engine was examined and stripped with the assistance of two engineers from a Rotax agent. The examination revealed that the piston, in the forward (‘power takeoff’¹) cylinder, had scoring marks on opposing sides of its walls (Figure 1). The walls of the ‘power takeoff’ cylinder were similarly scored and this damage was consistent with the piston having seized during operation. The piston and cylinder walls of the aft (‘magneto’) cylinder were undamaged. There was no evidence of detonation on the piston surfaces, which

‘Power takeoff’ piston showing vertical scoring marks consistent with piston seizure

indicated that an excessively lean mixture was an unlikely factor. There was sufficient oil in the engine and no evidence of oil pump failure or noticeable lack of oil surrounding the pistons. According to the engineer from the Rotax overhaul organisation, the evidence of scoring on opposing sides of the cylinder was consistent with overheating from insufficient cooling by the liquid cooling system. In his experience piston seizure from inadequate lubrication would have resulted in scoring around the entire circumference of the piston, which was not the case here. The piston-to-cylinder wall clearances were measured and were within specification.

The evidence from the scored 'power takeoff' piston was indicative of the piston having seized due to overheating. This evidence was consistent with the pilot's report that the engine stopped suddenly after a rapid rise in coolant temperature. The pre-impact coolant level quantity in the radiator could not be positively established due to multiple leaks suffered following impact, but the coolant level quantity in the overflow bottle was below the minimum required. This may have been an indication that the radiator was suffering from a leak, because if the

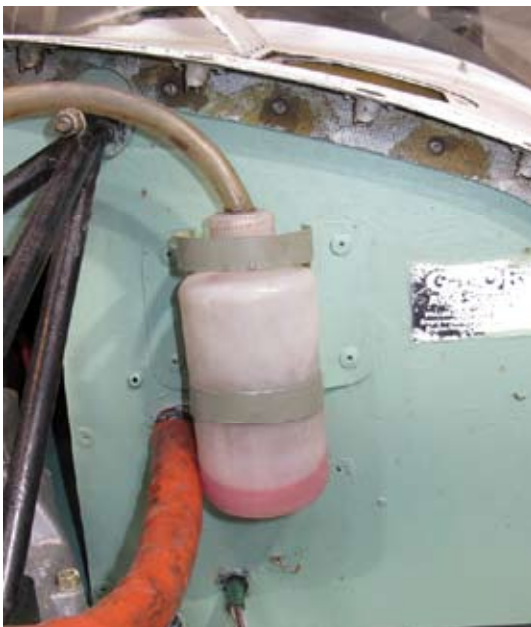
Figure 2

which would have resulted in much of the coolant loss. It was therefore not possible to pressure-test the system to examine for possible pre-impact leaks. The coolant level in the overflow bottle was below the ‘minimum cold’ red line; it was just under ¼ full, but should have been at least ⅓ full. This level was probably a reliable ‘pre-impact’ indication as the aircraft did not turn over. The red line on the overflow bottle was not initially visible, as it was covered by a circular strap bracket retaining the bottle (Figure 2). It was only when the bottle was pushed upwards into its correct seating position that the red line became visible (Figure 3). The pilot considered that he would have noticed if the bottle had not been correctly seated prior to the first flight of the day, and believes it more likely that the bottle slipped in its bracket during the impact.

Radiator overflow bottle in the as-found position with the as-found coolant quantity

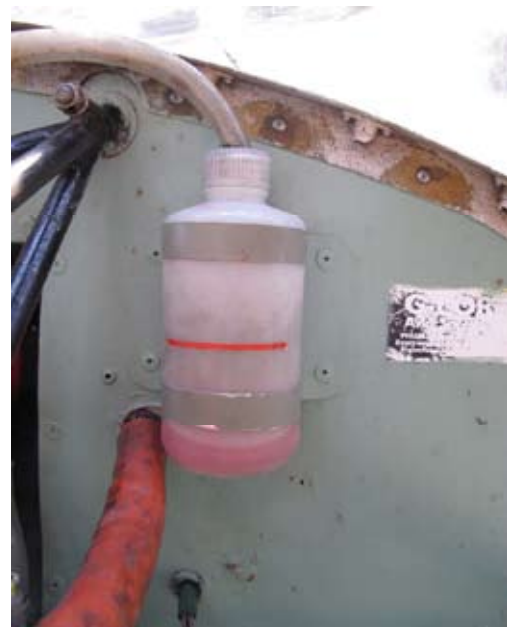
Figure 3

Radiator overflow bottle after being pushed up into its correct seating position (red ‘minimum cold’ line visible)

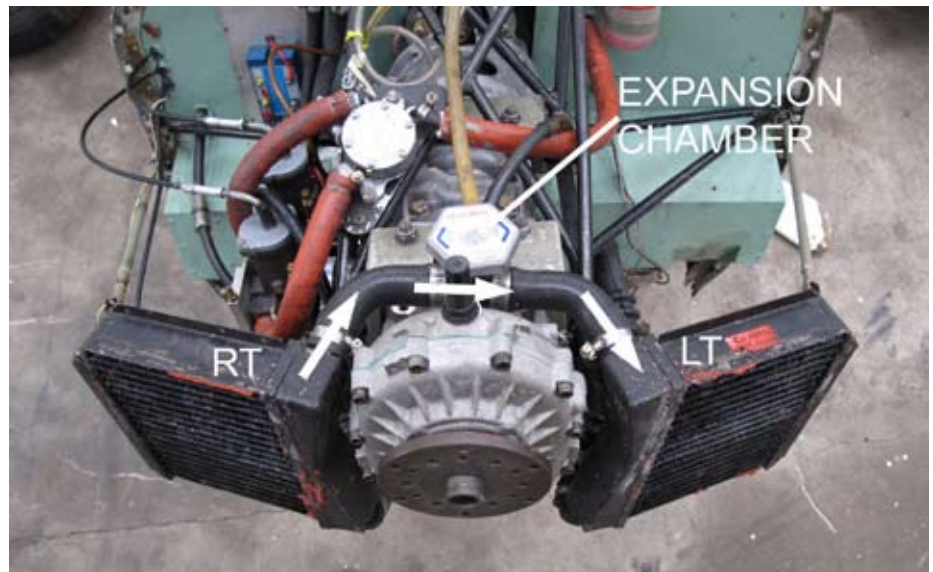
Figure 4

Dual radiator installation on G-LORT; white arrows show direction of coolant flow

Figure 4. The Rotax agent engineer suggested that with this installation and the small expansion chamber it might not require a significant coolant loss before the air gap was large enough in the upper connecting hose to stop the coolant flowing from the right radiator to the left radiator. The LAA were contacted regarding this installation and they confirmed that it was installed in accordance with the Avid build manual for the type, and that the LAA had approved the type based on successful in-service experience. They were not aware of any particular cooling issues on this version of the type. The builder of the aircraft stated to the LAA that he had not experienced any overheating problems with G-LORT.

level in the radiator was reducing due to a leak, then replacement coolant from the overflow bottle would have been sucked in. The design of the dual radiator installation, with the small expansion chamber, meant that it was probably less tolerant of a coolant leak than the Rotax-recommended installation - meaning that a smaller loss of coolant was necessary to stop the flow. The amount of coolant that would need to be lost, in the G-LORT installation, to stop the flow was not established. There were no defects with the radiator pump or thermostatic valve so the most probable cause of the engine overheating was a loss of coolant. It could not be established where the coolant leak occurred, when it started, the leakage rate, or why it was not noticed.

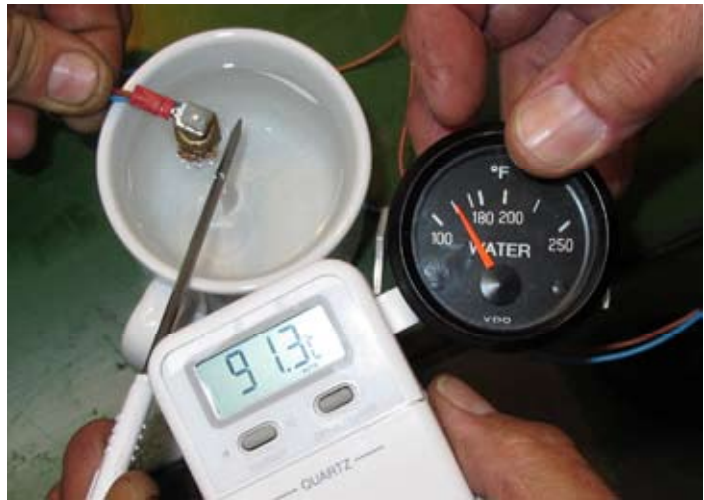
Figure 5

The coolant temperature sensor and temperature gauge were removed from the aircraft and tested together. At a water temperature of 196°F (91°C) the gauge was indicating about halfway between the 100° and 180° marks (Figure 5). The scale on the gauge did not appear to be linear so it was not possible to determine what the two marks between 100° and 180° represented, but it was apparent that the gauge was under-reading by about 40°F to 60°F.

as 175°F (80°C). These figures are consistent with the gauge under-reading by about 40°F to 60°F when it was indicating just over the 100°F mark. During the accident flight the pilot saw the gauge needle rise rapidly to the vertical position, which is about the 200°F mark. Therefore, the coolant temperature had probably risen to about 240°F to 260°F, well above the maximum operating limit. The coolant temperature is measured at the cylinder head block.

Coolant temperature sensor and gauge test
(91.3°C = 196°F)

The fact that the coolant temperature gauge was under-reading by 40°F to 60°F was not picked up, even though it was indicating well below normal minimum operating temperature in flight. If this problem had been fixed, and if the temperature gauge had been marked with the minimum and maximum limits, then it is possible that the temperature exceedence would
