Aircraft Type and Registration:	Grob G109, G-BRCG	
No & Type of Engines:	1 Limbach L 2000-EBIA piston engine	
Year of Manufacture:	1981	
Date & Time (UTC):	6 March 2005 at 1230 hrs	
Location:	Pocklington Airfield, East Yorkshire	
Type of Flight:	Private	
Persons on Board:	Crew - 1	Passengers - 1
Injuries:	Crew - None	Passengers - None
Nature of Damage:	Substantial to landing gear, propeller and lower fuselage	
Commander's Licence:	Private Pilot's Licence	
Commander's Age:	49 years	
Commander's Flying Experience:	336 hours (of which 35 were on type) Last 90 days - 9 hours Last 28 days - 4 hours	
Information Source:	Aircraft Accident Report Form submitted by the pilot

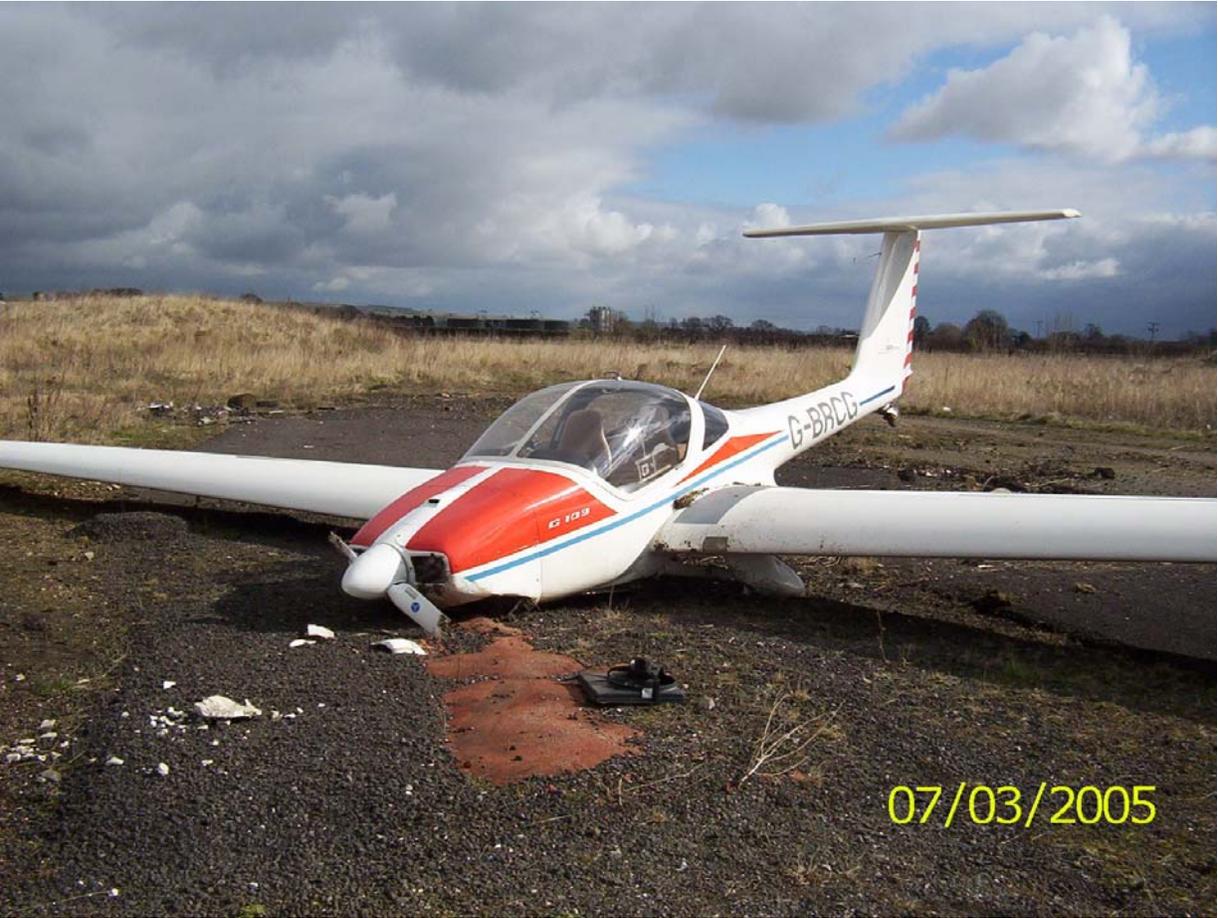
Figure 1

After an uneventful navigational exercise from Gamston, the pilot flew a shallower than normal approach to asphalt Runway 36 at Pocklington. The surface wind was 020°/10 kt and the runway was dry. The approach was flown at 60-65 kt with the throttle at idle and the airbrake marginally open; stabilising the approach on this type of motorised glider. At approximately 100 feet agl the aircraft sank rapidly. Although the pilot had time to retract the airbrakes his application of power was delayed as he had to change hands on the control column; the throttle being positioned on the opposite side to the airbrake control. Before these actions could take effect the aircraft landed heavily in rough grass in the undershoot, approximately 60 metres short of the runway threshold. The landing gear collapsed and the aircraft slid to a halt on its fuselage (Figure 1). The two occupants, who were both wearing 4 point harnesses, were able to vacate the aircraft normally without injury.

The pilot reported that, in the prevailing wind conditions, a three metre high earth bank, located 20 metres short of the runway threshold, may have created an area of sink. Exposure to this sink was exacerbated by the increased time at low level brought about by the shallower than normal approach angle. The aircraft's high aspect ratio wings are particularly susceptible to loss of lift and subsequent sink can occur very rapidly.
