No: 9/91

Ref: EW/C91/5/5

Aircraft Type and Registration: Bell 47G-5, G-BMDV

Location: 1 nm northwest of Cranfield airfield, Bedfordshire

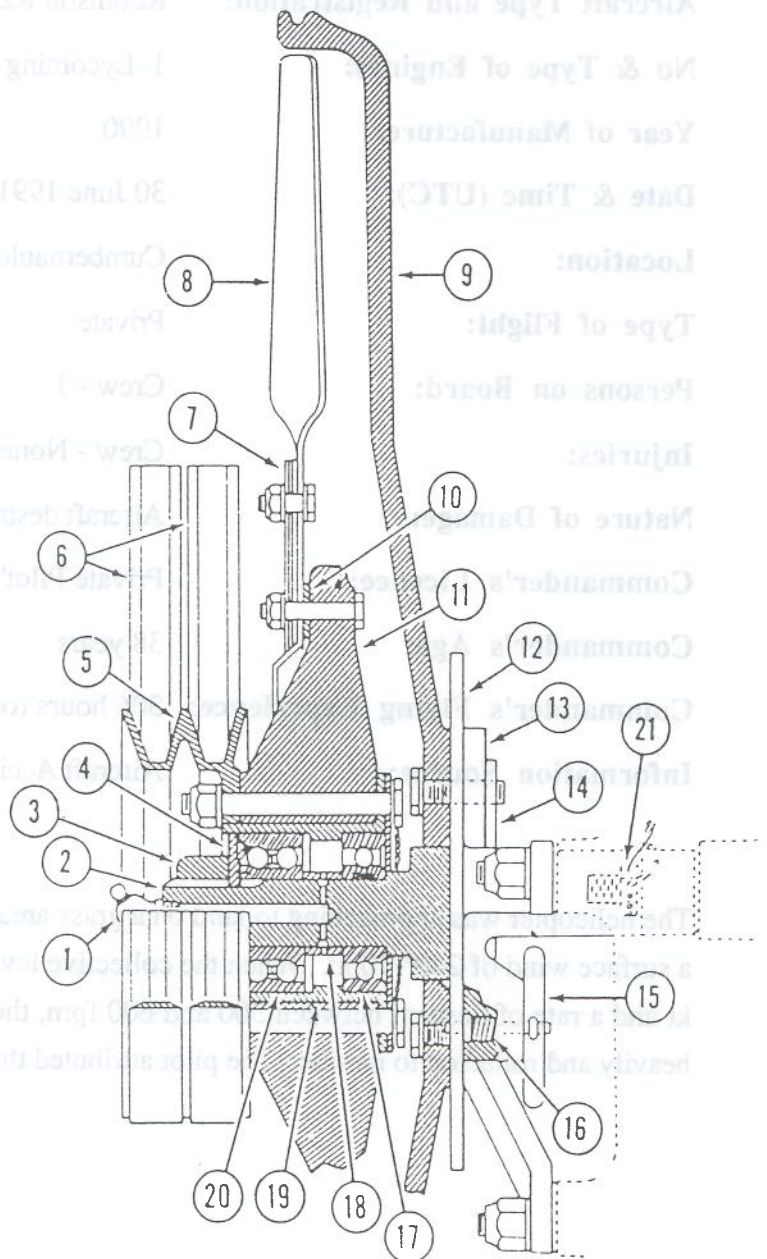
FIGURE 3 Diagram of Cooling Fan Assembly

The fan assembly and associated debris were examined by the Materials and Structures Department at the Royal Aerospace Establishment, Farnborough. This revealed the presence of 'high strain' fatigue on all three fan assembly mounting studs, i.e. indicative of failure having occurred as a result of high stresses over a relatively low number of cycles. The examination also confirmed that the fan blade and shroud ring support spoke failures were all as a result of overload. The break in the failed fan belt bore no evidence of being associated with a fan blade impact. Additionally, it was apparent that the belt had been through the fan, as there were rubber deposits on the leading edge of one of the fan blades, together with smear marks of a width similar to that of the belt on some of the other blades. A diagram of the fan assembly is shown at Fig. 3.

The bearing assembly upon which the fan rotates comprises two bearings located on a central shaft. It was apparent these had been destroyed and it was therefore necessary to establish through examination whether break-up had occurred before the incident or was as a result of out-of-balance forces following the fan blade damage. Disassembly revealed the presence of metal debris and a small amount of blackened grease which was heavily contaminated with metal particles. The raceways of the dual race front bearing bore evidence of heavy wear, with some spalling on the inner race. The outer race had to be drifted out of the hub and emerged in three pieces. This was found to be due to the presence of axial cracks that had turned in a circumferential direction under the action of removing the bearing. The relative lack of discolouration on the fracture surfaces suggested that these cracks had occurred very late in the break-up process. A small amount of 'blueing' around the cracks and on the inside of the washer located at the front of the bearing (item 4 in Fig. 3) indicated that high temperatures had been generated locally. Additionally the washer surface exhibited considerable circumferential scoring from contact with front bearing components. The inner race of the rear bearing was heavily spalled over approximately 100° of arc. The race had not rotated on the shaft, thus the orientation of the spalled area relative to the engine was preserved. This showed that the spalled area represented the loaded portion of the circumference, the load being due to the fan belt tension. This in turn suggested that the spalling had occurred over a long period, as a random distribution around the circumference would be the expected result had it occurred during the short period in which the fan was running in its damaged state. Two of the bearing cages had been reduced to fragments, some of which were found in the grease deposits. The rear cage of the front bearing had survived intact, although raised 'lips' were noted on the edges of the ball cut-outs. The balls themselves exhibited somewhat pitted surfaces.

Consideration of all the evidence indicated that the sequence of events was precipitated by failure of the front bearing. The resultant play in the bearing would have allowed upwards movement of the fan assembly under the action of the fan belt tension. The fan would also have tended to tilt rearwards, out of plane, due to the pulley being located several inches forward of the bearing. Further examination of the shroud support ring confirmed that blade rub had been confined to an area close to the 12 o'clock position, and that one of the support ring spokes, also at the 12 o'clock position, had received multiple blade strikes due to tilting of the fan. The reduced fan belt tension then probably allowed one of the belts to jump out of its channel so that it was running on the edge of a pulley flange. This in turn would have increased the tension to the extent that it broke and became entrained into the fan assembly. The subsequent damage to the fan would have produced out-of-balance forces causing rapid fatigue of the fan mounting studs, followed by fan assembly detachment.
