ACCIDENT

Aircraft Type and Registration:	Robinson R22 Beta, G-CHZN	
No & Type of Engines:	1 Lycoming O-320-B2C piston engine	
Year of Manufacture:	1988 (Serial no: 884)	
Date & Time (UTC):	6 January 2012 at 1126 hrs	
Location:	Ely, Cambridgeshire	
Type of Flight:	Private	
Persons on Board:	Crew - 1	Passengers - None
Injuries:	Crew - 1 (Fatal)	Passengers - N/A
Nature of Damage:	Aircraft destroyed	
Commander's Licence:	Private Pilot's Licence (Helicopters)	
Commander's Age:	50 years	
Commander's Flying Experience:	59 hours (of which 59 were on type) – Helicopters 4,960 hours – Aeroplanes Last 90 days - 18 hours Last 28 days - 12 hours	
Information Source:	AAIB Field Investigation

Synopsis

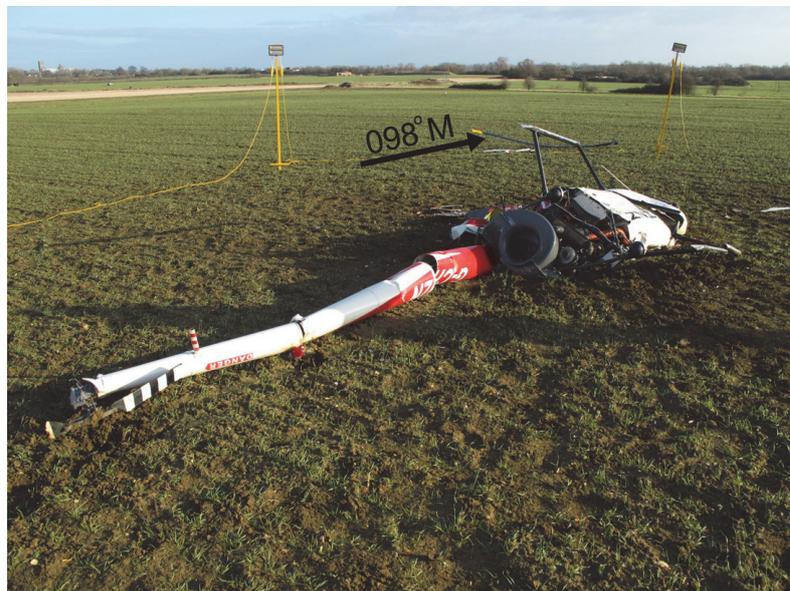
Figure 7
Main wreckage

The main wreckage was found lying inverted in a field 2 miles south-west of Ely with its main rotor shaft buried in the ground (Figure 7). The lack of ground marks surrounding the wreckage indicated that the helicopter had struck the ground in an inverted attitude with very little horizontal speed. The main rotor (MR) blades were missing and one blade was found 315 m south-east of the main wreckage, in a hedge with its root embedded in the ground and its tip in the air (this will be referred to as MR blade No 1). The other MR blade was found 450 m east of the main wreckage lying flat in a field (this will be referred to as MR blade No 2). Both blades had separated from the main rotor hub at the coning hinge. Scattered along the length of a 500 m wreckage trail (Figure 8) orientated to the south-east of the main wreckage were multiple pieces

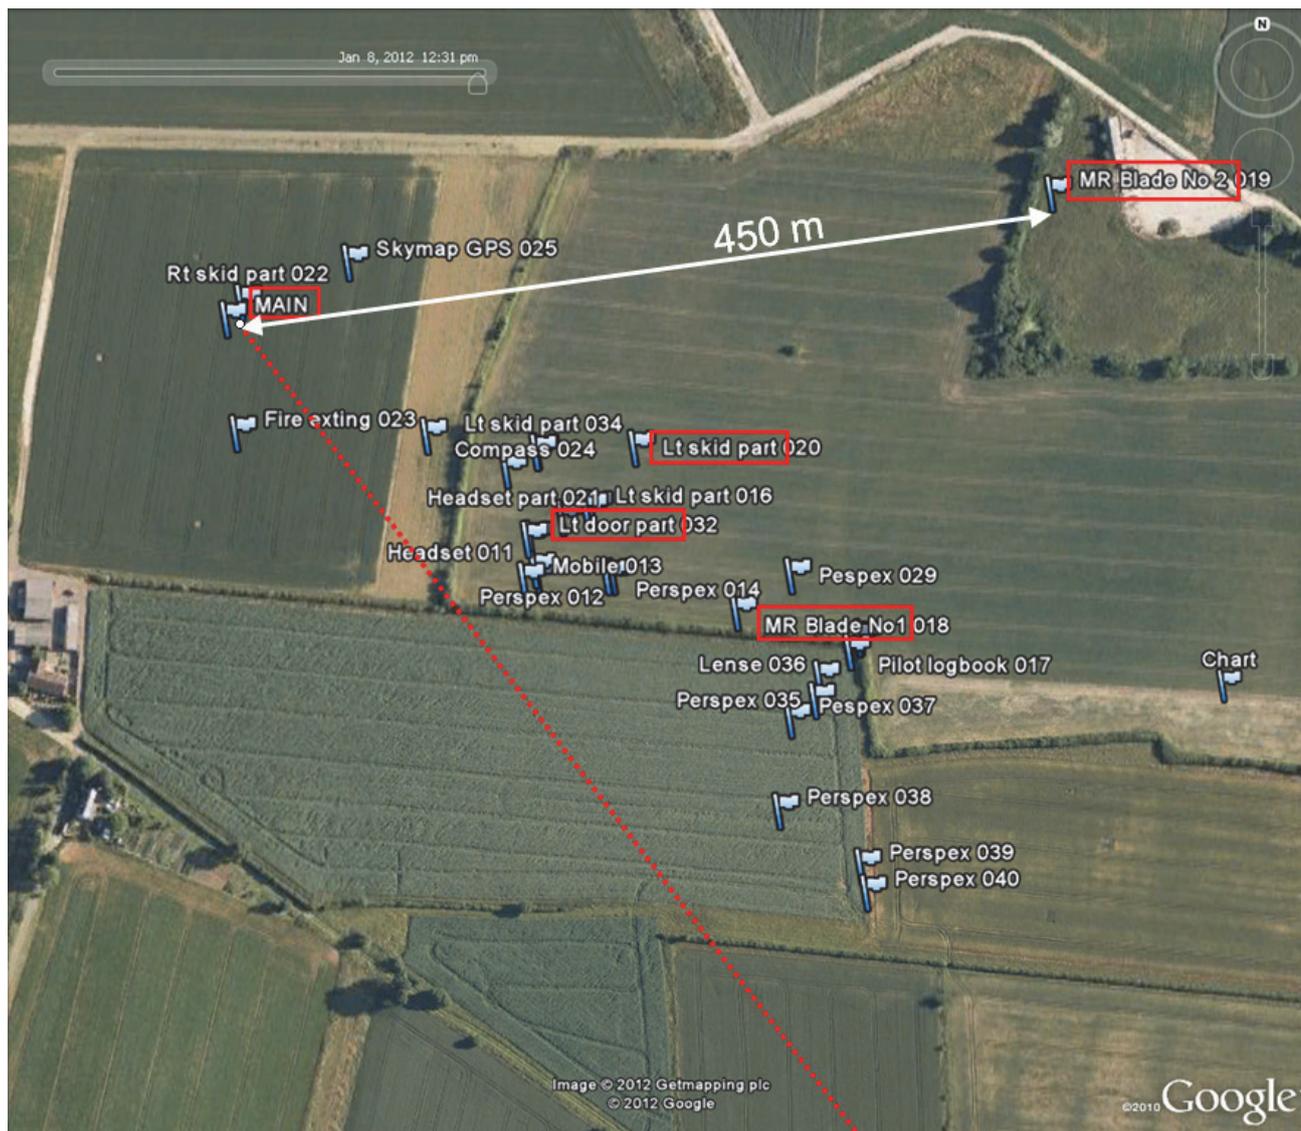
Figure 8

of broken 'perspex' transparency and items from the cockpit. The left door, a small part of the right door and parts from the front left skid were located about 220 m from the main wreckage.

Wreckage plot overlaid with probable final track (dashed red line)
 (image copyright Google Earth™ mapping service/Getmapping plc)

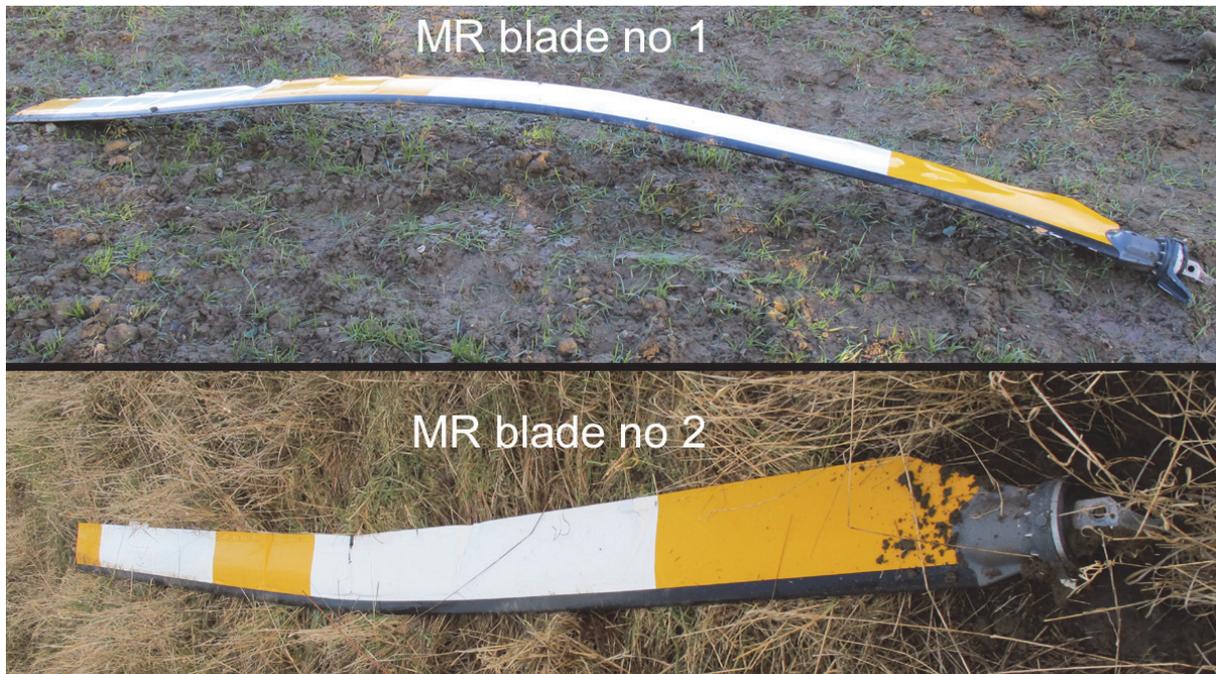
Figure 9

MR blade No 1 was bent downwards in a curve (Figure 9) and its lower skin was crinkled along the full span while the upper skin was crinkled from mid-span outwards. The blade also had a slight aft bend near the tip. The leading edge of the blade was undamaged, but it had a few black and red smears. At about 2.36 m span there was light scuffing on the leading edge which could have been caused by contact with the left skid. At

Main rotor blades No 1 and No 2 as recovered from the accident site

the blade's root the spindle tusk was bent 'aft' by about 10° (aft meaning opposite to the direction of rotation). The pitch horn was intact, but slightly bent, and there were witness marks at the edges of the hole that had secured the missing pitch link bolt – this indicated that a force was applied to the bolt before it separated. The spindle bearings were free to rotate with no 'ratchety' feel.

MR blade No 2 was bent aft at about mid-span and had a crinkled upper and lower skin (Figure 9). There was no leading edge or tip damage, but there were a few red and white smears on the leading edge. The spindle tusk was bent aft by about 40°. The pitch horn had failed near the blade root and metallurgical examination of the fracture surface revealed that this was an overload failure. The separated pitch horn was still attached to the pitch link which was still attached to the rotating swashplate. The spindle bearings were free to rotate with no 'ratchety' feel.

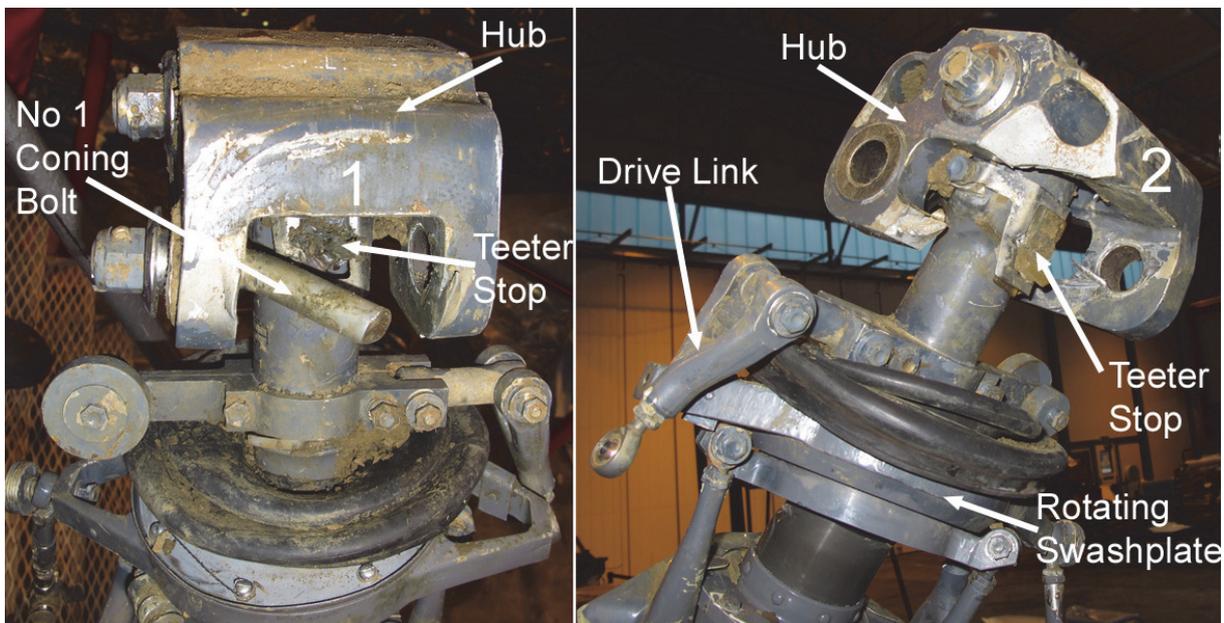
Figure 10

The main rotor hub was damaged as a result of the in-flight main rotor blade separations (Figure 10). The No 1 coning bolt had failed and was bent aft and the aft lug was also bent outwards. Metallurgical examination of the coning bolt fracture surface revealed that it had failed in overload with no evidence of fatigue. This evidence indicated that MR blade No 1 had separated following a radial and aft loading at the coning bolt that was in excess of design loads. MR blade No 2 had separated in a similar manner, failing the No 2 coning bolt in overload, and tearing the aft lug rearwards (Figure 10 – right image) – metallurgical examination of the hub fracture surfaces did not reveal any evidence of fatigue.

Both elastomeric teeter stops (Figure 10) were damaged and had split in the middle. This occurs when the blades flap downwards to an extreme angle and strike the mast and is known as 'mast bumping'. Witness marks on

Main rotor head as recovered from accident site, showing damaged teeter stops and drive link disconnected from rotating swashplate

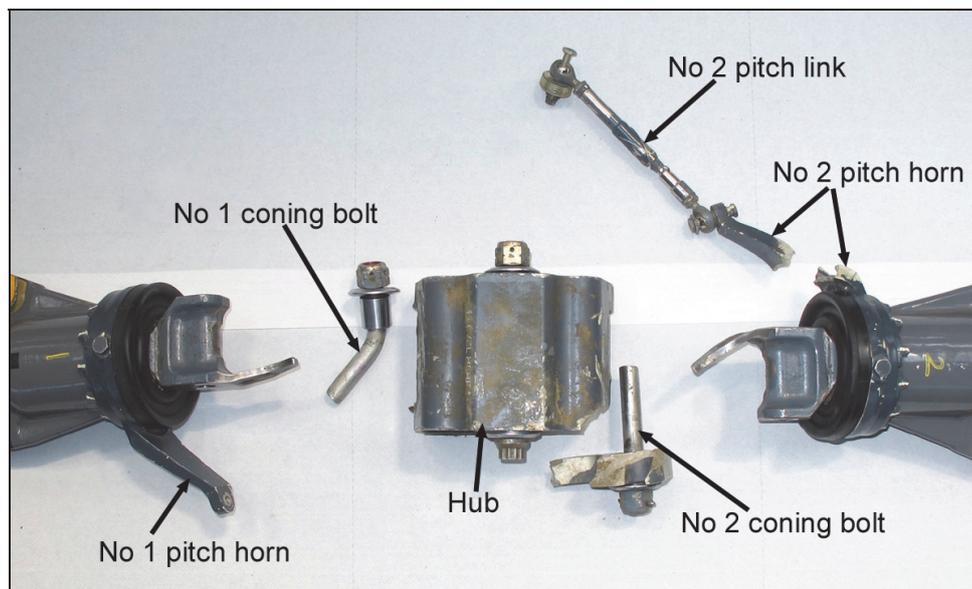
Figure 11

The No 1 pitch link had separated and the bolts at both the swashplate end and pitch horn end were missing. The pitch link bolt at the swashplate end secures the drive link to the swashplate through an eye end, so when this bolt separated the drive link detached from the swashplate as shown in Figure 10 (the drive link attaches on the inside of the swashplate, shown in Figure 6). Witness marks in the eye end of the drive link indicated that the bolt had been forced sideways and this lined up with a witness mark on the inside of the swashplate attachment hole. Such witness marks would not have been made if the nut had simply come off the bolt, or had broken, but the marks indicated that a high force was applied and therefore probably failed the bolt in overload. Similar witness marks at the pitch horn end of the pitch link indicated that this bolt probably also failed in overload, resulting in the separation of the No 1 pitch link. The

No 2 pitch link was found still secured at both ends but had separated from the blade where the pitch horn had failed (Figure 11).

Main rotor blade roots, coning bolts, hub and No 2 pitch link
(No 1 coning bolt removed from hub, No 2 pitch link disconnected from rotating swashplate.
No 1 pitch link and coning bolt heads were not found)

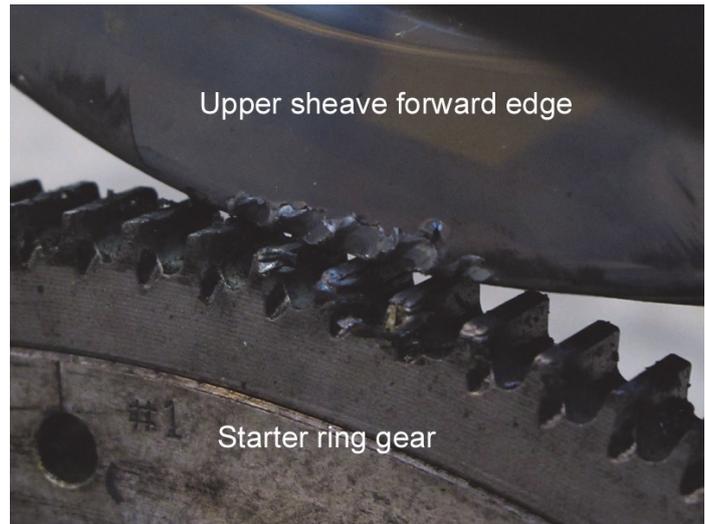
Figure 12

There was an impact imprint on the upper sheave from five teeth on the engine's starter ring gear (Figure 12) which probably occurred when the helicopter struck the ground inverted, causing the engine to strike the sheave. If the engine had been running at impact then multiple scores on the upper sheave would have been expected, therefore the engine was probably not rotating at impact. Fuel flow from the fuel tanks to the engine is by a gravity-feed system with no fuel pump, therefore the helicopter's inverted attitude prior to impact could have interrupted the fuel flow and caused engine stoppage prior to impact. To determine if engine stoppage had been an initiating event to the accident a strip examination was carried out.

Impact imprint on upper sheave from starter ring gear

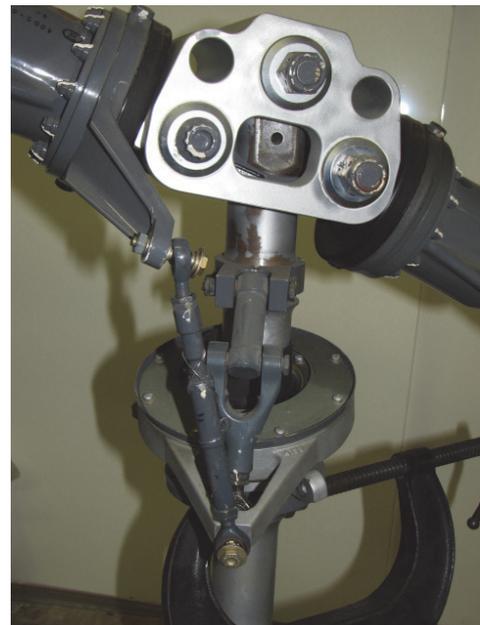
Figure 13

To explain the failure of the No 1 pitch link, the manufacturer set up a rig of an R22 main rotor head assembly (Figure 13), with the elastomeric teeter stops removed to simulate the geometric situation following mast bumping where the stops have been split and the blade root is striking the mast. Normally the pitch link is aligned vertically, perpendicular to the plane of rotation, and experiences pure tensile and compressive loads, but at extreme teetering angles the pitch link tilts aft. This allows bending loads to be applied to the pitch link and retaining bolts. The aerodynamic forces during rotor blade divergence could be sufficient to pitch the rotor blade further nose down than in Figure 13, which would force the pitch link down and fail the lower attachment bolt in a downwards and forward direction. This was consistent with the witness marks found in the swashplate attachment hole and the eye end of the drive link.

Failure and separation of the No 1 pitch link lower attachment bolt would have resulted in a loss of drive to the rotating swashplate, because the same bolt secures the drive link. This would cause the rotor to ‘overtake’ the swashplate which would have caused a nose down pitching moment of blade No 2 as the No 2 pitch link

lower attachment bolt lagged behind the upper bolt. It is possible that separation of MR blade No 2 followed this sequence and that it was blade separation that caused the pitch horn to fail.

R22 rotor head with elastomeric teeter stops removed to simulate the static geometry when mast bumping occurs. The MR blade on the left has been pitched to the maximum nose-down position that could be attained with hand force – the pitch link is no longer ‘over-centre’

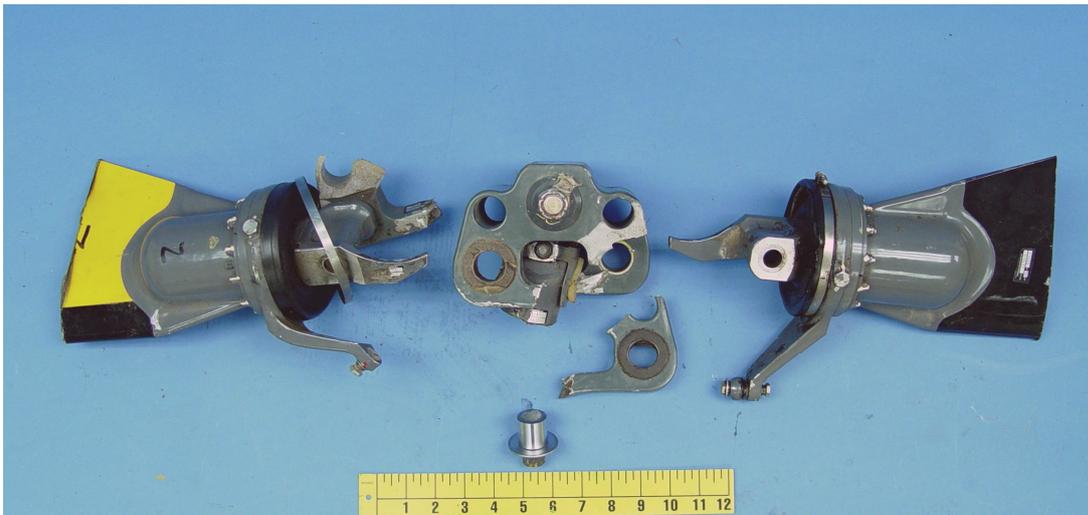
Figure G1

On 27 June 2011 an R22 (registration N7779M) suffered an in-flight breakup near Del Valle, Texas, USA. This accident is still under investigation but the NTSB provided the following information. The pilot had logged 220 flight hours, all of which were on the R22. Witnesses reported seeing it flying just above the trees and as it crossed the Colorado River they heard a loud 'pop' or 'bang' and saw something fall off the helicopter into the river. Both main rotor blades were found to have separated at the coning bolt and were located 265 m and 297 m respectively from the main wreckage. Both bolts were determined to have failed in overload and a corner of the hub had also failed, similar to the hub on G-CHZN (Figure G1). There was also clear evidence of mast bumping. One pitch link had failed at the upper thread and the other pitch link had separated following failure of both attachment bolts (Figure G2).

Rotor head components recovered from R22 accident (N7779M) near Del Valle, Texas
– blade roots have been cut for examination

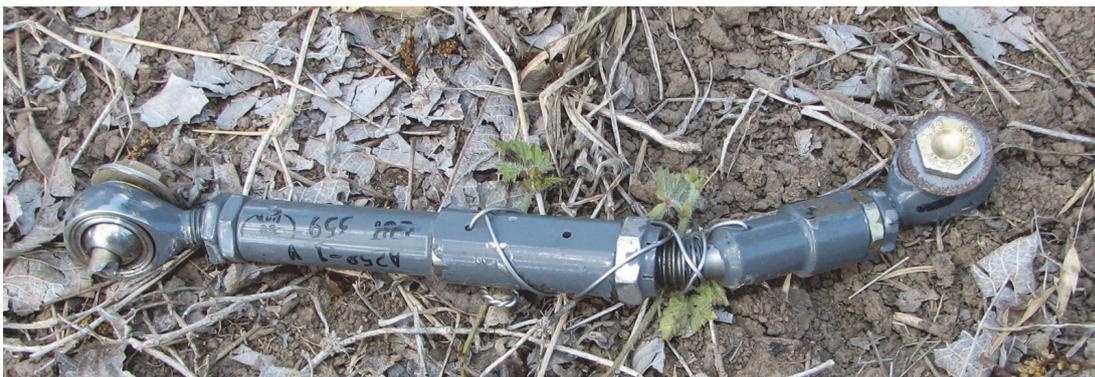
Figure G2

Separated pitch link from R22 accident (N7779M) near Del Valle, Texas
– bolts at both ends have failed
