**ACCIDENT**

<b>Aircraft Type and Registration:</b>	1) Boeing 777-200, N781AN 2) Airbus A340-300, TC-JDK
<b>No &amp; Type of Engines:</b>	1) 2 Rolls Royce Trent 892 turbofan engines 2) 4 CFM56-5C2 turbofan engines
<b>Year of Manufacture:</b>	1) 2000 2) 1993
<b>Date &amp; Time (UTC):</b>	6 November 2005 at 1238 hrs
<b>Location:</b>	Holding Area Runway 27L, London Heathrow Airport
<b>Type of Flight:</b>	1) Public Transport (Passenger) 2) Public Transport (Passenger)
<b>Persons on Board:</b>	1) Crew - 12                      Passengers - 267 2) Crew - 13                      Passengers - 270
<b>Injuries:</b>	1) Crew - None                      Passengers - None 2) Crew - None                      Passengers - None
<b>Nature of Damage:</b>	1) Left elevator and left wing tip damaged 2) Right winglet damaged
<b>Commander's Licence:</b>	1) Airline Transport Pilot's Licence 2) Airline Transport Pilot's Licence
<b>Commander's Age:</b>	1) Not known 2) 59 years

**Synopsis**

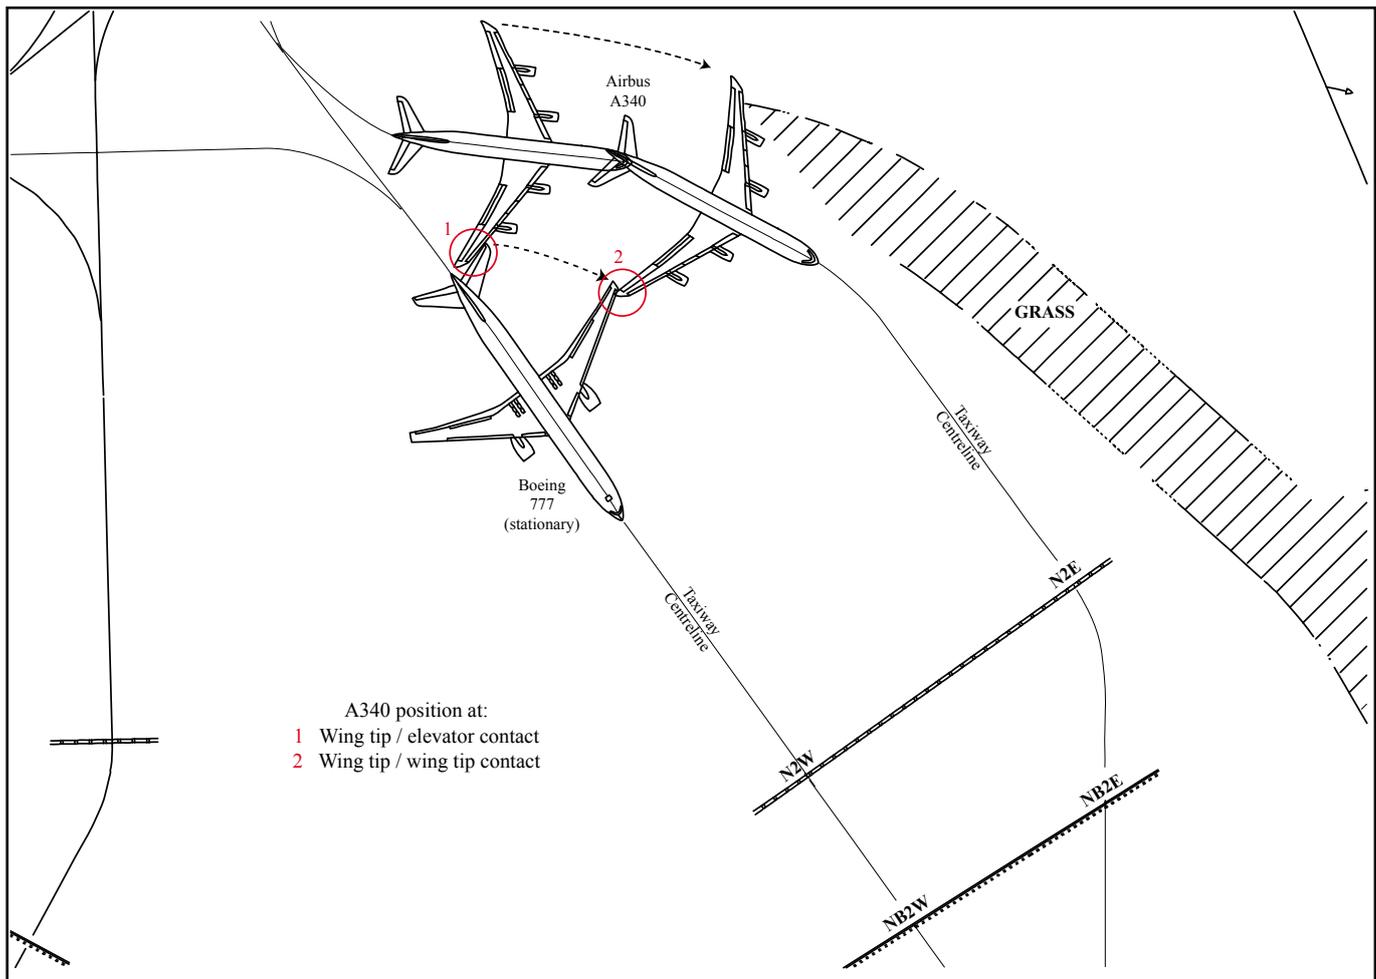
**Figure 2**

(A340) was instructed to taxi to N2E. As it passed behind the B777, the A340's right winglet made contact with the B777's left elevator and its left wing tip. The A340 had not reached the section of the line parallel to the parked B777. This accident happened at the same location as a collision between similar aircraft types reported in AAIB Bulletin 9/2005, reference EW/C2004/07/03.

Damage to the B777's left elevator and left wing tip appeared to have been inflicted by the upper part of the winglet of the A340. Damage to the A340 was temporarily repaired and the aircraft was dispatched. The B777 had been equipped with a replacement wing-tip fairing and was still awaiting delivery of a replacement elevator when examined by the AAIB.

Relative aircraft positions at points of contact

The B777 crew reported that, initially, they thought that the jolt caused by the first collision was the result of an engine surge. After checking the engine instruments they quickly discounted this and realised that they had been hit by another aircraft. Soon after the first collision they felt the second jolt and were now able to see the A340 on their left with what appeared to be a piece of their aircraft's wingtip embedded in its winglet. They added that the first collision was firmer than the second.

It is recommended that Heathrow Airport Limited review the current layout/design of the Holding Areas for departing aircraft, to ensure that wingtip clearance is maintained between manoeuvring aircraft.

It is recommended that Heathrow Airport Limited, in co-operation with National Air Traffic Services, review the current Air Traffic Control procedures applicable to the Holding Areas for departing aircraft, and any future layout of these Holding Areas, to ensure that adequate wingtip clearance is maintained between manoeuvring aircraft.
