HS 125 SERIES 3B
 AIRCRAFT RESPONSE TO ENGINE FAILURE AND CONTROL INPUT
 ANGLE OF BANK vs TIME

APPENDIX 2 RESCUE AND SURVIVAL

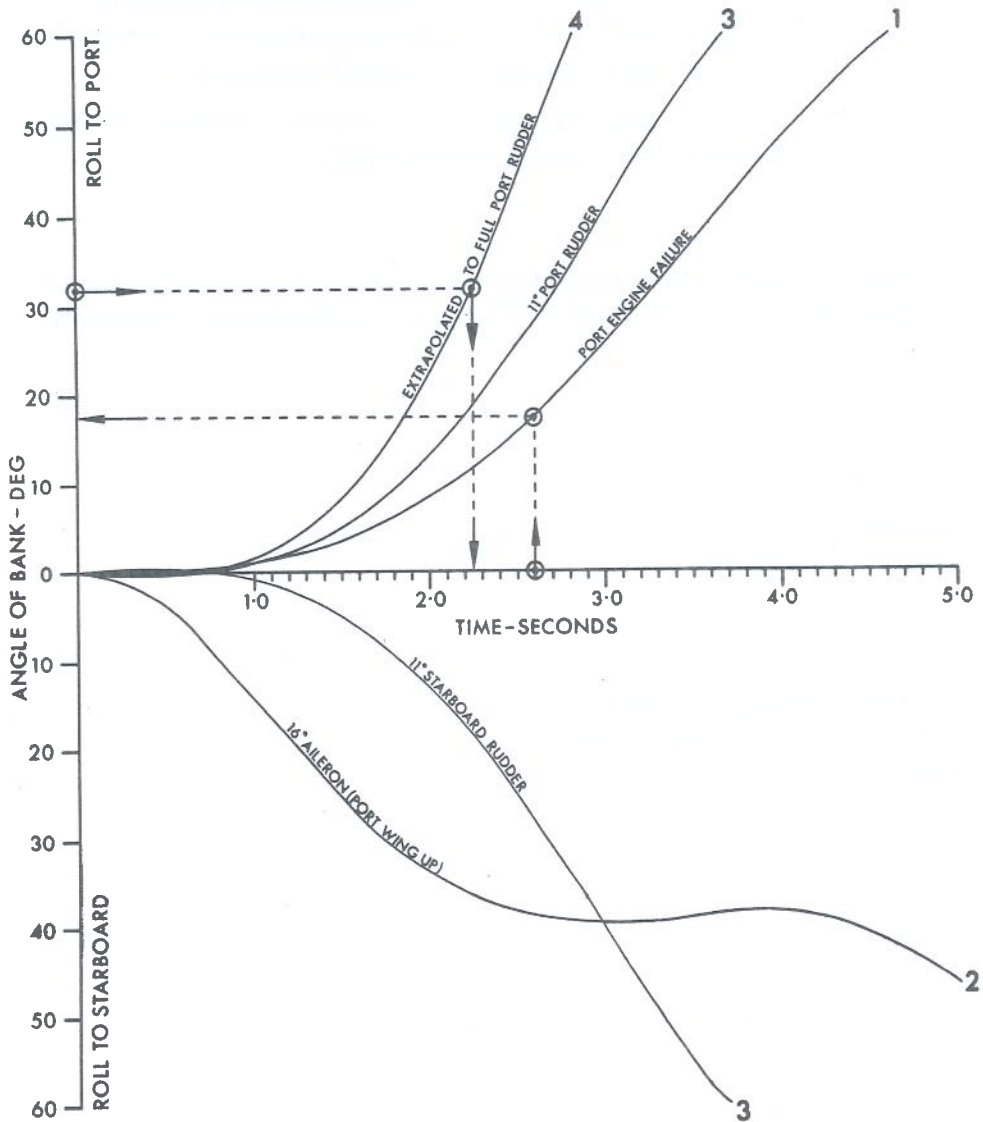
ASSUMPTIONS: AIRCRAFT WEIGHT.....19700 LB.
 ENGINE FAILURE SPEED.....130 KT. EAS
 HEIGHT.....SEA LEVEL
 OUTSIDE AIR TEMPERATURE.....11°C
 LOADING.....0.35 MC
