INCIDENT

Aircraft Type and Registration:	Boeing 757-204, G-BYAO	
No & Type of Engines:	2 Rolls-Royce RB211-535E4-37 turbofan engines	
Year of Manufacture:	1994	
Date & Time (UTC):	12 May 2005 at 1648 hrs	
Location:	Manchester Airport, Manchester	
Type of Flight:	Public Transport (Passenger)	
Persons on Board:	Crew - 8	Passengers - 234
Injuries:	Crew - None	Passengers - None
Nature of Damage:	Scrapes and wear to the rear of aircraft in vicinity of the tail scrape limiting device and auxiliary power unit access doors	
Commander's Licence:	Airline Transport Pilot's Licence	
Commander's Age:	48 years	
Commander's Flying Experience:	10,630 hours (of which 4,030 were on type) Last 90 days - 143 hours Last 28 days - 64 hours	
Information Source:	AAIB Field Investigation

Synopsis

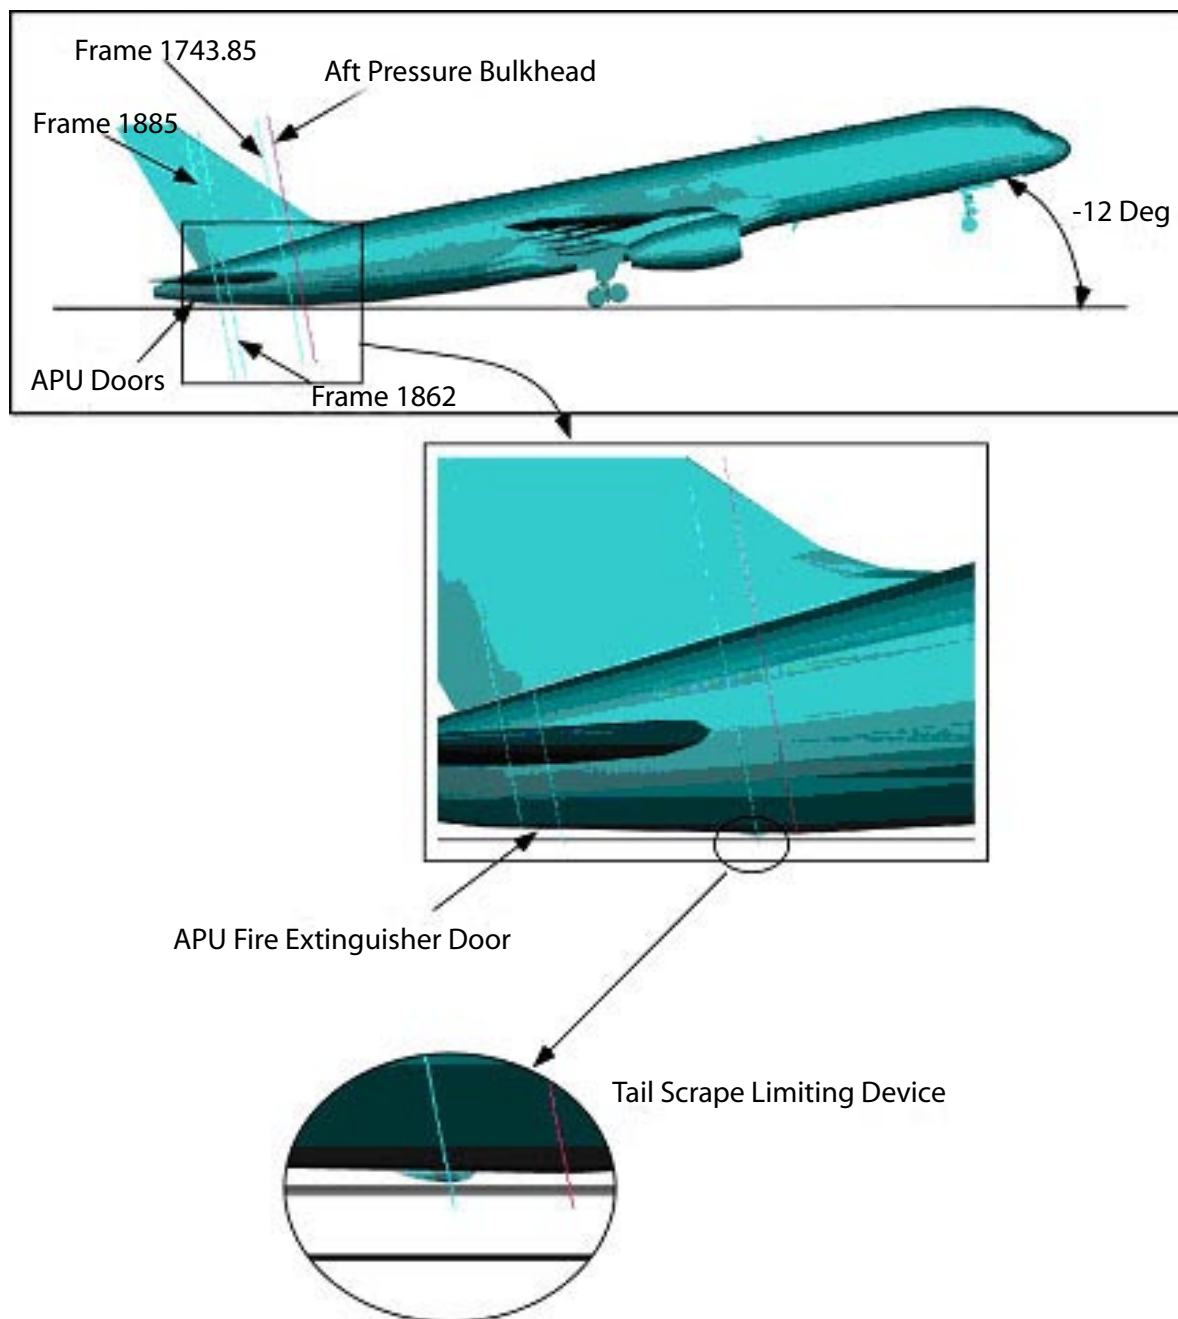
Figure 1

The TSLD had extensive contact damage, with the inverted section worn down so that it was flush with its fairing. Around the device, the airframe skin had buckled and rivets, attached to the frame, had pulled away from the external skin. Internally, frame 1743.85 had been

buckled in two diametrically opposite areas where stringer 29L and stringer 29R were attached to the frame. This buckling was consistent with an extensive upward force on the TSLD with the load being transferred into the frame, pushing this upward and causing the plastic deformation of the frame and aircraft skin.

Moving aft from the TSLD, the next contact point was at the APU fire extinguisher access door located between frames 1862 and 1885. Light scrapes were evident 150 mm aft of frame 1862, with these worsening toward the rear of the aircraft. 420 mm aft of the frame, the paint on the access door was worn away in line with the centreline of the aircraft and over an area measuring 160 mm wide and 90 mm in length. The APU access doors were mounted just aft of frame 1885, with a deflector strip mounted on the frame. The centre of the deflector strip was totally worn away, with scuffing of the airframe skin underneath over a width of about 100 mm either side of the aircraft centre line. The scrape damage continued onto the two APU access doors up to a point 470 mm aft of frame 1885. The APU doors contained several proud roundhead rivets and those along either side of the centre line had been completely worn down; coupled with additional wear of the door down to its metal skin. This damage was worse on the right hand door, with the damage at its widest point some 65 mm to the right of the centre line. The left door also suffered similar damage but this only extended 20 mm to the left of the centreline.

The airframe damage was limited to the un-pressurised area of the aircraft. The aft pressure bulkhead remained undamaged, which was mainly as a result of the TSLD. The aircraft was later flown to its home base for repair. The frame and the skin damage repairs at frame 1885 were carried out in accordance with prescribed manufacturer structural repair manual instructions and a bespoke doubler repair was carried out to the skin surrounding the TSLD. The APU fire extinguisher doors, the two APU access doors and the deflector strip were all replaced with new parts. (See Figure 1)

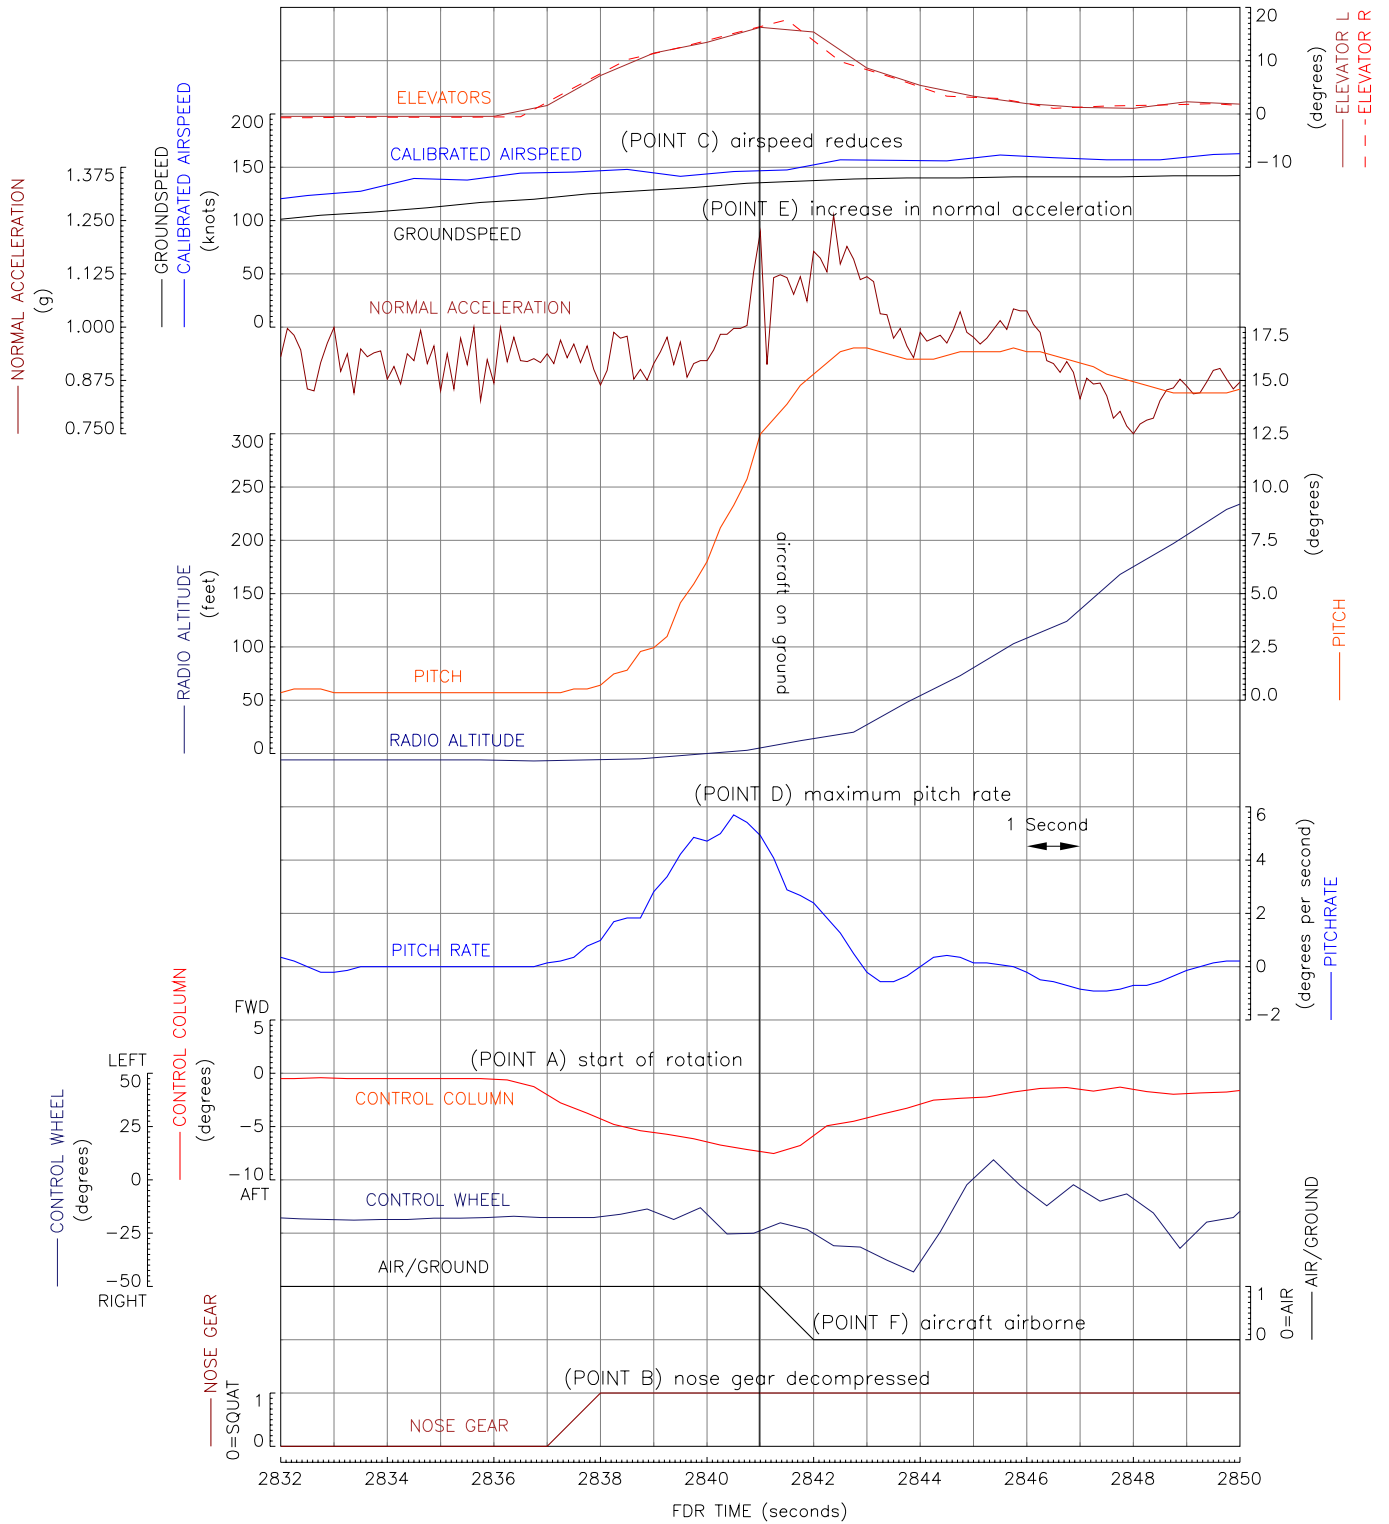
Figure 2
Salient FDR Parameters

Figure 2 details the salient parameters during the takeoff phase. At 1647:18 hrs, at an airspeed of about 144 kt and a groundspeed of about 120 kt, the control column started to move aft (Figure 2, Point A) and about two seconds later the nose squat switch indicated that the nose gear was no longer compressed (Figure 2, Point B).

About one second later the airspeed reduced to about 142 kt (Figure 2, Point C), however the groundspeed continued to increase.

About four seconds after the control column had started to move aft the pitch attitude was at about 10° nose up and the airspeed was about 146 kt; at that time the pitch rate was about 5.7° per second (Figure 2, Point D). The control column continued to move aft and the pitch attitude continued to increase. When the pitch attitude was at about 12.5° nose up, a normal acceleration of 1.22 g was recorded (Figure 2, Point E). At that time the main undercarriage truck tilt parameters indicated that the aircraft was on the ground and the elevators were at about 16° trailing edge up. For a short duration the control column continued to move aft and the elevators moved to about 17.6° trailing edge up, before the control column was then moved forward. About half a second later the air ground parameter indicated that the aircraft was airborne¹ (Figure 2, Point F), airspeed was about 148 kt and the groundspeed was about 137 kt. During the take-off roll and rotation phase the aircraft had remained predominantly wings level.

About four seconds after rotation had been initiated the pitch attitude had reached 10°, this was in accordance with the manufacturer's recommended average rotation rate of 2.5° per second over a four second period, however the pitch rate at the commencement of the rotation had initially been low and had then rapidly increased. During the rotation the elevator had moved to about 17.6°, about 5.6° beyond the maximum position that the manufacturer advised would have been necessary to have maintained an average pitch rate of about 2.5° per second. The control column position and coincident elevator movement indicated that the rapidly increasing pitch rate had been due to an increase in the aft column position.

between the airspeed and groundspeed). As the aircraft had started to rotate the headwind component started to reduce which, as the aircraft had approached 10° of pitch attitude, resulted in an airspeed that was about 10 kt below V_{LOF} . The pitch attitude continued to increase while the aircraft's landing gear was still in contact with the runway and it was most likely that at about 12.5° pitch attitude the aft body made initial contact with the runway as indicated by the coincident recording of 1.22 g.
