Pilatus PC-6/B2-H2 Turbo Porter

Centre rear angle bracket failure – left aileron

Centre rear angle bracket failure — right aileron

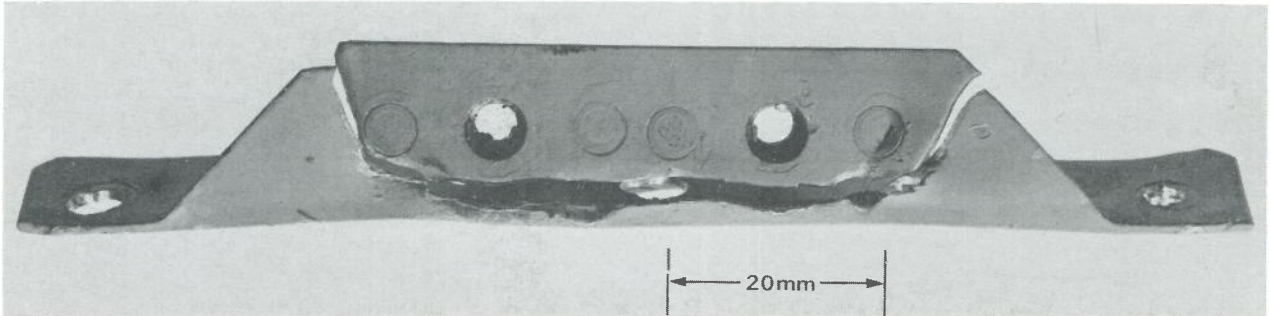
Left centre rear bracket, fatigue affected area indicated (x 1.4)

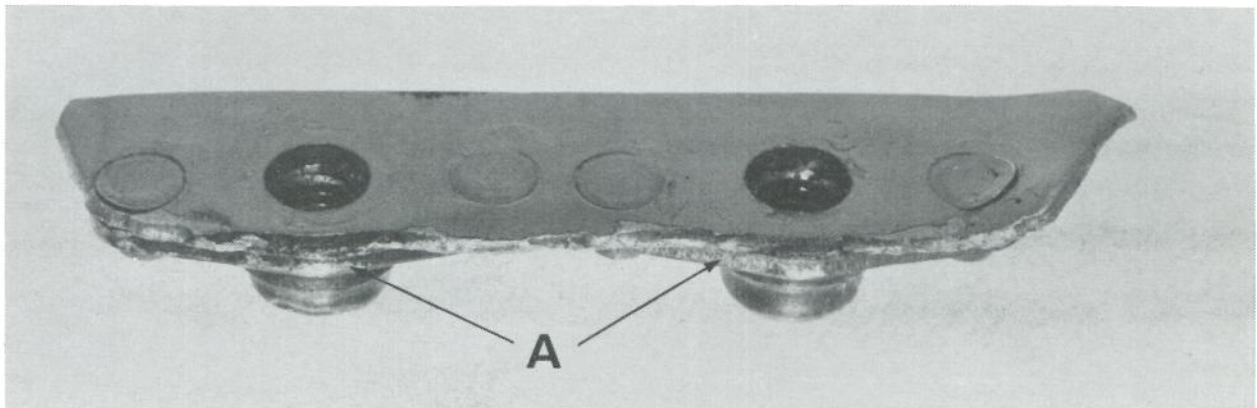
Left centre rear bracket fracture. Arrow A indicates captive nut flanges (x 2.4)

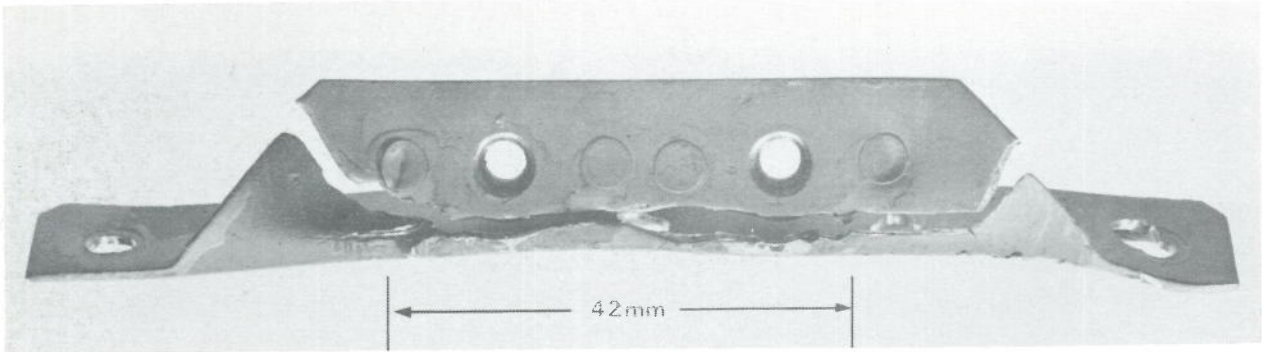
Right centre rear bracket. Length of fatigue crack indicated by arrows (x 1.4)

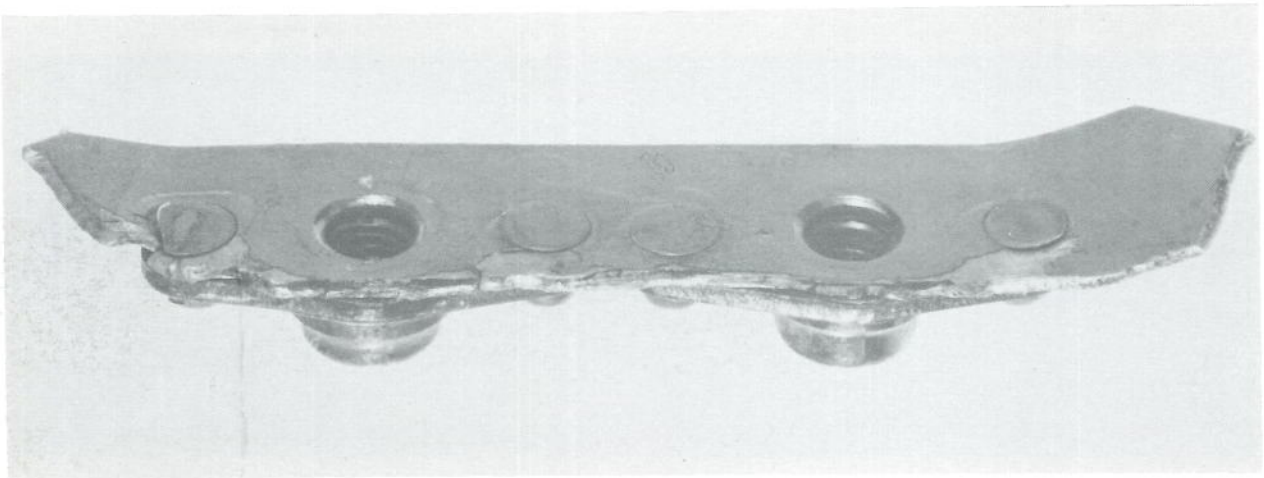
Right centre rear bracket fracture (x 2.4)
