**No: 5/88**

**Aircraft Type and Registration:** Piper PA-31-350, G-OGRV

**Date and Time (UTC):** 23 January 1988 at 0220 hrs

**Location:** Manchester International Airport

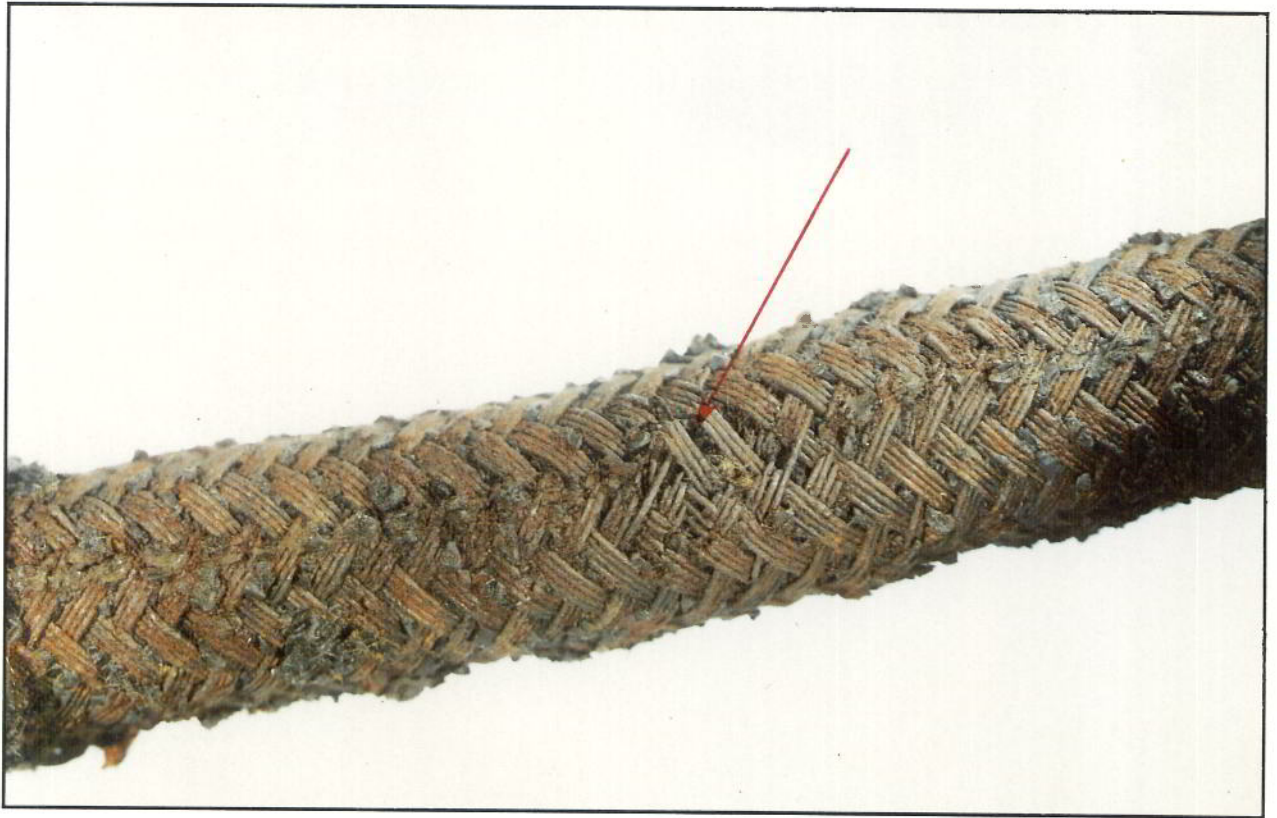
A detailed examination showed that the rupture was associated with an area of severe and relatively long-term corrosion of the high tensile steel braiding within the structure of the hose. As a result of the rupture, it could not be positively established that the outer protective layer of rubberised fabric braiding had been "chafed" sufficiently by the doubler plate to allow ingress of water. However, examination of another PA-31 operated by the same organisation revealed that one of the two gear-down hoses was also in contact with the same raised edge of the doubler plate. Localised damage and fraying of the outer braid was present. Corrosion was also present on the steel braiding of this hose, although to a lesser degree than that on the hose which failed.

Corroded section of hose steel braiding - outer fabric/rubber layer removed  
Arrow indicates burst area

A recommendation has been made to the CAA that they ensure that the requirements of CAIP AL/3-13, with regard to applicable service lives and pressure testing of hoses, are applied to CAA Approved Maintenance Schedules, so that they are clearly specified.

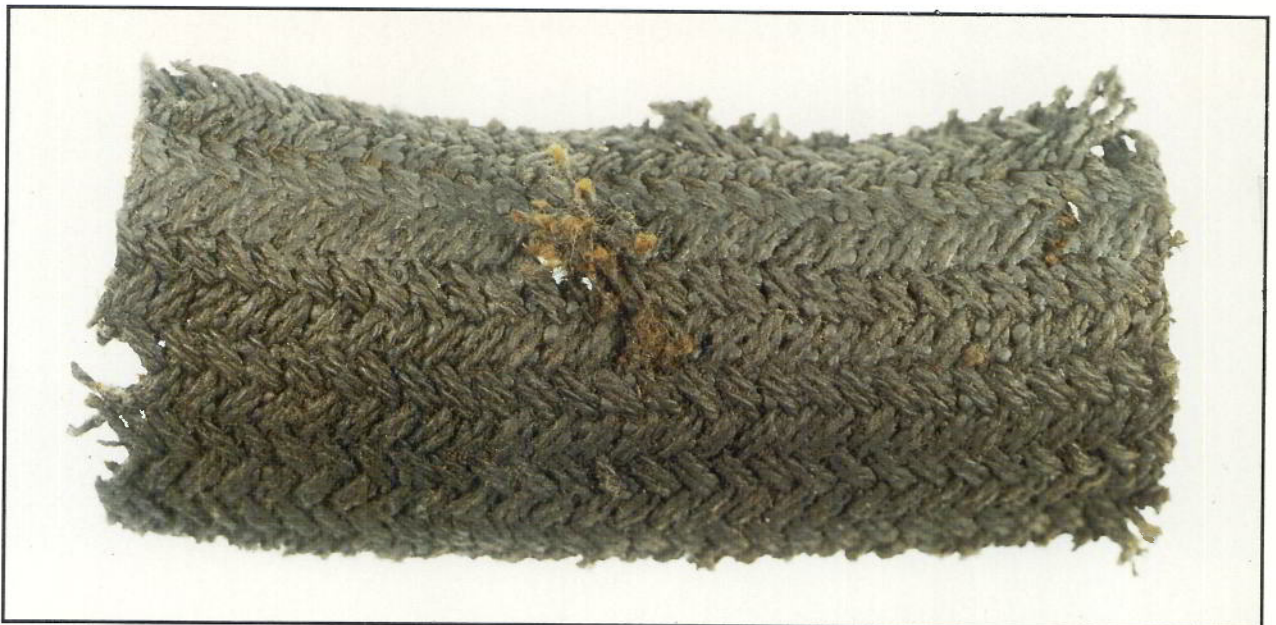
Initial examination of the aircraft revealed it to have landed with the left main landing gear locked up, the right main landing gear locked down and the nose landing gear unlocked. It was apparent that a major discharge of hydraulic fluid had occurred within the right landing gear bay, and that the power pack reservoir was empty. When replenished, fluid was seen to gush from the right landing gear bay, the source of this being traced to a rupture in the "gear down" flexible hose to the actuator. The position of this rupture was adjacent to a raised edge on a "doubler plate" on the wing rear spar. Close examination revealed that no clearance existed between the hose and this edge in either the "gear-up" or "down" positions. After hose replacement and fluid replenishment, the system operated satisfactorily.

Hose outer layer covering area of rupture
