**INCIDENT**

<b>Aircraft Type and Registration:</b>	Europa XS, G-IOWE	
<b>No &amp; Type of Engines:</b>	1 Rotax 912-UL piston engine	
<b>Year of Manufacture:</b>	2001	
<b>Date &amp; Time (UTC):</b>	10 August 2001 at 1137 hrs	
<b>Location:</b>	Wolverhampton	
<b>Type of Flight:</b>	Private	
<b>Persons on Board:</b>	Crew - 1	Passengers - 1
<b>Injuries:</b>	Crew - None	Passengers - None
<b>Nature of Damage:</b>	None	
<b>Commander's Licence:</b>	Private Pilot's Licence	
<b>Commander's Age:</b>	18 years	
<b>Commander's Flying Experience:</b>	52 hours (of which 2 were on type) Last 90 days - Not known Last 28 days - Not known	
<b>Information Source:</b>	AAIB Field Investigation

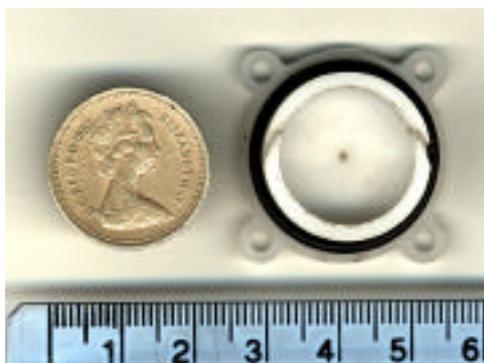
The fuel flow transducer was sent to the AAIB for examination. It was a small unit manufactured in Germany. The internal diameter of the flow chamber containing the rotor was smaller than a £1 coin (see photograph 1 below).

**Photograph 1 fuel flowmeter chamber size**

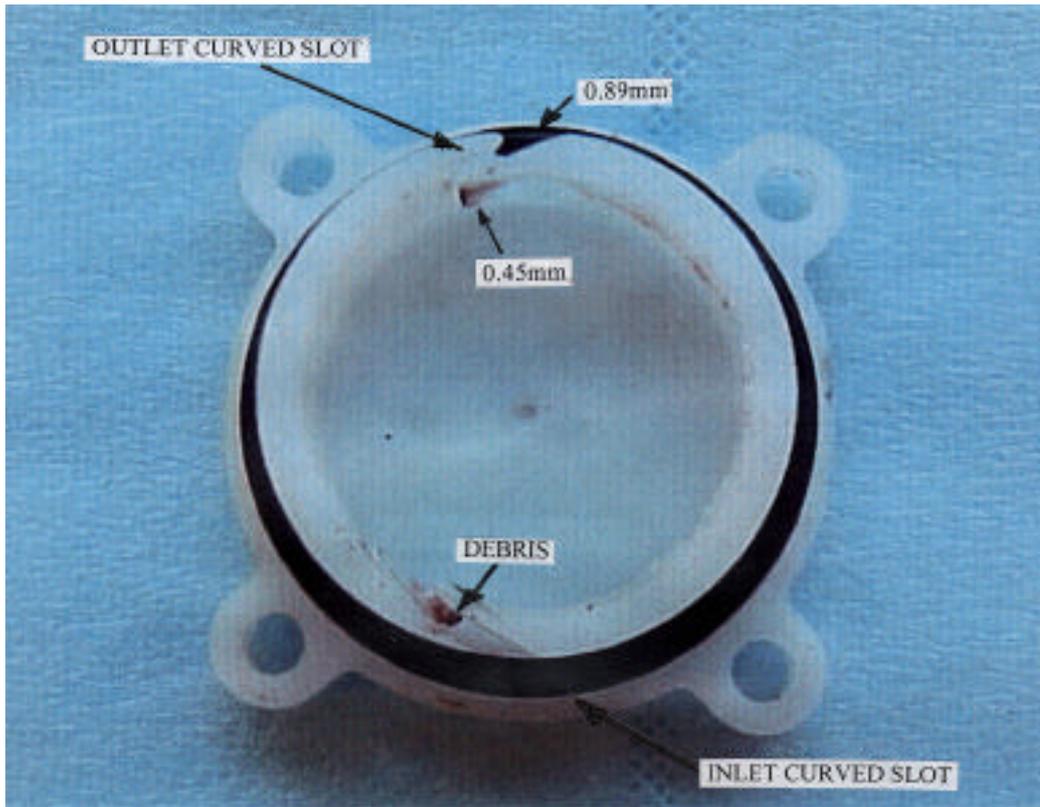
An identical new transducer was obtained by the AAIB and flow checks were carried out on both units. From the flow tests it was found that the incident transducer was restricting the flow to one third of that achieved through the new transducer. Upon disassembly, it was found that an inlet internal flow channel was partially blocked with unidentified debris (photograph 2). It was noted that this inlet internal flow channel was a curved slot that tapered from approximately 0.85mm at the inlet end to 0.30mm at its outlet end. It was also noted that the magnets mounted on the central revolving sensor were heavily coated with ferrous particles (photograph 3). There was no bypass system within this fuel flow transducer.

**Photograph 2**  
**Inner body of the fuel flow transducer**

### **Recommendation 2002 - 38**

It was recommended to the Popular Flying Association that fuel flow transducers fitted to PFA ‘Permit to Fly’ aircraft types should either be invulnerable to blockage by small particles or have an automatic, remedial bypass mechanism that prevents fuel supply restriction.

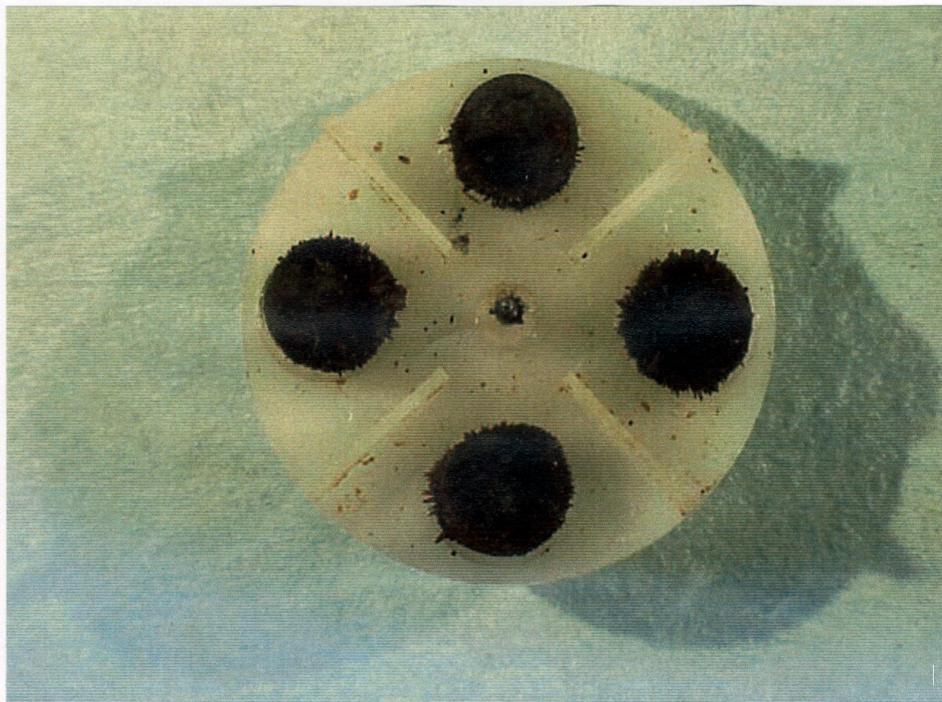
No explanation was forthcoming for the means by which debris (particularly the ferrous debris) entered the fuel flow transducer downstream of the fuel filter. The transducer was supplied as a sealed unit. The manufacturer's instructions contained the following caution: *'Do not open, loosen or in any way alter the transmitter as by doing so the measuring results will inevitably be falsified and there will be no more guarantee on the appliance'*.

**Photograph 3**  
**Ferrrous debris on the magnets of the central revolving sensor**
