# Boeing 737-500, G-OBMX

## AAIB Bulletin No: 2/97 Ref: EW/C96/9/3 Category: 1.1

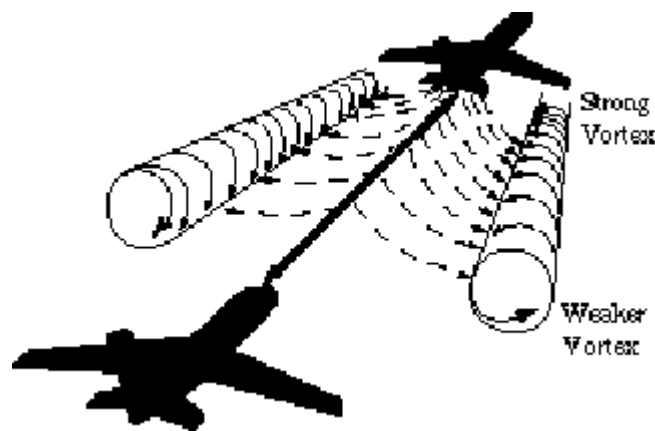
Figure 1

Wake vortices are present behind every aircraft but are particularly severe when generated by heavy aircraft. The characteristics of the wake vortex system generated are determined initially by the aircraft's gross weight, wing span, airspeed, configuration and attitude. Subsequently, these characteristics are altered by interaction between the vortices and the ambient atmosphere. Time to total decay can vary from a few seconds to a few minutes after the passage of the aircraft. For practical purposes, the vortex system in the wake of an aircraft may be regarded as being made up of two counter-rotating cylindrical air masses trailing aft from the aircraft, as shown in Figure 1. Studies suggest that, at medium level, the two vortices are separated by about three quarters of the aircraft's wingspan and, in still air, tend to drift slowly downwards, at a rate of approximately 400 feet per minute, and level off, usually not more than 1,000 feet below the flight path of the aircraft. However, their behaviour is not predictable, particularly in the aspects of their trajectory and decay.
