**ACCIDENT**

<b>Aircraft Type and Registration:</b>	Schweizer 269D Configuration A (Schweizer 333), G-TAMA	
<b>No &amp; Type of Engines:</b>	1 Rolls Royce Allison 250-C20W turboshaft engine	
<b>Year of Manufacture:</b>	2004	
<b>Date &amp; Time (UTC):</b>	4 February 2008 at 1455 hrs	
<b>Location:</b>	Sheffield City Airport	
<b>Type of Flight:</b>	Aerial Work	
<b>Persons on Board:</b>	Crew - 1	Passengers - None
<b>Injuries:</b>	Crew - None	Passengers - N/A
<b>Nature of Damage:</b>	Significant component and airframe damage	
<b>Commander's Licence:</b>	Commercial Pilot's Licence	
<b>Commander's Age:</b>	40 years	
<b>Commander's Flying Experience:</b>	1,125 hours (of which 75 were on type) Last 90 days - 131 hours Last 28 days - 49 hours	
<b>Information Source:</b>	AAIB Field Investigation

**Synopsis**

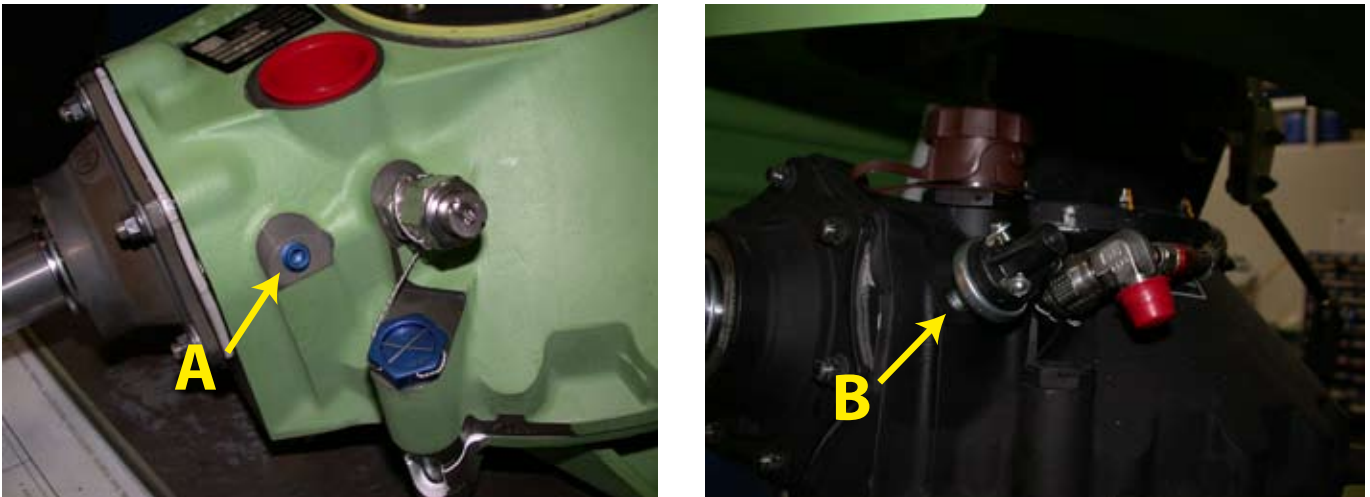
**Figure 2**

A low oil pressure warning switch is located in the oil gallery to the pinion outer bearing. The pressure switch port has a tapered thread to provide adequate sealing. Replacement gearboxes are supplied without a pressure switch installed and the port is blanked off with a threaded aluminium alloy plug, Figure 2.

The plug must be replaced with a pressure switch before installing the gearbox in the helicopter, although this is not mentioned in the maintenance manual procedure for MRGB removal and installation.

Photographs showing MRGB with blanking plug ('A') and low oil pressure switch ('B') installed

On reviewing its procedure for assembling the MRGB, the helicopter manufacturer found that it contained no instruction to install the blanking plug in the low oil pressure switch port and therefore no torque value was specified for the plug. It is also noteworthy that the MRGB is painted after the blanking plug has been installed.

In response to this incident, the manufacturer has stated that they are in the process of revising their gearbox build documents to reflect a maximum torque to be applied to the blanking plug prior to shipping.

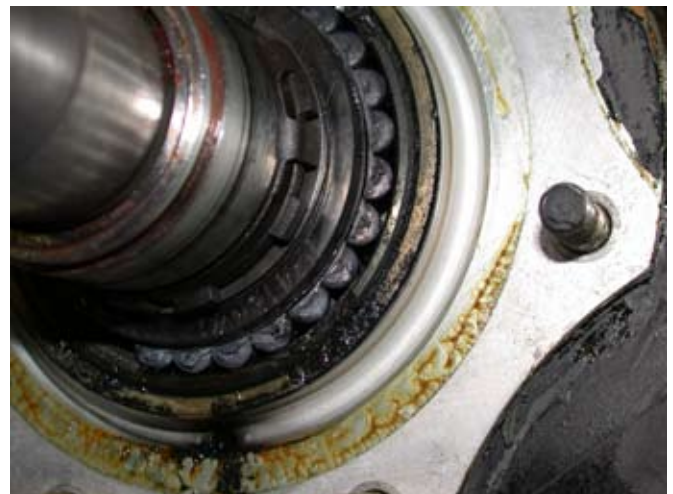
**Figure 3**

The MRGB input shaft was found to be binding intermittently and felt rough when rotated by hand. The pinion outer bearing was badly damaged from apparent oil starvation and subsequent overheating (Figure 3). The bearing cage had fractured and the rollers exhibited a dull grey coloration, with some having partially melted. The bearing retention nut and washer were intact and correctly located. The oil feed orifice in the bearing retainer was correctly aligned with the oil gallery orifice and was free of obstruction. Some ferrous debris was found in the bearing oil drain passage. No other defects were reportedly found within the MRGB which could have restricted or blocked the oil supply to the pinion outer bearing.

Photograph showing damage to MRGB pinion outer bearing

The damage to the MRGB outer pinion bearing is consistent with the effects of oil starvation. It could not be determined whether this was caused by the ferrous

fragment or the non-ferrous debris in the oil gallery, but the latter seems more likely as the smaller, lighter aluminium alloy chips would be have been more easily carried by the oil to a location where they could cause a restriction in the bearing oil supply.

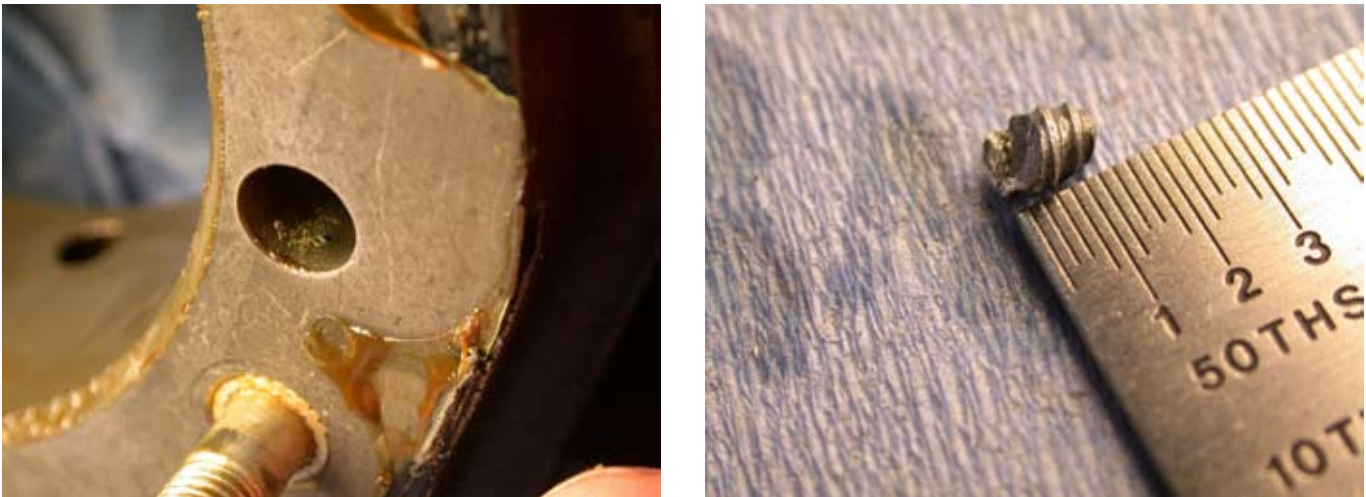
**Figure 4**

Examination of the bearing oil supply gallery revealed the presence of oil, small shiny chips of non-ferrous debris and a single fragment of ferrous debris (Figure 4). This fragment, which measured approximately 3 mm in length with a diameter tapering from approximately 0.8 mm to 2.5 mm at its widest, was found to have a machined threaded/spiral finish closely resembling the tip of a stud extractor bit.

Photographs showing metallic debris in pinion bearing oil gallery (left) and close-up view of ferrous fragment (right)

When offered up to each other under a visual microscope, the fragment and broken tool bit were found to be a close geometric match, however, an exact fracture match was not possible as some material was missing from the tool bit and the fracture surface of the fragment had been destroyed by mechanical damage.

An Energy Dispersive X-ray analysis was performed to compare the material of the fragment against that of the broken tool bit. The results showed the fragment to be a low alloy steel containing chromium with lesser amounts of manganese, molybdenum and silicon. The broken tool bit was found to be of a similar material. The surface of the fragment was also contaminated with what appeared to be an aluminium-copper alloy.

The evidence suggests that the fragment removed from the gearbox was probably the tip of the broken stud extractor tool, indicating that the blanking plug was breached in the attempts to remove it. The non-ferrous debris in the oil gallery appeared to be shavings or chips from the damaged aluminium alloy plug.
