## Cessna 310R, N234SA

<b>AAIB Bulletin No: 11/2003</b>	<b>Ref: EW/G2003/03/26</b>	<b>Category: 1.2</b>
<b>Aircraft Type and Registration:</b>	Cessna 310R, N234SA	
<b>No &amp; Type of Engines:</b>	2 Continental TSIO-520-BB piston engines	
<b>Year of Manufacture:</b>	1979	
<b>Date &amp; Time (UTC):</b>	13 March 2003 at 1550 hrs	
<b>Location:</b>	Nottingham Airport, Nottinghamshire	
<b>Type of Flight:</b>	Private	
<b>Persons on Board:</b>	Crew - 1	Passengers - 2
<b>Injuries:</b>	Crew - None	Passengers - None
<b>Nature of Damage:</b>	Damage to left main landing gear, left propeller, left wing and horizontal tail	
<b>Commander's Licence:</b>	Private Pilot's Licence	
<b>Commander's Age:</b>	60 years	
<b>Commander's Flying Experience:</b>	890 hours (of which 72 were on type)	
	Last 90 days - 7 hours	
	Last 28 days - 2 hours	
<b>Information Source:</b>	Aircraft Accident Report Form submitted by the pilot and further enquiries by the AAIB

### Synopsis

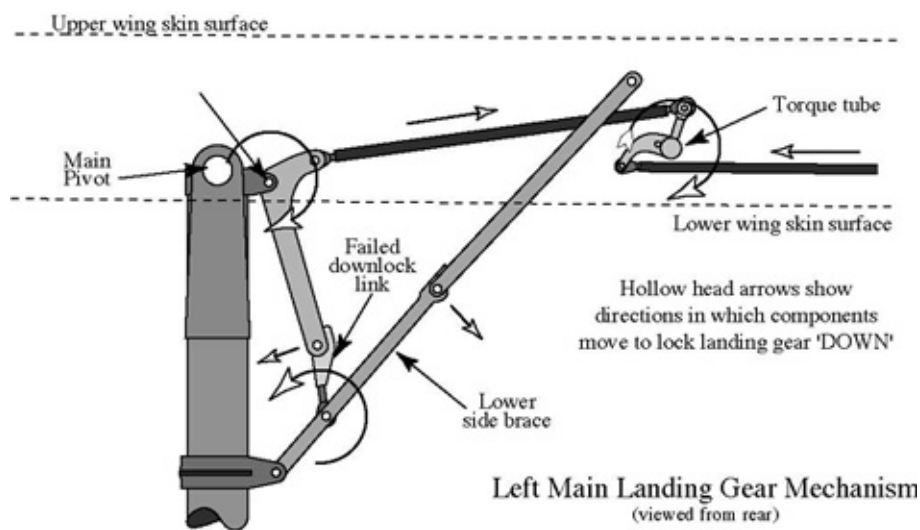
**Figure 1**

The main landing gear on the Cessna 310 is held in the down and locked position by a side brace that is rigged to an over-centre position (see Figure 1). A downlock link applies pressure to the side brace to keep it in the over-centre position. The main landing gear rigging procedure is quite involved and covers nine pages in the service manual. The aircraft manufacturer contends that small deviations from the rigging procedure can lead to a situation where the landing gear will collapse as a result of the side brace coming out of its over-centre position.

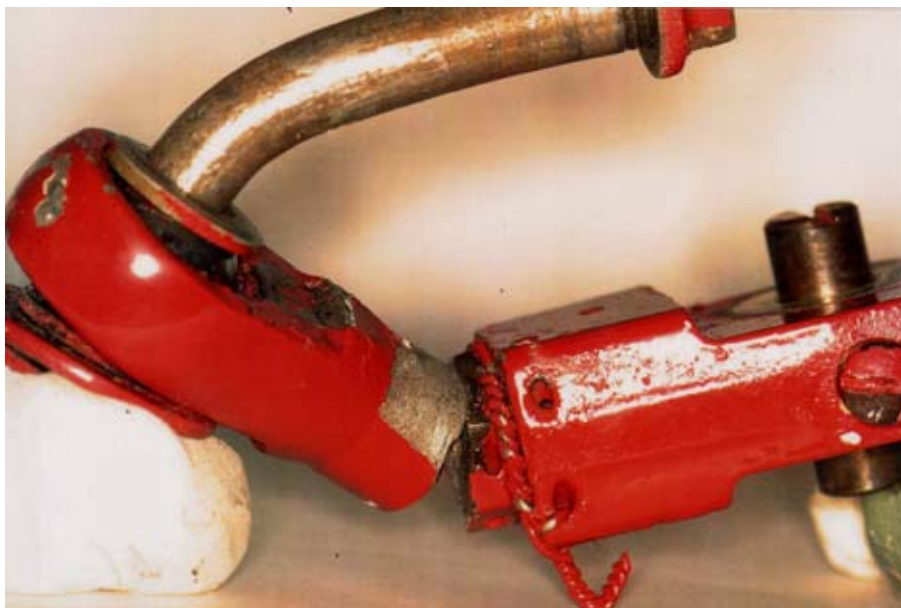
**Figure 2**

The aircraft was recovered by the maintenance organisation and later inspected by the AAIB. The aircraft had sustained damage to its left wing tip and left horizontal tail, and the left engine propeller tips were bent backwards. The downlock link that supported the left gear lower side brace had failed at the threaded portion (see Figure 2). The pivot bolt securing the downlock link to the side brace had bent and the bush through which the pivot bolt passed had been plastically deformed downwards. Further minor damage inside the left main landing gear wheel well was noted.

A metallurgical examination of the fracture in the downlock link revealed that it had failed as a result of bending overload. The metallurgist reported that the overload had been applied through the pivot bolt in the eye end and the bolt itself had been plastically bent in the process. Vickers hardness tests were carried out on undeformed regions of both the threaded stud and the pivot bolt. The hardness values of both materials were consistent with a tensile strength of  $980 \text{ N/mm}^2$  (Newtons per square millimetre) which was considered to be normal. It was further noted that the length adjustment provided by the threaded stud was almost at its minimum length position - this would provide for a minimum movement of the side brace into the over-centre position.

The overload failure of the downlock link was consistent with the failure that would result following a collapse of the side brace as it came out of its over-centre position. Under load, an unlocked side brace would push against the downlock link and bend the pivot bolt before eventually failing the link itself.

The Cessna 310R main gear rigging procedure is very involved and needs to be followed from start to finish. According to the manufacturer, making small adjustments to parts of the rigging can result in the gear collapsing. The threaded stud in the downlock link was adjusted to almost its minimum length, which would have provided the minimum movement against the side brace. Any slack in the system could have resulted in the side brace unlocking and the gear collapsing.
