ACCIDENT

Aircraft Type and Registration:	Rans S6-ES Coyote II, G-BYRS	
No & Type of Engines:	1 Rotax 582-48 piston engine	
Year of Manufacture:	2000	
Date & Time (UTC):	15 October 2010 at 1132 hrs	
Location:	Sandy Airfield, Bedfordshire	
Type of Flight:	Private	
Persons on Board:	Crew - 1	Passengers - 1
Injuries:	Crew - None	Passengers - None
Nature of Damage:	Nose landing gear collapsed	
Commander's Licence:	National Private Pilot's Licence	
Commander's Age:	71 years	
Commander's Flying Experience:	152 hours (of which 117 were on type) Last 90 days - 6 hours Last 28 days - 2 hours	
Information Source:	Aircraft Accident Report Form submitted by the pilot

Synopsis

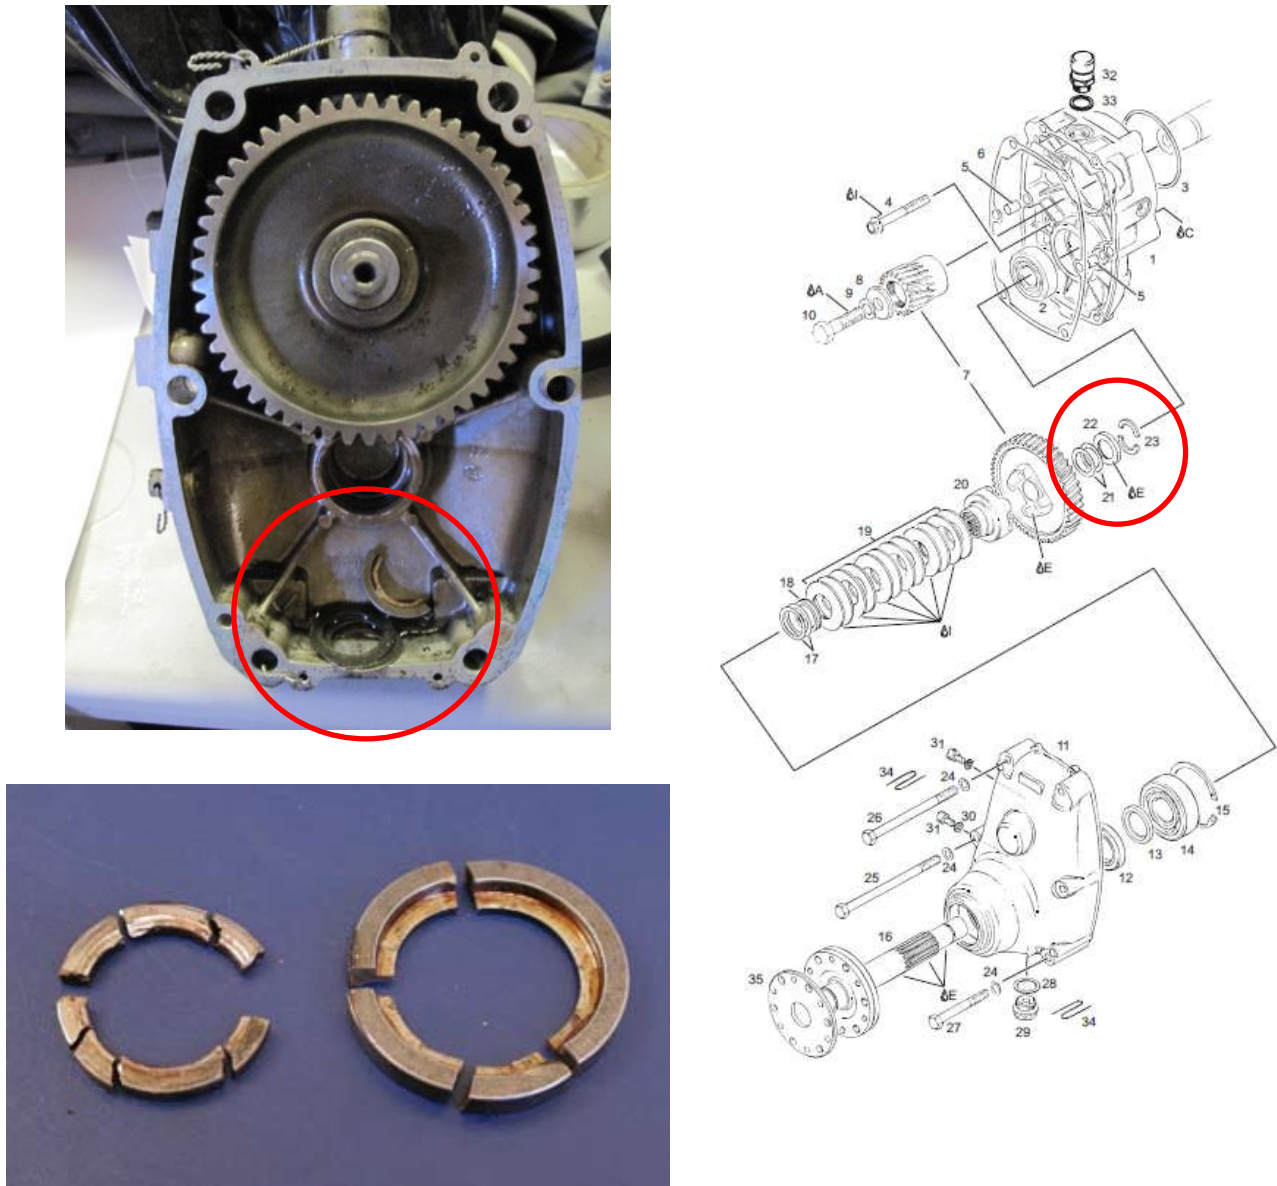
The pilot/owner reported that a strip inspection of the gearbox revealed that the secondary gear angular ring and the two retaining half rings had broken into several pieces (Figure 1). It is most likely that the failure of this retaining mechanism allowed the gear to move axially causing the overload dog-clutch to disengage, thereby removing drive to the propeller. The engine had completed 446 hours since new, but had been recently inspected. The gearbox had completed approximately 90 hours since an inspection and overhaul.

Figure 1
Failed gearbox components

The condition of the half rings is assessed as part of the 100-hour gearbox inspection. Enquiries with various organisations familiar with the inspection and overhaul of this type of gearbox indicated that failures of the half rings are occasionally seen and in these previous cases the broken parts had usually remained in position. The failed parts have been returned to the manufacturer

The propeller fitted to this aircraft was of a type and size approved by the LAA but its exact mass moment of inertia is not known. Similar propellers from the same manufacturer are known to exceed the maximum admissible values specified by ROTAX for the B-type gearbox. It is therefore possible that the propeller may have contributed to the failure. Given this possibility both the LAA and the BMAA intend to offer advice on the implications of propeller selection to owners of aircraft fitted with B-type gearboxes, so they can take appropriate action.
