INCIDENT

Aircraft Type and Registration:	BN2A Mk.III-2 Trislander, G-RLON	
No & Type of Engines:	3 Lycoming O-540-E4C5 piston engines	
Year of Manufacture:	1975	
Date & Time (UTC):	24 March 2009 at 0758 hrs	
Location:	Jersey Airport	
Type of Flight:	Commercial Air Transport (Passenger)	
Persons on Board:	Crew - 1	Passengers - 15
Injuries:	Crew - None	Passengers - None
Nature of Damage:	Forward baggage bay door missing	
Commander's Licence:	Commercial Pilot's Licence	
Commander's Age:	56 years	
Commander's Flying Experience:	5,133 hours (of which 1,596 were on type) Last 90 days - 123 hours Last 28 days - 41 hours	
Information Source:	Aircraft Accident Report Form submitted by the pilot

Synopsis

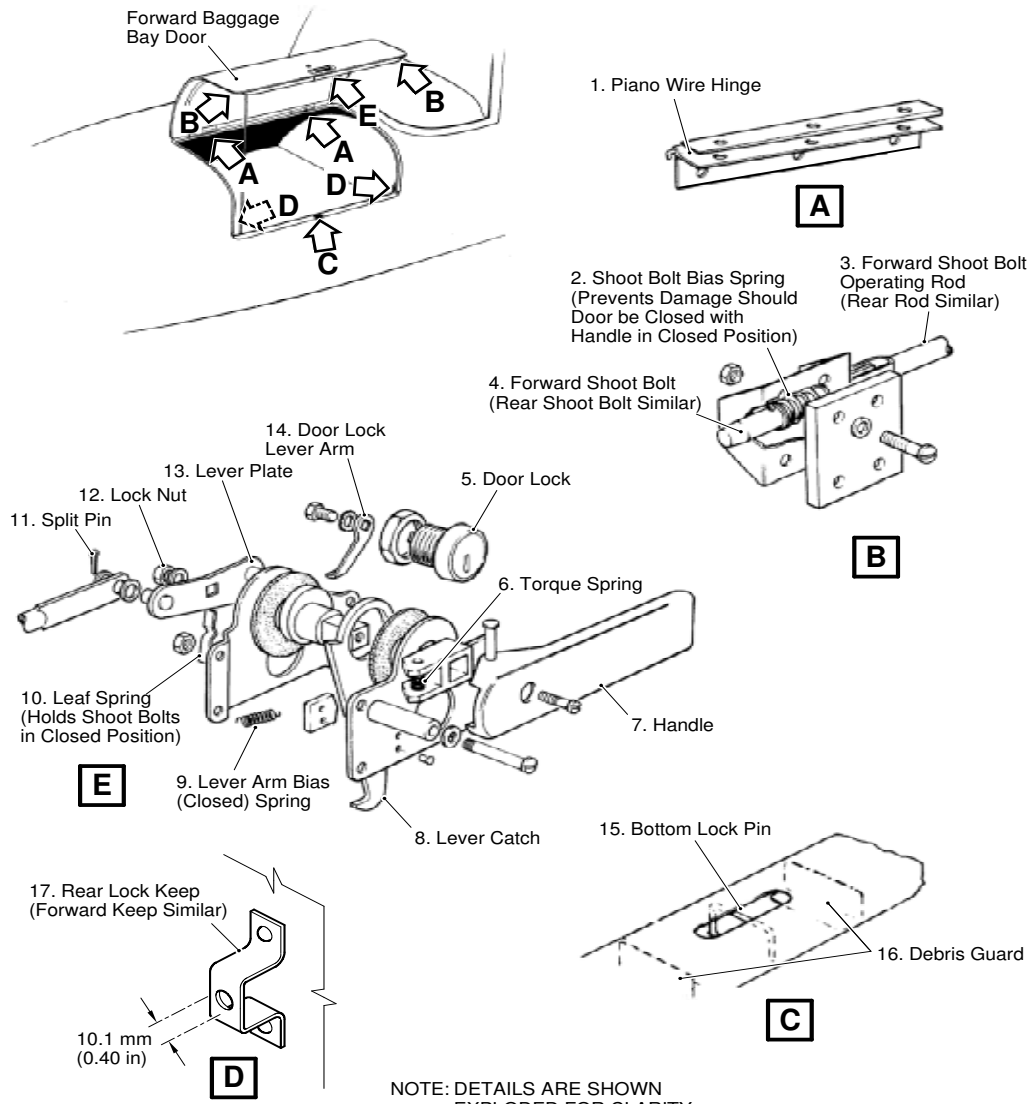
Diagram extracted from SB BN2A Mk111-319

The upward-opening nose baggage bay door is located on the left side of the nose of the aircraft and is hinged at the top (see figure below). It is secured at the lower edge by shoot bolts which engage at the front and rear of the door. When the handle is rotated from the outside, a

square drive turns an eccentric lever plate which engages the shoot bolts into their locks (marked D in the figure below). Rotating the lever also engages a bottom lock (marked C).

Initial enquiries made by the operator regarding the dispatch of the aircraft, concluded that the door was unlikely to have been incorrectly latched prior to departure. Without any physical evidence from the door and its latch, which had fallen into the sea, the operator carried out an inspection of its remaining six aircraft. This inspection called for a detailed visual examination and revealed evidence of movement between the lever assembly and the eccentric lock. The square drive on the lever showed evidence of ‘rounding off’. Subsequent movement between the square drive and the lever could

result on the lock nut becoming loose and the handle detaching.

The operator decided to repeat the inspection every 100 hours.

The manufacturer has since issued a Service Bulletin (SB) BN2A Mk111-3 SB319, dated 30 June 2009. The

SB 'highly recommends' an inspection of the forward baggage bay door to be performed at the earliest opportunity, but not later than 50 hours. An amendment to the maintenance manual is proposed which will include a periodic inspection.
