Piper PA-34-200 Seneca, G-EMER

AAIB Bulletin No: 10/2004	Ref: EW/G2004/06/23	Category: 1.3
Aircraft Type and Registration:	Piper PA-34-200 Seneca, G-EMER	
No & Type of Engines:	2 Lycoming IO-360-C1E6	
Year of Manufacture:	1973	
Date & Time (UTC):	29 June 2004 at 0950 hrs	
Location:	Old Sarum Airfield, Salisbury, Wiltshire	
Type of Flight:	Training	
Persons on Board:	Crew - 1	Passengers - None
Injuries:	Crew - None	Passengers - N/A
Nature of Damage:	Damage to both propellers, nose landing gear and nose cone	
Commander's Licence:	Licence not required (see below)	
Commander's Age:	59 years	
Commander's Flying Experience:	5,695 hours (of which 22 were on type)	
	Last 90 days - 27 hours	
	Last 28 days - 10 hours	
Information Source:	Aircraft Accident Report Form submitted by the pilot and further AAIB enquiries

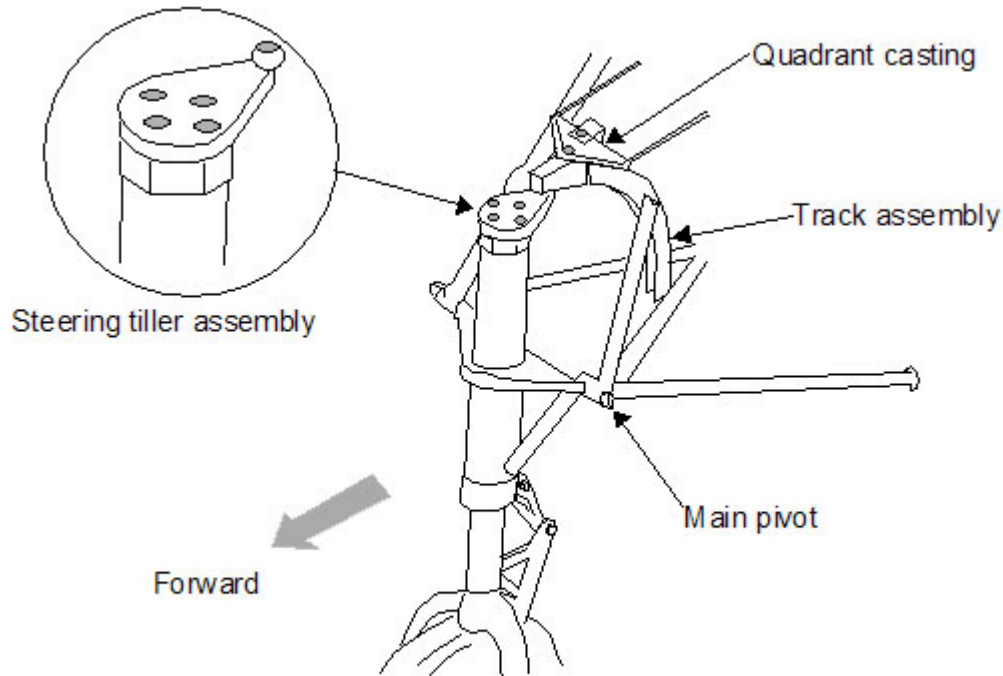
Figure 1 Nose landing gear - general arrangement

Mounted on the upper end of the nose leg is a tiller assembly, attached to which is a roller assembly. This roller sits within a curved track which it follows as the gear leg is raised (see Figure 1).

The track assembly itself is made up of two sections. The lower section is fixed to the aircraft structure, whilst the upper section is attached to a hinged quadrant casting, to allow for nose wheel steering. This quadrant is attached by cables to the steering arm. With the gear locked down, the roller assembly remains within the upper hinged section of track, movement of which is transmitted to the nose wheel from the quadrant via the tiller. As the nose landing gear starts to retract, the nose wheel and tiller is centred automatically, and the hinged and fixed sections of track line up, allowing the roller assembly to follow the track as the nose leg retracts.

The quadrant and associated section of track pivot laterally about a bolt that passes through a U-bracket. This bracket is welded to a section of frame within the nose landing gear bay.

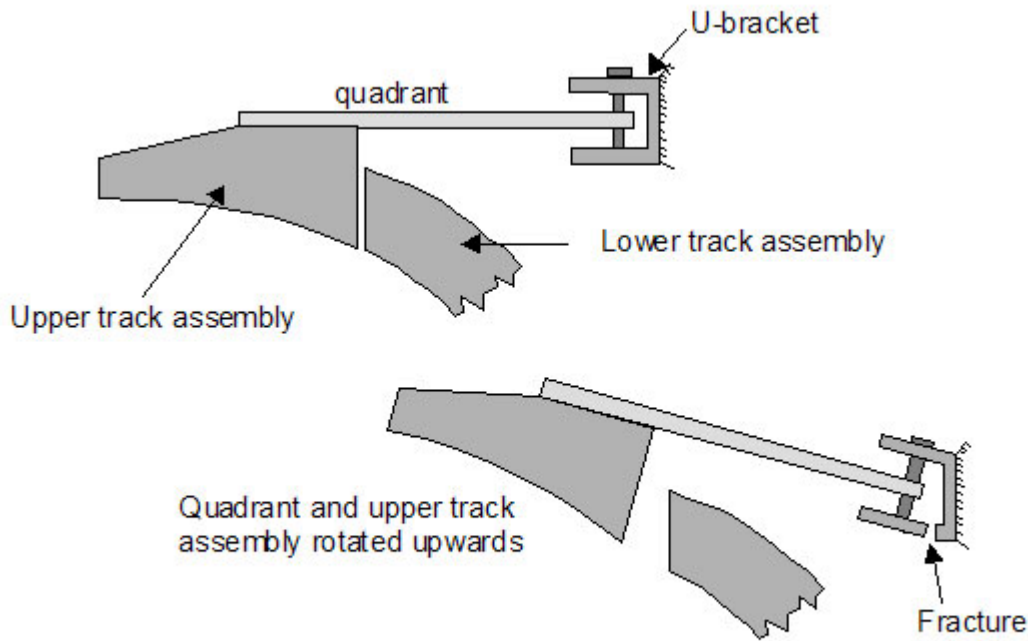
Figure 2 Quadrant Assembly - side view

Inspection of the nose landing gear assembly showed that the lower arm of the U-bracket had fractured, allowing the quadrant casting and the upper section of track to pivot upwards (see Figure 2). This in turn placed bending loads on the upper arm of the U-bracket that showed initial signs of failure as a result of these loads. The two fracture faces had suffered significant abrasion and it was not possible to determine the reason for the fracture.

The roller assembly, which would normally be captive within the track assembly, was found to be out of the track, and against the outer side of the track mounting.

With the quadrant and the hinged section of track able to pivot upwards, a larger than normal gap formed in the channel of the curved track assembly. With the nose landing gear down and locked, this had no effect, as the roller assembly was still captive within the upper track section, which was still able to transmit steering commands to the nose wheel via the tiller. However, as the nose leg commenced retraction, the roller assembly moved along the track until it encountered the gap, at which point it left the channel and continued aft and down in contact with the outside of the track mounting. The leg continued to retract until, still short of the fully up position, the loads associated with the abnormal condition of the leg could no longer be overcome by the hydraulic actuator.

The accident was caused by the failure of the U-bracket which allowed the nose landing gear roller assembly to leave the guide track, making it impossible to lock the nose landing gear down.
