No: 10/92

Ref: EW/G92/07/15

**Aircraft Type and Registration:** Piper PA-34-200 Seneca, G-TEST

**Nature of Damage:** Left maingear collapsed, damage to rear of left nacelle and adjacent wing structure

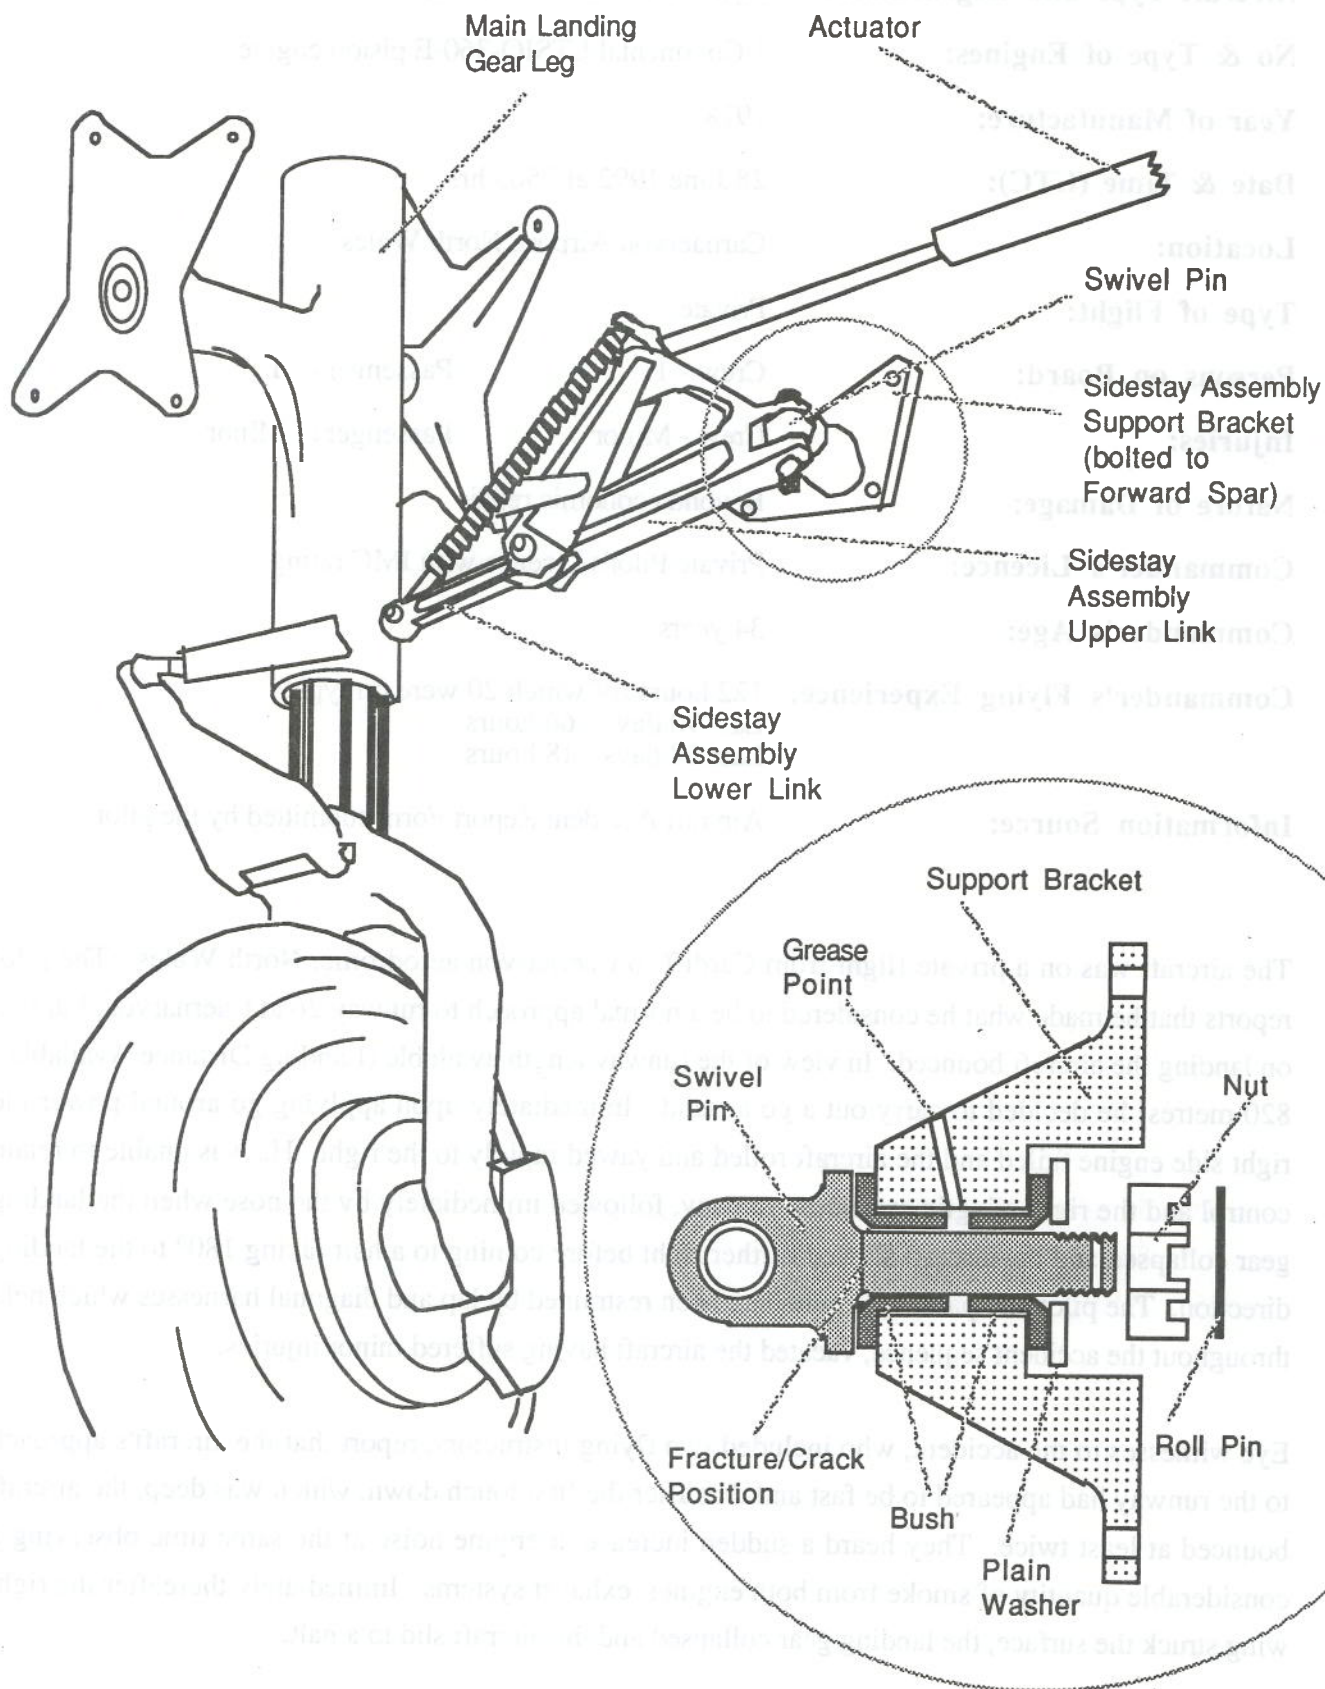
**Figure 1**

It was found that there had been a failure of the swivel pin at the attachment of the mainleg's diagonal brace to a bracket on the wingspar. The pin is part of the bracket assembly currently listed as part number 95643 (-06, left and -07, right) and similar components are used on Piper PA-28R and PA 32R single-engined models. The pin was sent to the AAIB for examination. The fracture of the pin had occurred at its root end where there was a large change of section to accommodate the protruding lug to which the diagonal brace attached (see Fig 1). The plane of fracture was through the

pin's shank at the start of the blending radius at the change of section. The failure was in fatigue in reverse bending in the plane of normal loading from the sidestay. The diametrically opposed areas of pre-existing fatigue cracking had occupied about 80% of the pin's cross section but there were indications that the fatigue development had accelerated before final rupture. The fatigue had started from multiple origins on both sides of the pin. The shank surfaces adjacent to the fracture were pitted with corrosion and the original cadmium plating had been worn away in the contact areas of the bushing which supported the pin within the bracket. Some of the fatigue initiations had developed along circumferential marks on the pin surface at the edge of the blending radius. The aircraft had completed 4069 operating hours at the time of the accident but it has not been ascertained whether the failed pin had been fitted from new. The diameter of the pin from G-TEST was 9/16 inches but later bracket assemblies contain pins of 5/8 inches diameter.

Two previous cases which were effectively identical to the subject swivel pin failure have been reported by the AAIB; Piper PA34-200 Seneca G-BACB in AAIB Bulletin 4/91 and Piper PA34-200T Seneca II G-BOUM in AAIB Bulletin 7/92. In G-BOUM the pin in the unfailed right maingear was also found to contain cracks. Following the accident to G-BACB the AAIB made a recommendation that consideration be given to requiring a periodic check of the swivel pin. The CAA undertook to consult with Piper Aircraft on the overall service record and the possibility of issuing a Service Bulletin on the subject. The CAA also undertook to consider issuing an Airworthiness Directive. When the accident to G-BOUM occurred no check had been instituted and a further AAIB Recommendation (Reference Number 92-47) was made that, 'The CAA require a periodic check of the swivel pin and assess the need for mandatory replacement of the fitting type with one of more robust design'. Copies of the recommendation were also sent, for information, to JAA, FAA, NTSB and Piper Aircraft Corporation. The FAA Office of Accident Investigation have dispatched the Recommendation to the Small Airplane Directorate for evaluation and response which is normally completed within 90 days of receipt. The CAA is currently in communication with Piper Aircraft on the subject.
