## ACCIDENT

<b>Aircraft Type and Registration:</b>	DH82A Tiger Moth, G-ACDJ	
<b>No &amp; Type of Engines:</b>	1 de Havilland Gipsy Major 1C piston engine	
<b>Year of Manufacture:</b>	1933	
<b>Date &amp; Time (UTC):</b>	18 August 2005 at 1034 hrs	
<b>Location:</b>	Remenham (Berkshire), near Henley-on-Thames	
<b>Type of Flight:</b>	Private	
<b>Persons on Board:</b>	Crew - 1	Passengers - 1
<b>Injuries:</b>	Crew - 1 (Fatal)	Passengers - 1 (Fatal)
<b>Nature of Damage:</b>	Aircraft destroyed	
<b>Commander's Licence:</b>	Private Pilot's Licence	
<b>Commander's Age:</b>	61 years	
<b>Commander's Flying Experience:</b>	289 hours (of which 107 were on type) Last 90 days - 9 hours Last 28 days - 2 hours	
<b>Information Source:</b>	AAIB Field Investigation

### Synopsis

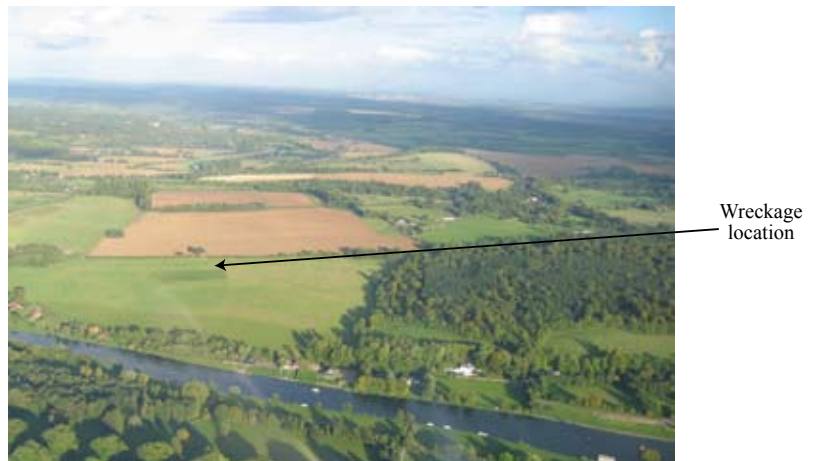
**Figure 1**

Photograph showing accident site

The aircraft wreckage was contained within a small area consistent with a low impact speed and typical of a spinning accident. The left tip of the horizontal tail plane had dug into the ground, and the wooden fin post had broken so that the fin and rudder were angled to the left of the aircraft. One blade of the wooden propeller had broken away from the hub and lay next to the aircraft's nose, and the tip of this blade (20 cm in length) had been thrown 17 m forward of the aircraft's nose. Scuff marks, consistent with propeller rotation, were clearly evident on the blade that had broken away. No such scuff marks were found on the other blade, or the spinner. It was concluded that the engine was probably rotating at low speed at the time of the impact.

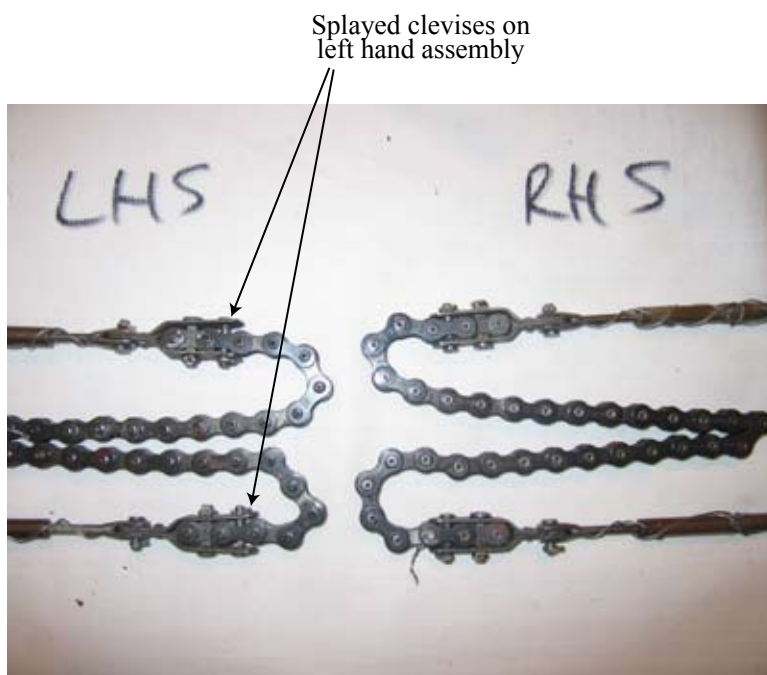
**Figure 4**

Photograph showing left and right hand aileron chains.

The left and right chains were compared, see Figure 4, and the clevises on the left chain were found to be splayed, consistent with a significant load being applied. The bracket which attaches the rear spar of the lower mainplane to the fuselage was found to have suffered a significant upward load, thus supporting the evidence that the left wing, including the aileron cable, was subject to an abnormally high load in the accident.
