AAIB Bulletin No: 3/94

Aircraft Type and Registration: Beech 76 Duchess, G-WACJ

Date & Time (UTC): 30 January 1994 at 1548 hrs

Location: Wycombe Air Park, Buckinghamshire

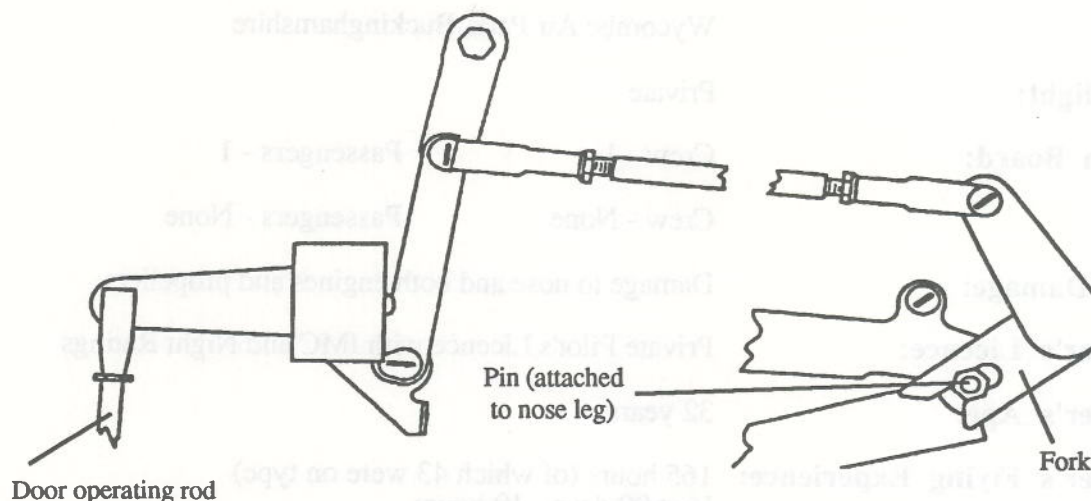
Examination of the nose gear mechanism revealed that a 3 inch section of the right-hand nose door hinge had seized, this had prevented the fork from achieving its correct position for the subsequent retraction. In these circumstances the pin will go underneath the fork; witness marks under the fork showed that this had occurred.

NOSE DOOR OPERATING MECHANISM - SHOWN IN RETRACTED POSITION

The nose door hinge line is curved when the hinge is fitted to the aircraft, under these circumstances it is not practical to remove the hinge pin for lubrication. The maintenance organisation described the difficulty of obtaining the specified lubrication (Brayco 300) and demonstrated the difficulty of lubricating the hinge with the pin installed. The Beech Duchess maintenance manual shows WD40 as an approved substitute for Brayco 300 oil and specifies lubrication at 60 day intervals, or less if severe conditions apply.
