No: 10/90

Ref: EW/C1167

BAe 146-200 series, G-PRIN

Accident to a Bae 146-200 G-PRIN at Jersey Airport on 16 June 1990

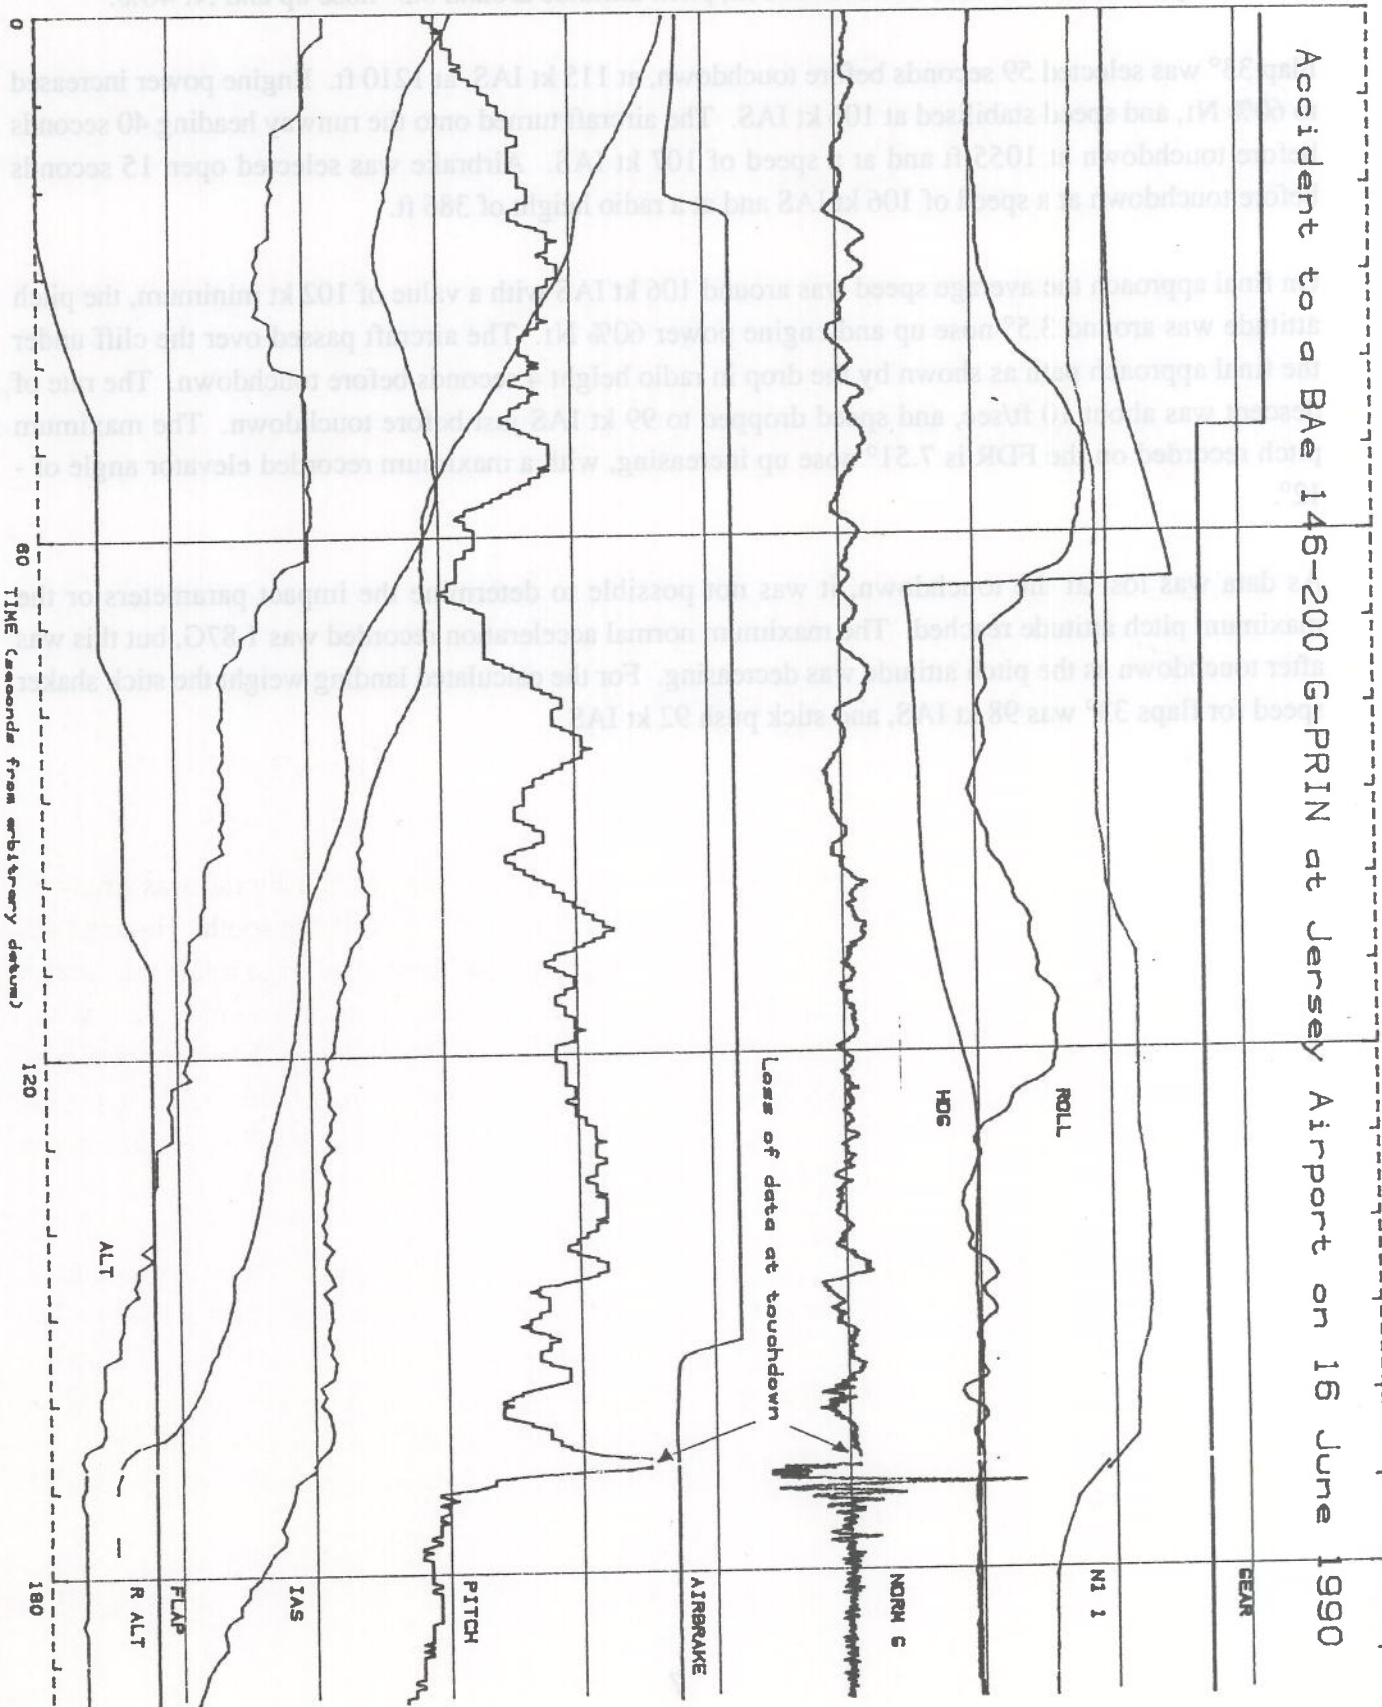
The attached figure shows the approach, with a selection of the relevant FDR parameters plotted. It should be noted that the ALT trace is referenced to the standard pressure of 1013 mb. The following

altitudes assume a QNH of 1019 mb. Landing gear was selected down 2 mins before touchdown at an altitude of 1690 ft and an IAS of 157 kt. Flap 18° was selected 140 seconds before touchdown at a speed of 200 kt IAS, and at 1500 ft. The aircraft then stabilised at a speed of 142 kt, pitch attitude 1° nose up, at this flap setting. N1 was around 46%. Having levelled at 1363 ft, the aircraft recommenced the descent. Flap 24° was selected at 91 seconds before touchdown, at a speed of 143 kt IAS and at 1183 ft. Speed then decreased to about 120 kt, pitch attitude around 3.5° nose up and N1 46%.

Flap 33° was selected 59 seconds before touchdown, at 115 kt IAS, at 1210 ft. Engine power increased to 60% N1, and speed stabilised at 106 kt IAS. The aircraft turned onto the runway heading 40 seconds before touchdown at 1055 ft and at a speed of 107 kt IAS. Airbrake was selected open 15 seconds before touchdown at a speed of 106 kt IAS and at a radio height of 386 ft.

On final approach the average speed was around 106 kt IAS with a value of 102 kt minimum, the pitch attitude was around 3.5° nose up and engine power 60% N1. The aircraft passed over the cliff under the final approach path as shown by the drop in radio height 4 seconds before touchdown. The rate of descent was about 10 ft/sec, and speed dropped to 99 kt IAS just before touchdown. The maximum pitch recorded on the FDR is 7.51° nose up increasing, with a maximum recorded elevator angle of -12°.

As data was lost at the touchdown, it was not possible to determine the impact parameters or the maximum pitch attitude reached. The maximum normal acceleration recorded was 1.87G, but this was after touchdown as the pitch attitude was decreasing. For the calculated landing weight the stick shaker speed for flaps 33° was 98 kt IAS, and stick push 92 kt IAS.
