No: 8/92

Ref: EW/C92/4/8

<b>Aircraft Type and Registration:</b>	BAe ATP, G-PEEL	
<b>No &amp; Type of Engines:</b>	2 Pratt and Whitney 126 turboprop engines	
<b>Year of Manufacture:</b>	1990	
<b>Date &amp; Time (UTC):</b>	19 April 1992 at 1942 hours	
<b>Location:</b>	Liverpool Airport	
<b>Type of Flight:</b>	Scheduled passenger	
<b>Persons on Board:</b>	Crew - 4	Passengers - 29
<b>Injuries:</b>	Crew - None	Passengers - None
<b>Nature of Damage:</b>	Nose gear collapsed; nose gear door torn off; abrasion to underside of nose and damaged tips on the right propeller	
<b>Commander's Licence:</b>	ATPL(A)	
<b>Commander's Age:</b>	45 years	
<b>Commander's Flying Experience:</b>	10,528 hours (of which 1410 were on type) Last 90 days - 112 hours Last 28 days - 28 hours	
<b>Information Source:</b>	AAIB Field Investigation

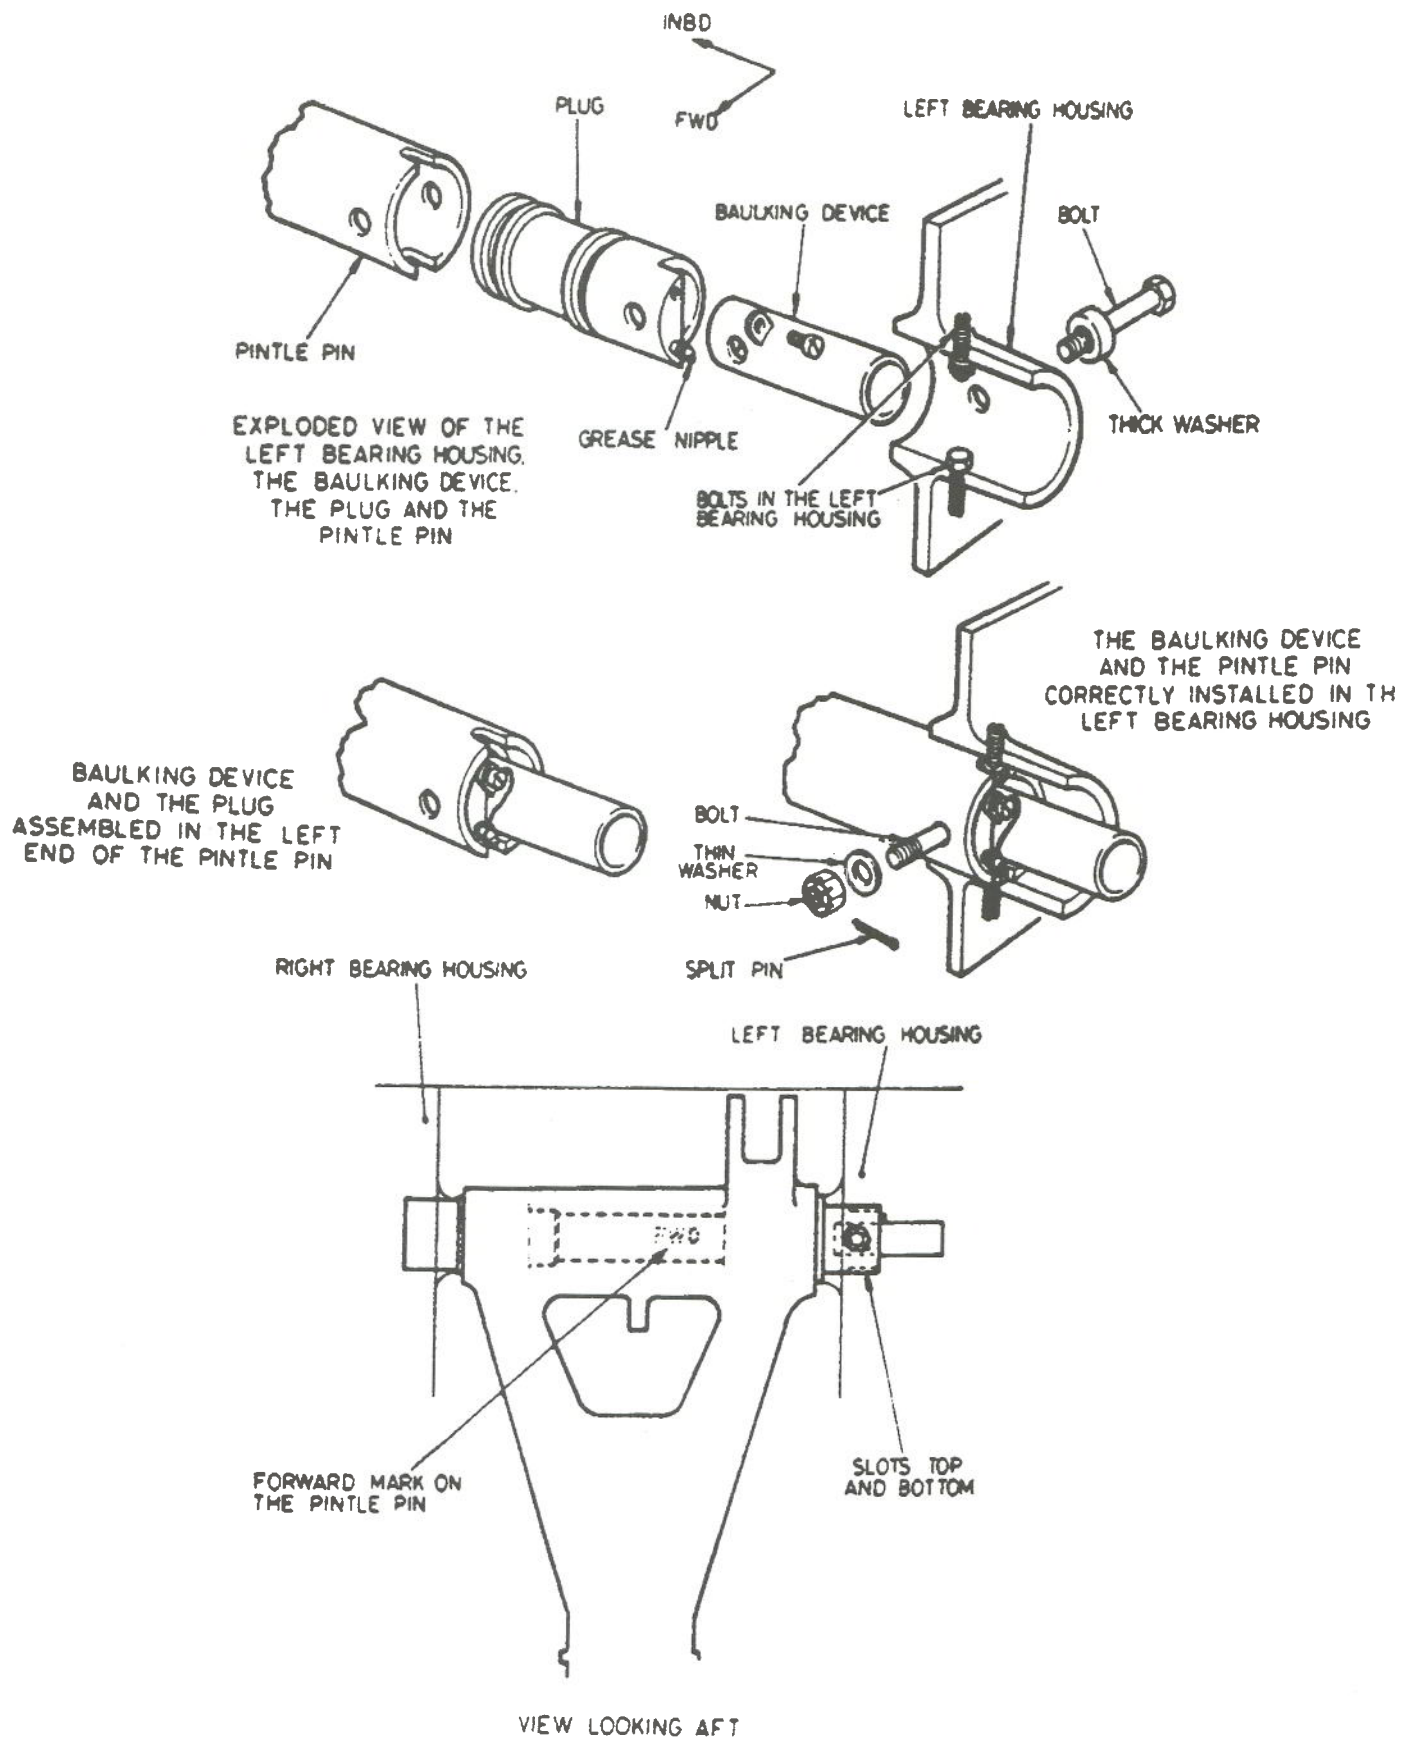
FIGURE 1

EXTRACT FROM BAe ATP SIL 32/3

Nose landing gear - Within four days of this accident, BAe issued ATP Service Information Leaflet 32/3 to all operators. This advised that an incident had occurred and contained detailed information on the fitting of the pintle-pin . It stated, in part:

IF THE NOSE LANDING GEAR IS NOT CORRECTLY ALIGNED  
THE BAULKING DEVICE CAN CATCH ON THE BOLTS IN THE  
LEFT BEARING HOUSING. IF IT IS NOT CORRECTLY ALIGNED  
AND TOO MUCH FORCE IS USED:-

- THE BAULKING DEVICE CAN BE DAMAGED.
- THE BAULKING DEVICE CAN BE PUSHED INTO THE  
PINTLE PIN WHERE IT WILL HAVE NO EFFECT.

The same document contained detailed information which was intended to enable operators to confirm the correct position of the pintle-pin and to ensure that the baulk device remains undamaged after assembly. Additionally, BAe has completed a review of the ATP Maintenance Manual, Revision 35 issued to all ATP operators on 30th June 1992, to ensure that BAe 748 experience where relevant is reflected.

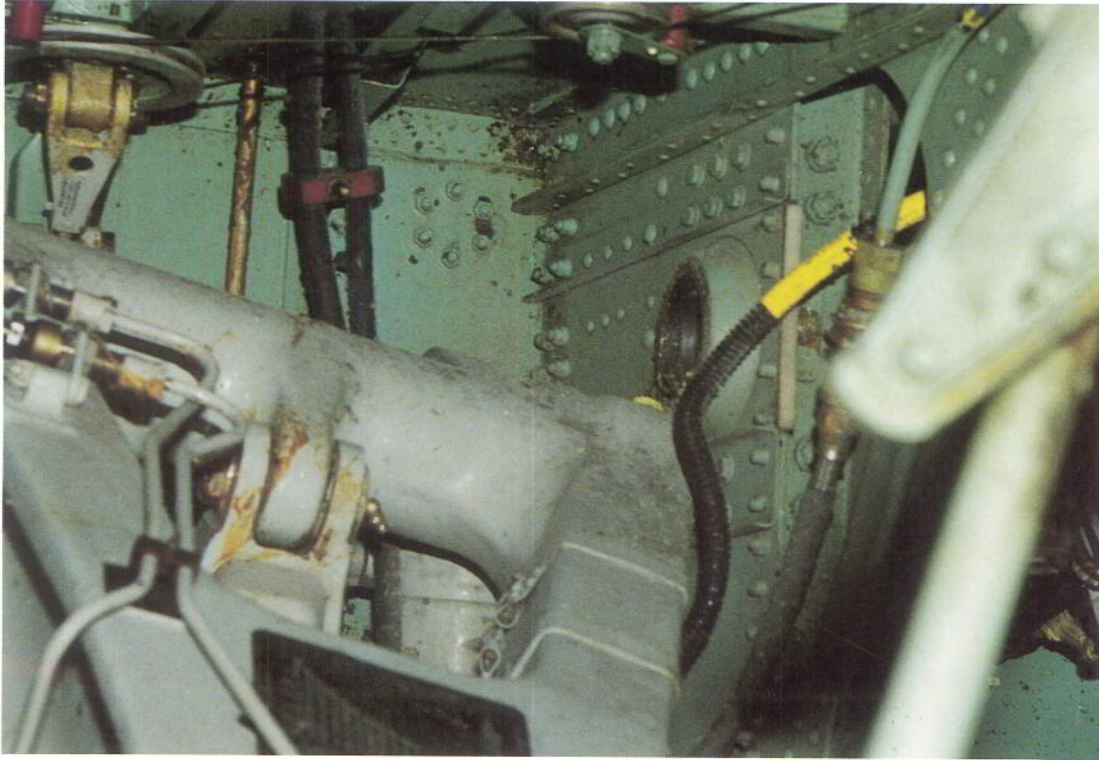
The aircraft was subsequently recovered from the runway to a suitable hangar and the nose landing gear inspected. The ATP is fitted with a Dowty manufactured landing gear, very similar to the landing gear on the BAe 748 aircraft. The primary attachment of the nose landing gear to the aircraft is by means of a 'pintle-pin', also of Dowty manufacture, which engages in bearing housings in the nose structure, either side of the oleo. The pintle-pin is inserted from the right hand side of the aircraft and is secured in the left hand bearing housing by a retaining bolt which passes through the pin and the housing. A baulk device, of BAe manufacture, is fitted within the end of the pintle-pin, and is designed to prevent assembly of the retaining bolt if it was incorrectly located across the end of the pin, or in the slots which clear the bolts in the bearing housing (see Figure 1). On this aircraft the pintle-pin had migrated out of the left hand bearing housing (Figures 2 and 3) and there was evidence that after this had occurred it had then moved downwards causing the wheels to be displaced to the right. The retaining bolt was in place, undamaged, and was secured with its castellated nut and split pin; however there was evidence that it had been fitted across the end of the pintle-pin, instead of through the holes in the end of the latter. The baulk device was damaged in that the lug was broken off and the baulk was pushed down inside the pintle pin (Figure 4). It had therefore not performed its intended function.

FIGURE 2 - VIEW OF NOSE LANDING GEAR LOOKING AFT WITH THE PINTLE PIN MIGRATED OUT OF THE LEFT BEARING HOUSING

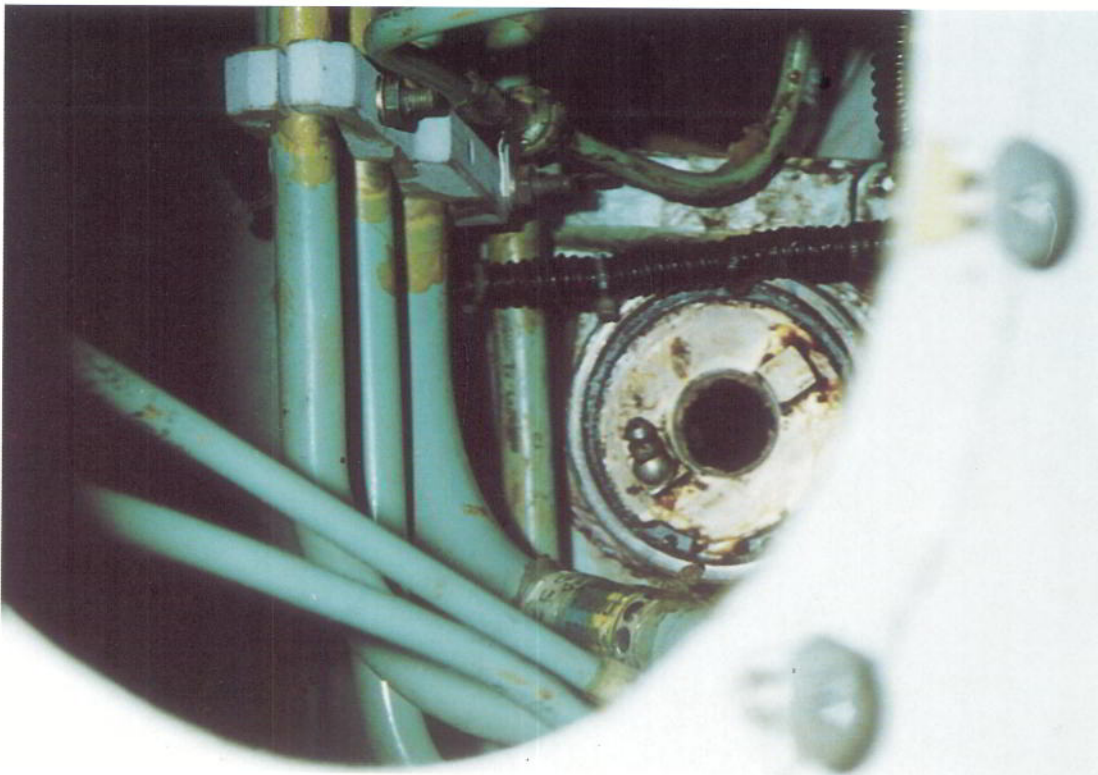
retaining bolt was in place and locked correctly. Since the pintle-pin appeared to be in place, he believed that the baulk device had ensured that the retaining bolt had passed correctly through the holes in the pintle-pin. The Shift Supervisor then signed the job off, apart from the function checks which were left for the next shift. During the next shift, the function checks were carried out and although another problem associated with the nose landing gear arose, no problem with the pintle assembly was noted. Prior to gear retraction, a close inspection of the pintle area was made and no abnormalities were found. It should be noted that the end of a correctly installed pintle-pin should be flush with the right hand bearing housing, and no protrusion is acceptable. This was not stated in the Maintenance Manual and in fact the pin must have protruded by between about 0.1 and 0.8 inches. However, viewing of this protrusion must be done through a small access panel, looking 'end-on' at the pin, and may therefore be difficult.

FIGURE 3 - VIEW ON THE RIGHT HAND END OF THE PINTLE PIN AS SEEN AT THE SKIN ACCESS PANEL. THE PIN IS APPROXIMATELY 2 INCHES OUT OF POSITION

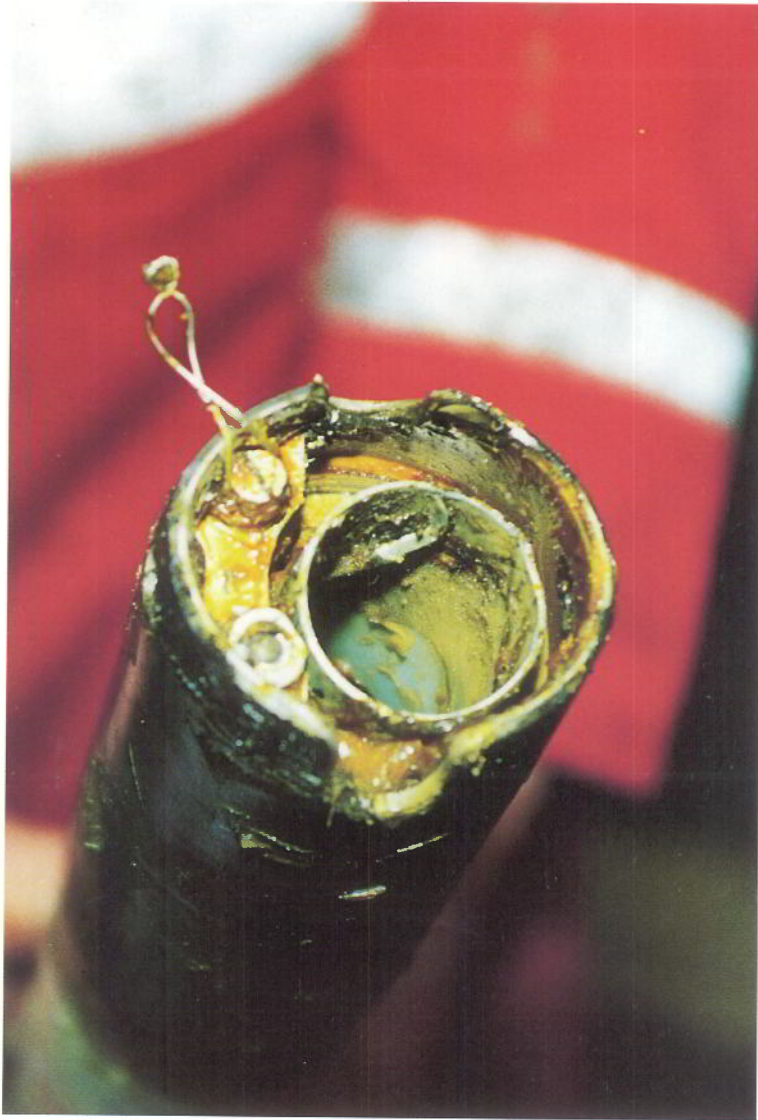
FIGURE 4 - LEFT.  
THE BAULK DEVICE PUSHED INTO  
THE PINTLE PIN, AS FOUND

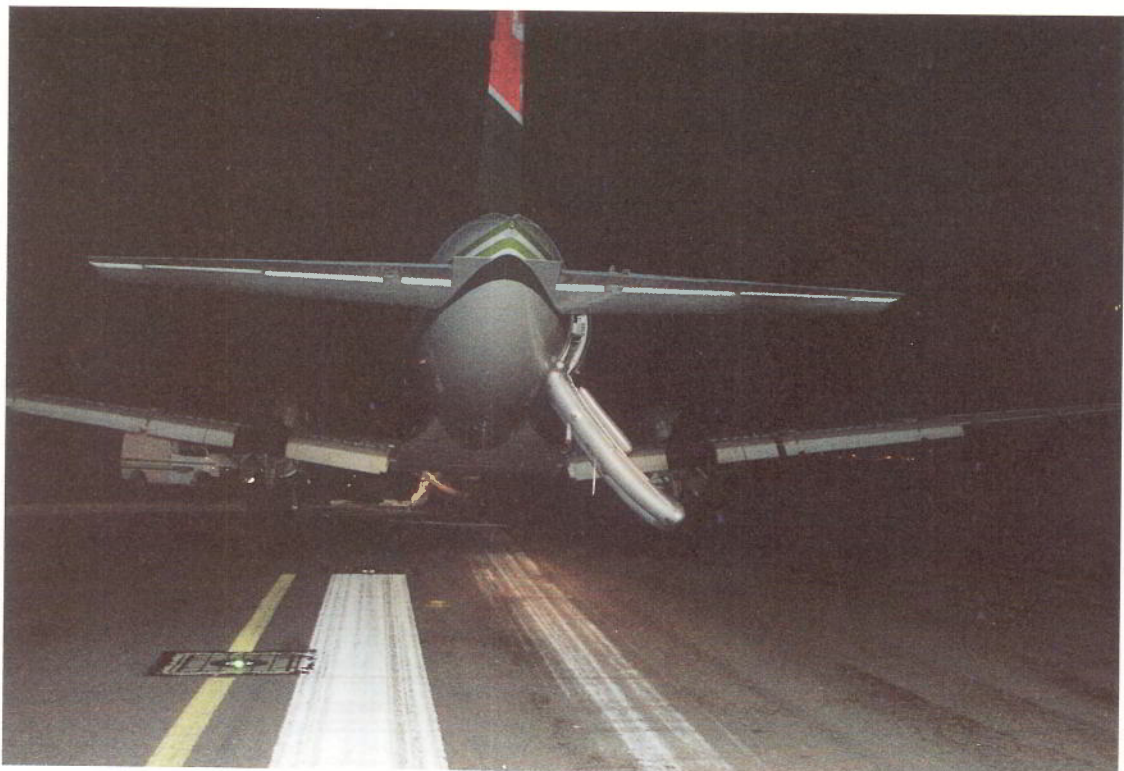
The commander was faced with the choice of burning-off fuel and landing in darkness, or landing in daylight with significant excess fuel. He elected to burn-off fuel until just before dark (sunset was at 1920 hrs) and to land on runway 09 from a visual approach. Instructions to the cabin occupants to adopt forced landing positions were given at the appropriate heights on final approach, which culminated in a 27° flap landing with a  $V_{ref}$  of 96 kt. At the commander's request, as the aircraft touched down on its mainwheels, the runway edge and centreline lights were switched off by ATC. Whilst the commander held the nose gear off the runway, the first officer simultaneously shut down both engines, activated the engine fire extinguishers and switched off the batteries. The commander held the nose wheel off for several additional seconds before lowering it gently on to the runway. However the nose leg collapsed forwards almost immediately and the underside of the nose contacted the runway, trailing a large plume of 'sparks'. The aircraft was brought to a halt close to the centreline of the runway and near to its midpoint. The emergency services arrived within seconds and used foam to cool the underside of the nose. All the passengers were evacuated through the left forward exit door after the escape slide had inflated. There were no injuries. Some time later the passengers' baggage was removed from the aft baggage compartment. The girt bar of the rear right escape slide was not disconnected from the floor brackets before this door was opened and the associated escape slide inadvertently deployed. After deployment it was noted that this slide terminated about 3 feet above the runway (Figure 5). Joint Aviation Requirements (JAR) certification requires that slides reach the ground after a nosegear collapse.

FIGURE 5 - BELOW.  
G-PEEL AFTER THE ACCIDENT,  
WITH THE REAR BAGGAGE DOOR  
SLIDE DEPLOYED AND APPROX. 3  
FEET CLEAR OF THE GROUND

Slides - The discrepancies between the slide certification demonstration and the actual deployment of the slide on G-PEEL are reported to be 'complex'. The resolution of this aspect will be monitored and related information will be included in a supplementary AAIB Bulletin.

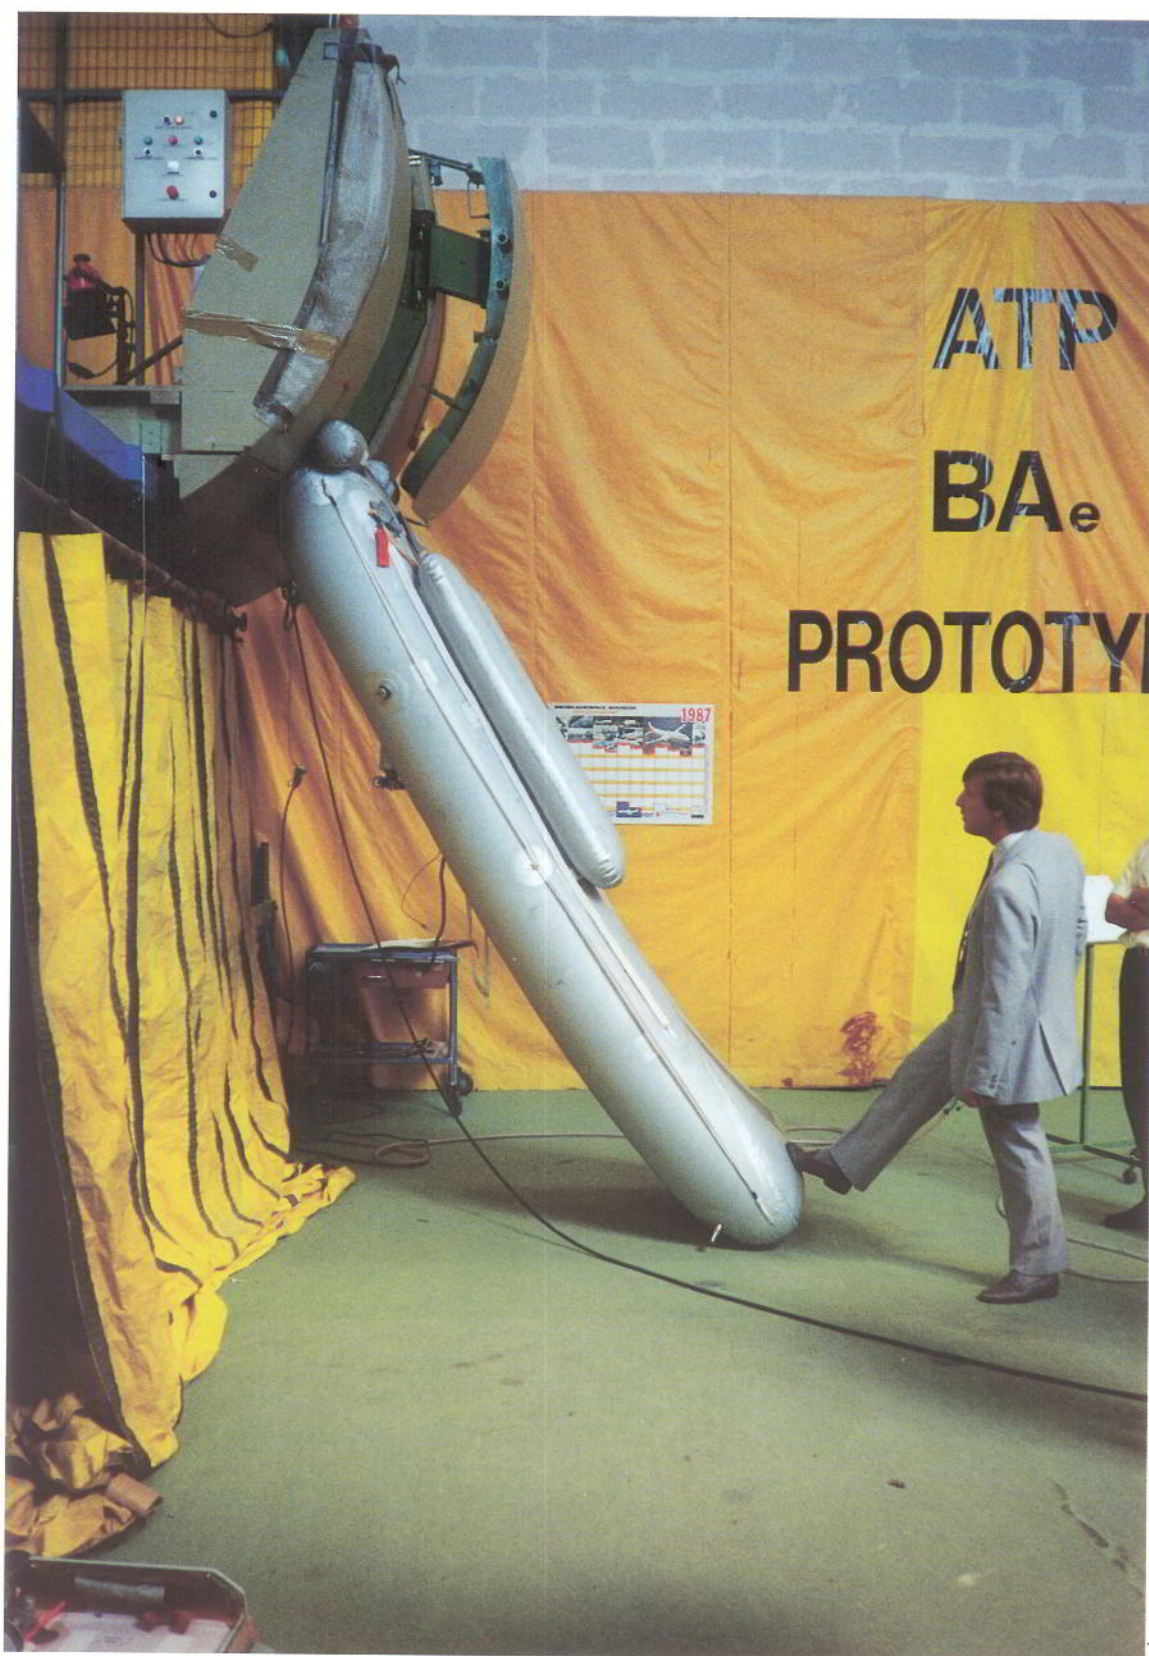
The certification demonstration of the slide was conducted by the slide manufacturer using a 'mockup' of part of the fuselage surrounding the rear door. The mockup could be elevated to represent various sill heights. The slide was jointly certificated by the FAA, CAA and the French DGAC. As part of this investigation, the certification demonstration was repeated at normal sill height and at a sill height representative of that caused by a collapsed nose landing gear. The slide reached the ground in both cases with satisfactory geometry, requiring just a little pressure at the maximum sill height to deflect it to the ground (Figure 6). This was considered to be in accordance with the requirements and was judged satisfactory.

FIGURE 6 - THE SLIDE FROM G-PEEL FITTED TO THE MOCKUP AND DEPLOYED AT MAXIMUM SILL HEIGHT, I.E. NOSE GEAR COLLAPSED.
