INCIDENT

Ref: EW/C868

Aircraft type and registration: Boeing 747-135 N621US (Multi-Jet Public Transport Aircraft)

Location: London Gatwick Airport

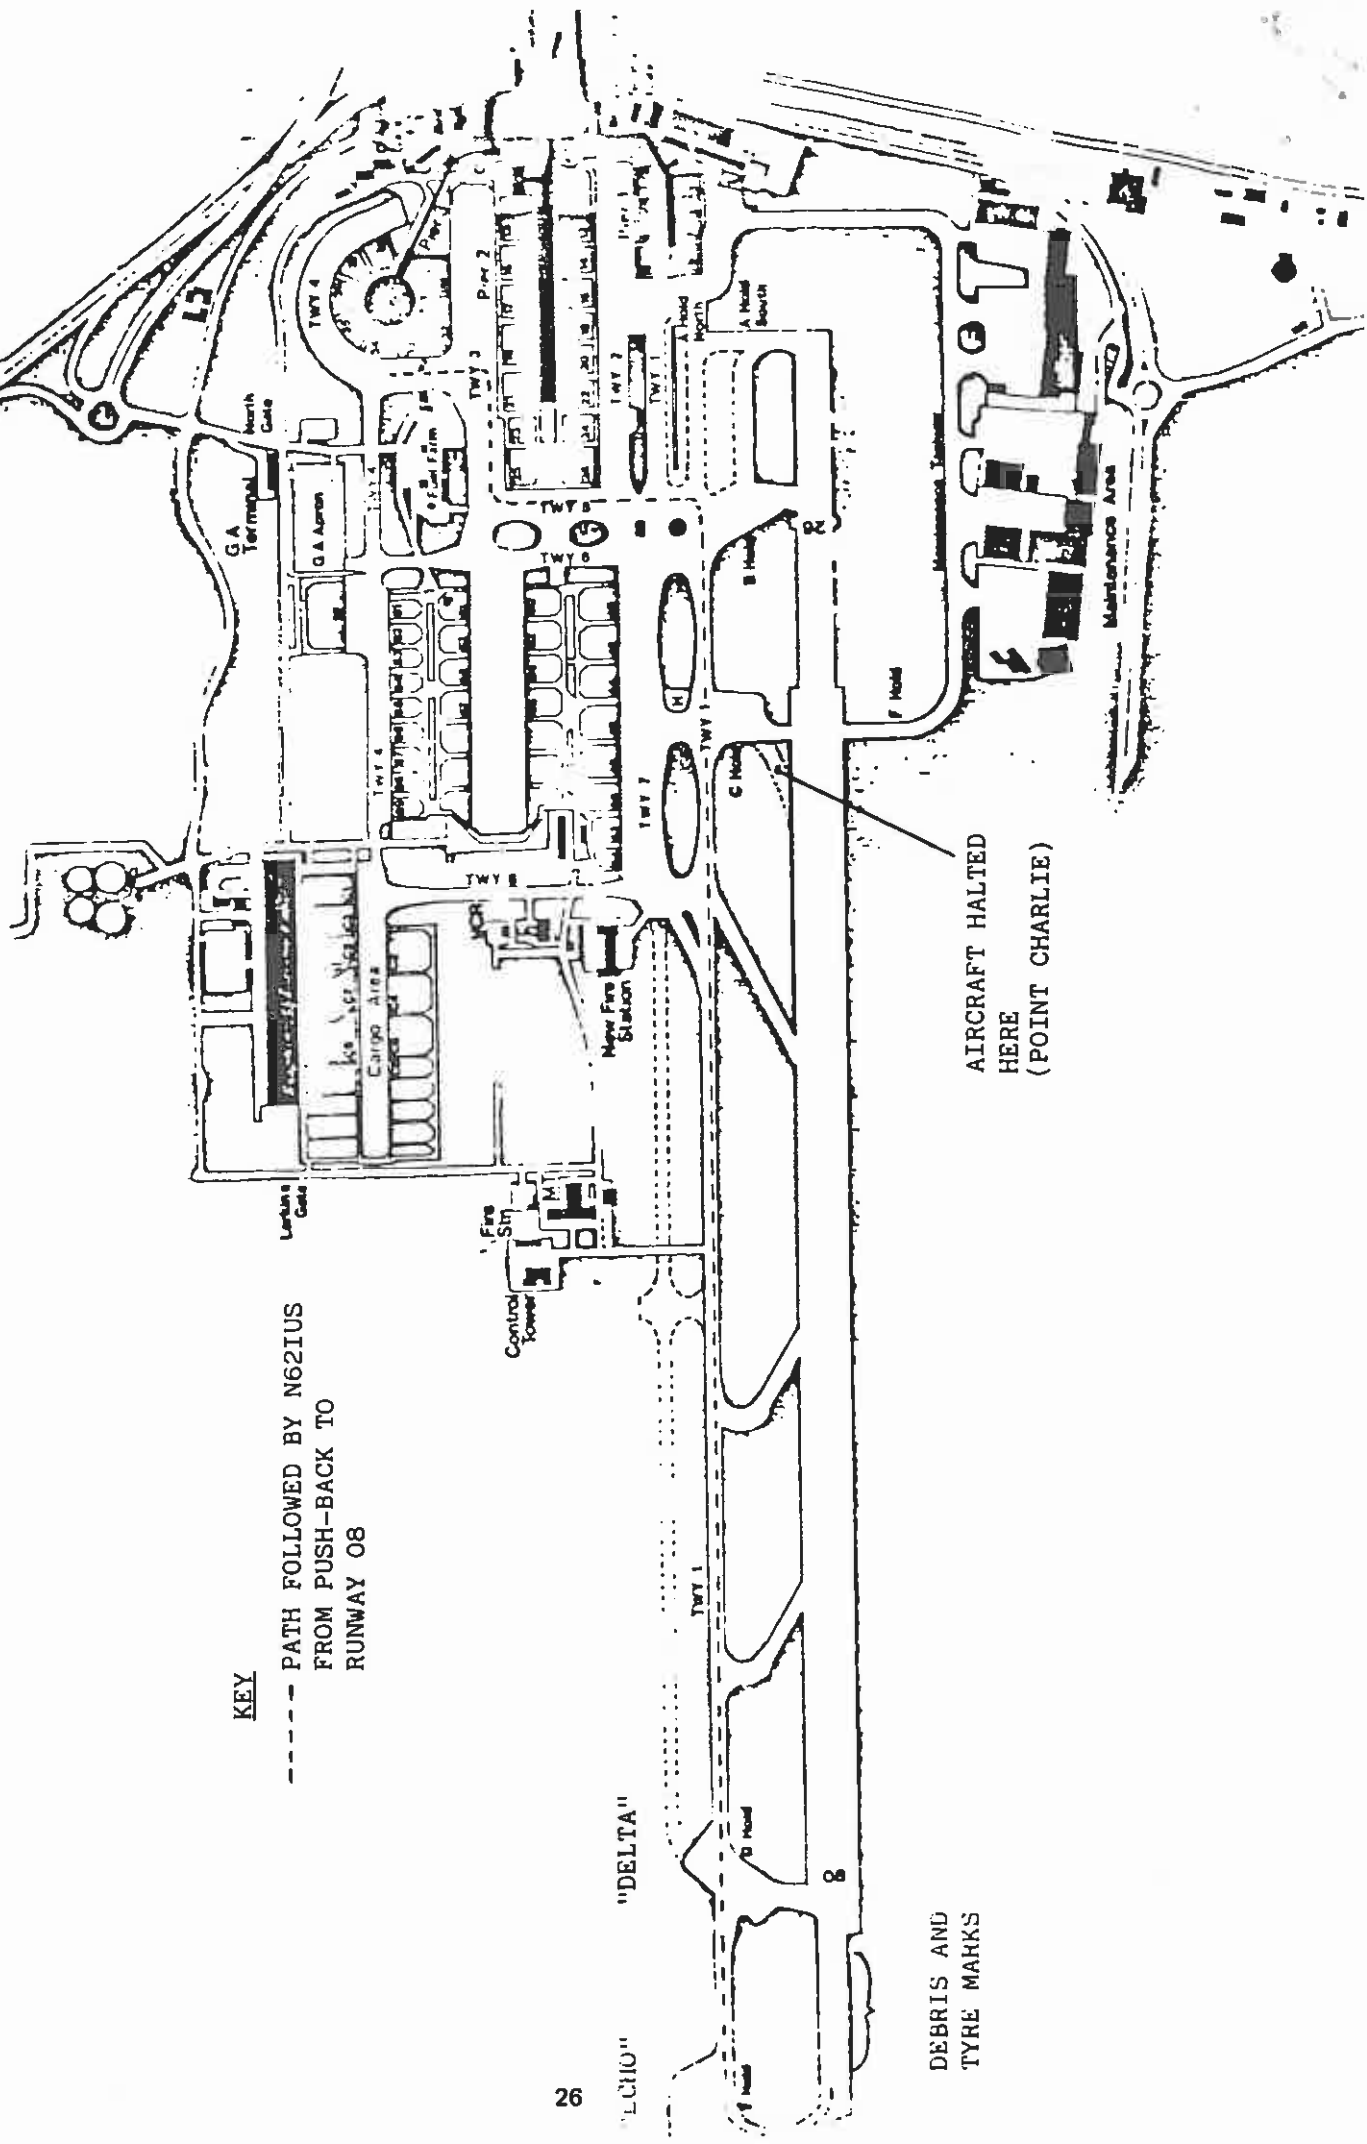
INCIDENT TO B747-135 N62IUS AT GATWICK ON 30.4.84

During the roll another aircraft, positioned at runway access point Delta, (see Dia.) noticed N621 shedding rubber from the fuselage landing gear tyres and reported it to Air Traffic Control (ATC). ATC relayed this to N621 and declared a 'ground incident', thereby activating the Airport Fire Service.

Marks on the runway indicated that the tyre had started to break up between the 'Echo' and 'Delta' holding points, i.e. during the first few hundred feet of the take-off roll. Examination of the tyre debris indicated that the failure was a shoulder blow-out, resulting in most of the carcass remaining on the wheel. Pronounced wrinkling on the inner liner was indicative of the tyre being taxied in a low pressure condition prior to failure, although it could not be established when this had occurred. The ground crew reported checking the tyre pressures at 215 psi prior to push-back; thus in view of the defect subsequently confirmed on the steering gear, it is conceivable that tyre deflation could have occurred during a left turn on the 2½ mile taxi to runway 08 prior to the take-off roll.
