Concorde Type 1 Variant 102, G-BOAE, 5 May 1996

AAIB Bulletin No: 7/96 Ref: EW/C96/5/3 Category: 1.1

INCIDENT

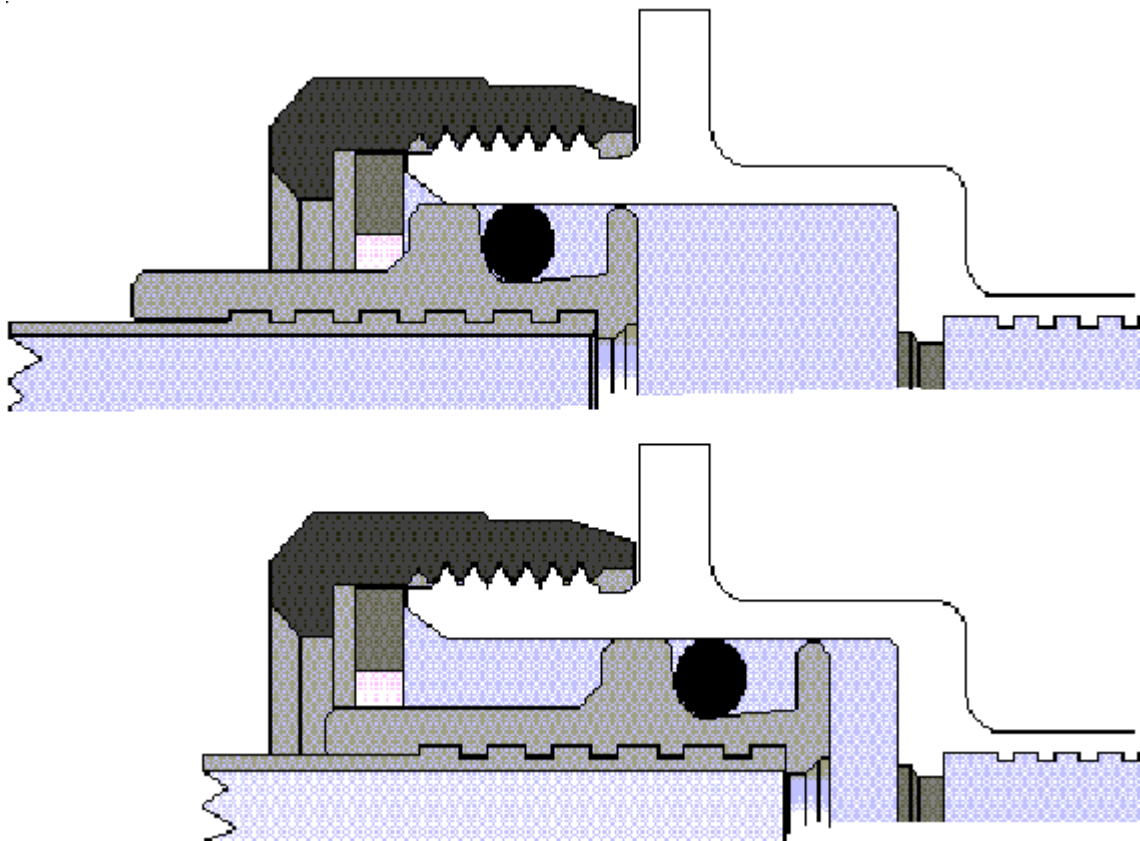
The No 1 fuel collector tank feeds the No 1 engine and the delivery pipe passes through the No 6 tank. The access to the tank is severely limited, and consequently the pipe run consists of an assembly of 4 pipes and 5 pipe couplings. One of these pipe couplings had come apart, with the exception of its electrical bonding lead, and the coupling seal was found on the tank floor.

The compression seal coupling used on the fuel distribution pipework was designed to allow for expansion and contraction of the pipework in sympathy with airframe thermal expansion. Consequently the screw end cap defines the extent of the pipe movement rather than forming a fixed locating device. It is locked by a spring which sits between two adjacent lugs. Whilst not to Class 1 locking standards, there is no record of a previous coupling failure in the CAA data base.

Expanding fuel pipe coupling

The pipes were removed and replaced during an intermediate check for access to tank fuel leaks, but the pipe joint had remained intact during the subsequent ground runs and for two sectors

comprising flights to New York and return. The Concorde Operations Engineering Controller has conducted an internal enquiry into this lapse in quality and has made recommendations to his management to prevent a recurrence; these include a recommendation to carry out a duplicate check of fuel couplings.
