AAIB Bulletin No: 2/95

Aircraft Type and Registration: Boeing 747-238B, G-VLAX

Nature of Damage: Forward right-hand body gear axle fractured

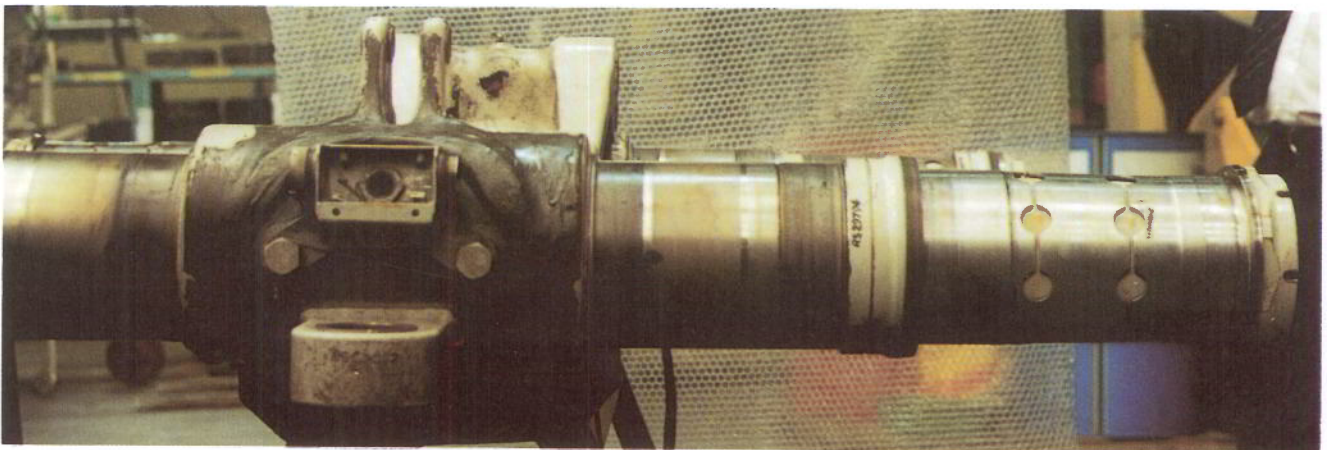
View on front of truck before disassembly; No 9 axle on right of picture

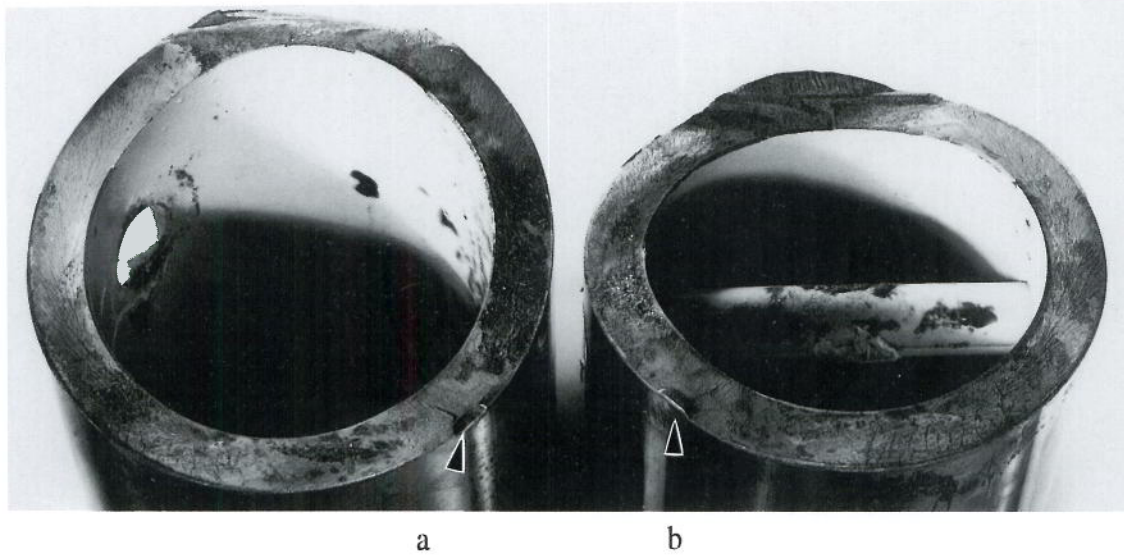
The stress corrosion origin was at a position which was about 45° below and aft from the axle axis. It had initiated in the base steel of the axle, below the nickel fill layer, in one of the areas which had been blended during its last overhaul. In the same blended area, nearer to the axle mid-point, a succession of small, circumferentially orientated, intergranular cracks was found.

View on fracture faces; No.9 end of axle on right of picture.
 Note:- (a & b) Stress corrosion origin

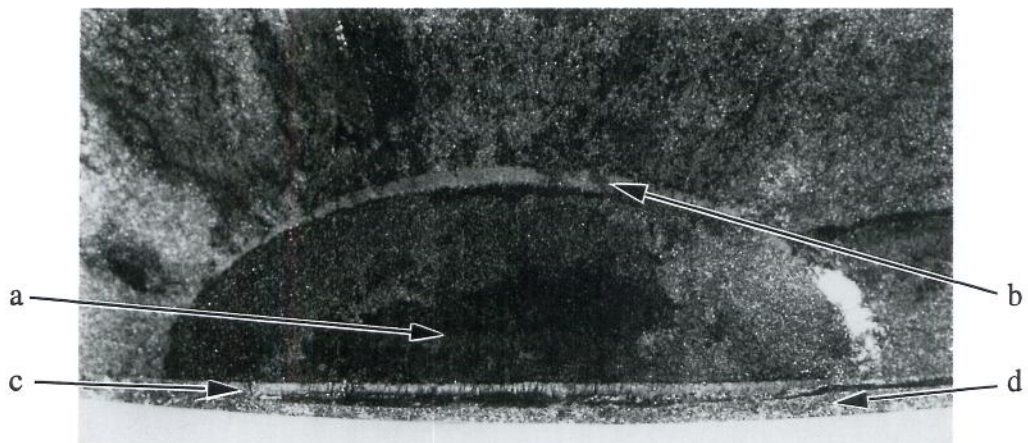
Area of initial fracture

The axle, which was removed from the truck assembly under AAIB supervision, was found to have fractured completely across a section about 1½ inches from its mid-point, towards the end used as the No 9 stub axle; a position not visible even with the wheels and brakes removed. Metallurgical examination revealed that the initial 0.5% of the fracture had been principally by a stress corrosion mechanism followed by a short period of fatigue, with the remaining 99.5% being by overload.

- Note:- (a) Area of stress corrosion fracture in steel of axle
 (b) Area of fatigue extending inwards from it
 (c & d) Layers of nickel and Chromium plating
