Piper PA-28-161 Cherokee Warrior, G-BTBC

AAIB Bulletin No: 9/2004	Ref: EW/C2003/10/03	Category: 1.3
Aircraft Type and Registration:	Piper PA-28-161 Cherokee Warrior, G-BTBC	
No & Type of Engines:	1 Lycoming O-320-D3G piston engine	
Year of Manufacture:	1979	
Date & Time (UTC):	28 October 2003 at 1408 hrs	
Location:	Wellesbourne Mountford, Warwickshire	
Type of Flight	Training	
Persons on Board:	Crew - 2	Passengers - None
Injuries:	Crew - None	Passengers - N/A
Nature of Damage:	Minor to right main landing gear and flap	
Commander's Licence:	Airline Transport Pilot's Licence	
Commander's Age:	43 years	
Commander's Flying Experience:	9,672 hours (of which 645 were on type)	
	Last 90 days - 168 hours	
	Last 28 days - 40 hours	
Information Source:	Aircraft Accident Report Form submitted by the pilot and metallurgical examination of components

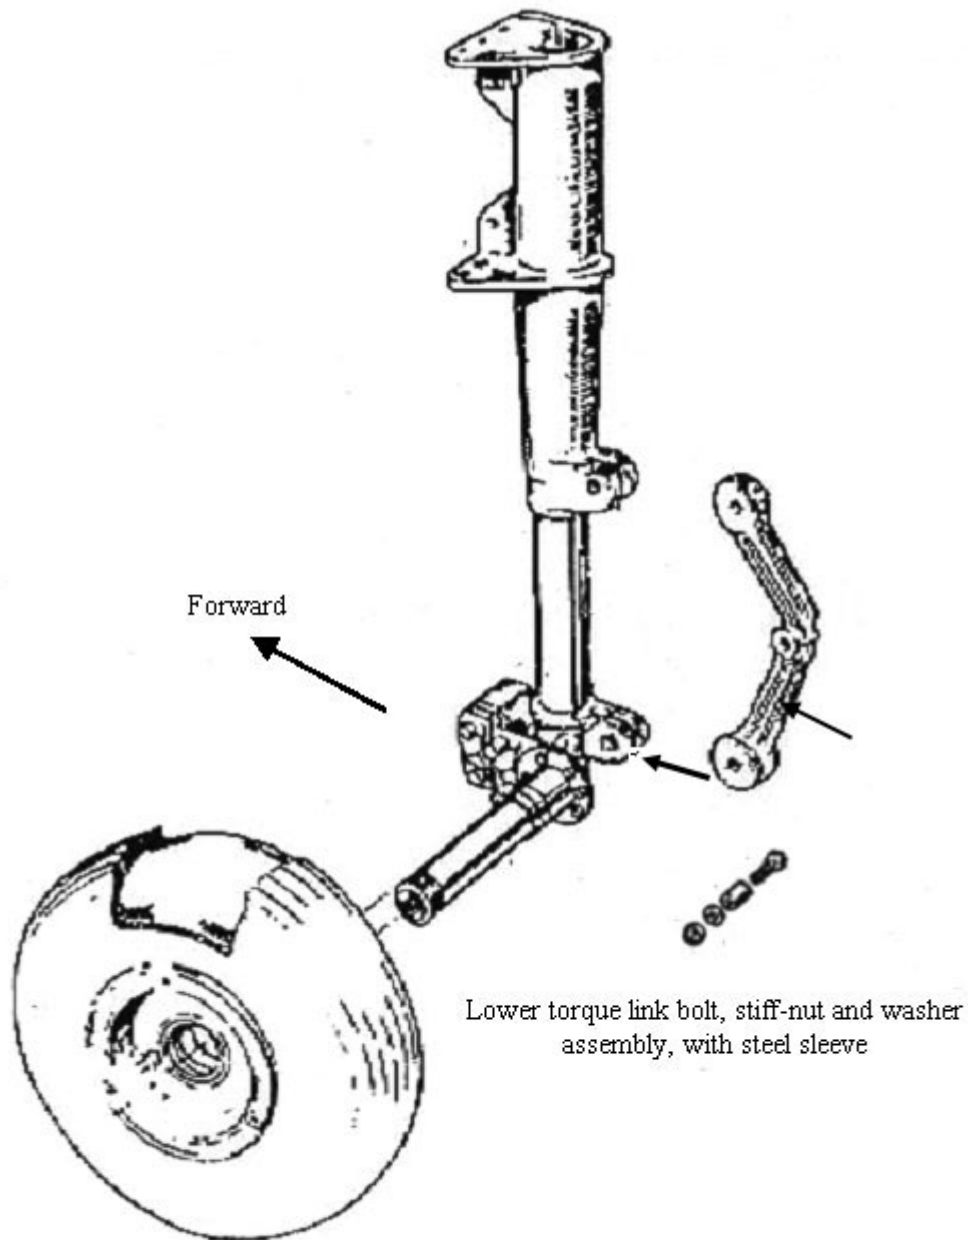
Figure 1. View of principal components of main landing gear

It was found that the lower torque link bolt had failed; - see the main landing gear details in Figure 1. This had allowed the wheel and axle assembly to pivot such that the wheel would have been pointing at approximately right angles to the direction of travel, thus causing drag forces sufficient to result in a bending overload failure of the leg.

For reasons of clarity, Figure 1 shows the installation without a wheel fairing, which has a conventional bolt attaching the lower torque link to a fork on the axle assembly. In this case, where a fairing was installed, the 'bolt' in reality consisted of a steel shank, threaded at both ends, with a stiff-nut at one end and a castellated nut and split pin at the other. Integral with the shank was a hexagonal section, which functioned as a spacer. A steel sleeve had been located inside the bore of the lower torque link, and through which the bolt had passed. However this was not recovered after the accident. A number of washers and shims, designed to limit the lateral play of the lower link to 0.005 to 0.007 inches, were similarly not recovered. A photograph of the failed bolt is shown at Figure 2.

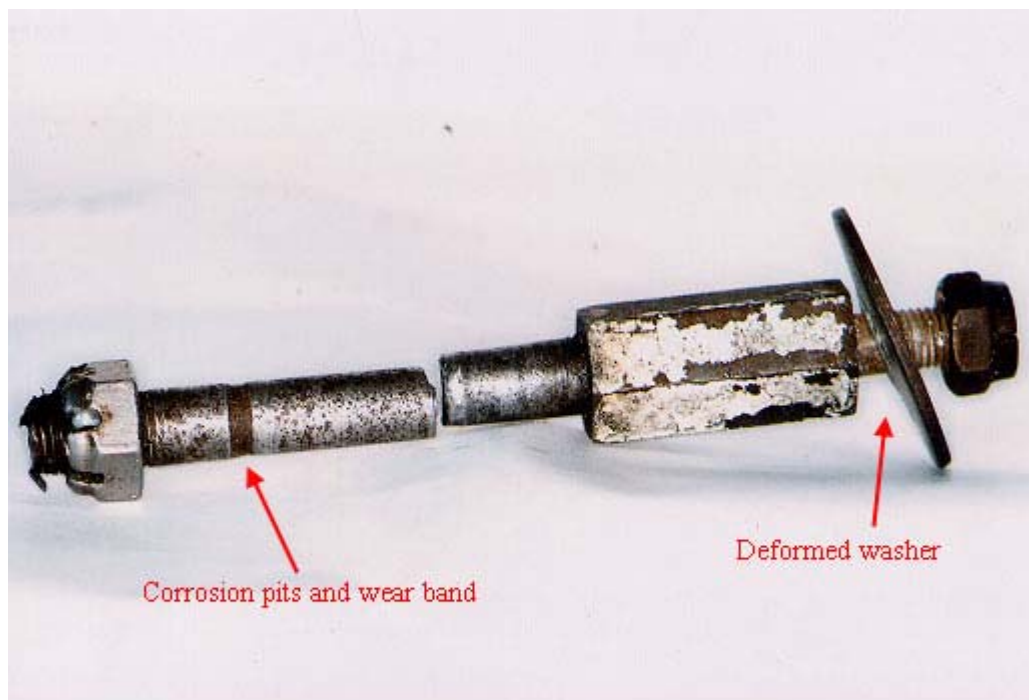
Figure 2. View of failed bolt

It can also be seen from the photographs that the portion of bolt shank containing the separation had been extensively attacked by pitting corrosion. The plane of separation was located at the interface between the lower torque link and the inner face of the inboard lug of the fork. A band of wear was apparent on the shank at a position corresponding to the outboard lug. The diameter in this region was 0.280 inches, compared with 0.290 inches for most of the rest of the shank. Close to the hexagonal section the shank diameter was 0.3125 inches.

Of particular interest was the large washer under the stiff-nut; this had suffered plastic deformation, indicating that the assembly had been over-tightened at some stage. Since this would have placed the bolt in tension, as well as preventing any rotation, it is considered that the bending fatigue resistance would have been reduced.

The general condition of the failed bolt was poor, with the degree of corrosion pitting suggesting that inadequate lubrication had featured at some time in its (probably lengthy) history. The degree of wear that had occurred on the bolt shank was an additional indication of a lack of lubrication. The distortion of the washer suggested that the bolt had been over-tightened at some stage, which would have rendered it more susceptible to fatigue initiation. Finally, the nature of the installation does not readily lend itself to ease of inspection, as so little of the bolt surface is visible without disassembly. Access is even more difficult where wheel fairings are fitted.

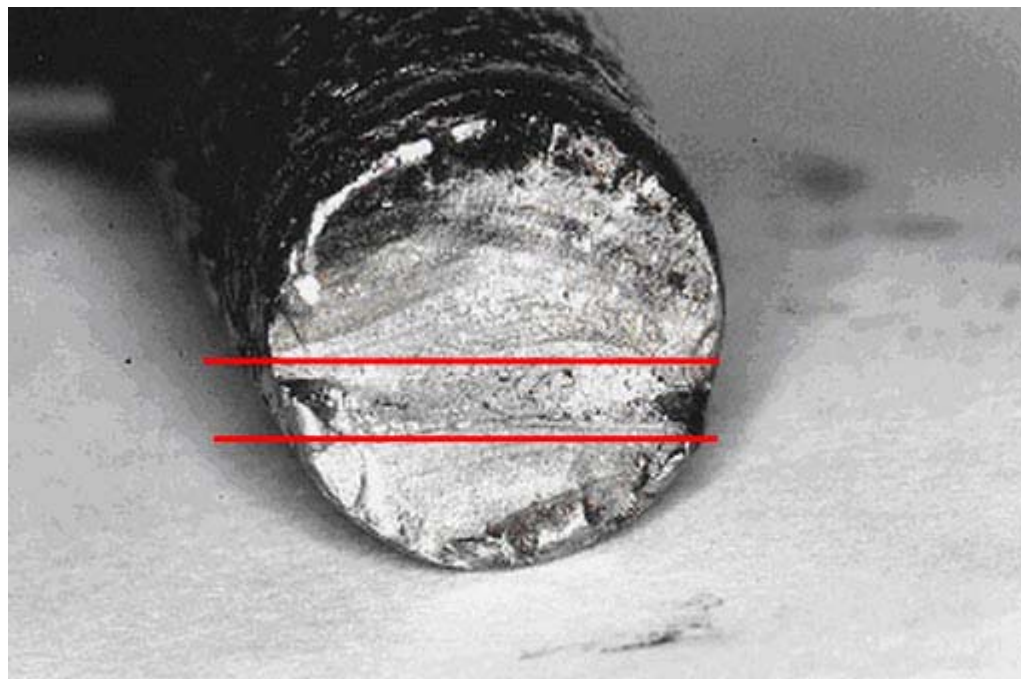
Figure 3. View of fracture face showing fatigued areas above and below approximate region of overload

The bolt and its related parts were subjected to a metallurgical examination and it was found that the bolt shank had fractured across its diameter as a result of a low cycle, reverse bending fatigue mechanism; - see the photograph of the fracture face at Figure 3. Approximately 80% of the fracture was due to fatigue, with multiple initiation sites around the circumference of the shank. The remainder of the failure was due to overload. Although the axial orientation of the bolt was not known, it is likely that the reverse bending process occurred about a vertical axis, ie parallel to the leg, as a result of oscillatory loads being transmitted from the wheel via the axle. Such loads could arise from wheel spin-up on touchdown and from braking.

It is recommended that the Federal Aviation Administration, (FAA), as certifying authority for the Piper PA-28 series of aircraft, mandate Piper Service Letter No 842, which called for an improved inspection procedure for the bolt attaching the upper and lower links in the main landing gear torque link assembly. It is further recommended that a similar inspection procedure should be mandated for the lower torque link bolt.

It is recommended that the European Aviation Safety Agency (EASA) review the torque linkage in PA-28 aircraft with fixed main landing gears, with a view to implementing an improved inspection procedure for the lower torque link bolt. It is additionally recommended that EASA implement a similar procedure for the centre bolt that reinstates the intent of the Civil Aviation Authority's (United Kingdom) Additional Airworthiness Directive No 016-02-80 Revision 1 which has now been cancelled.
