Aircraft Type and Registration:	Robinson R44 Raven I, G-OUEL
No & Type of Engines:	1 Textron Lycoming O-540-F1B5 piston engine
Year of Manufacture:	2002
Date & Time (UTC):	30 July 2003 at 1004 hrs
Location:	Carlenrig, Teviothead, near Hawick, Scotland
Type of Flight:	Private
Persons on Board:	Crew - 1 Passengers - None
Injuries:	Crew - 1 (Fatal) Passengers - N/A
Nature of Damage:	Helicopter destroyed
Commander's Licence:	Private Pilot's Licence
Commander's Age:	41 years
Commander's Flying Experience:	96 hours - (of which 20 were on type) Last 90 days - 6 hours Last 28 days - 4 hours
Information Source:	AAIB Field Investigation

Synopsis

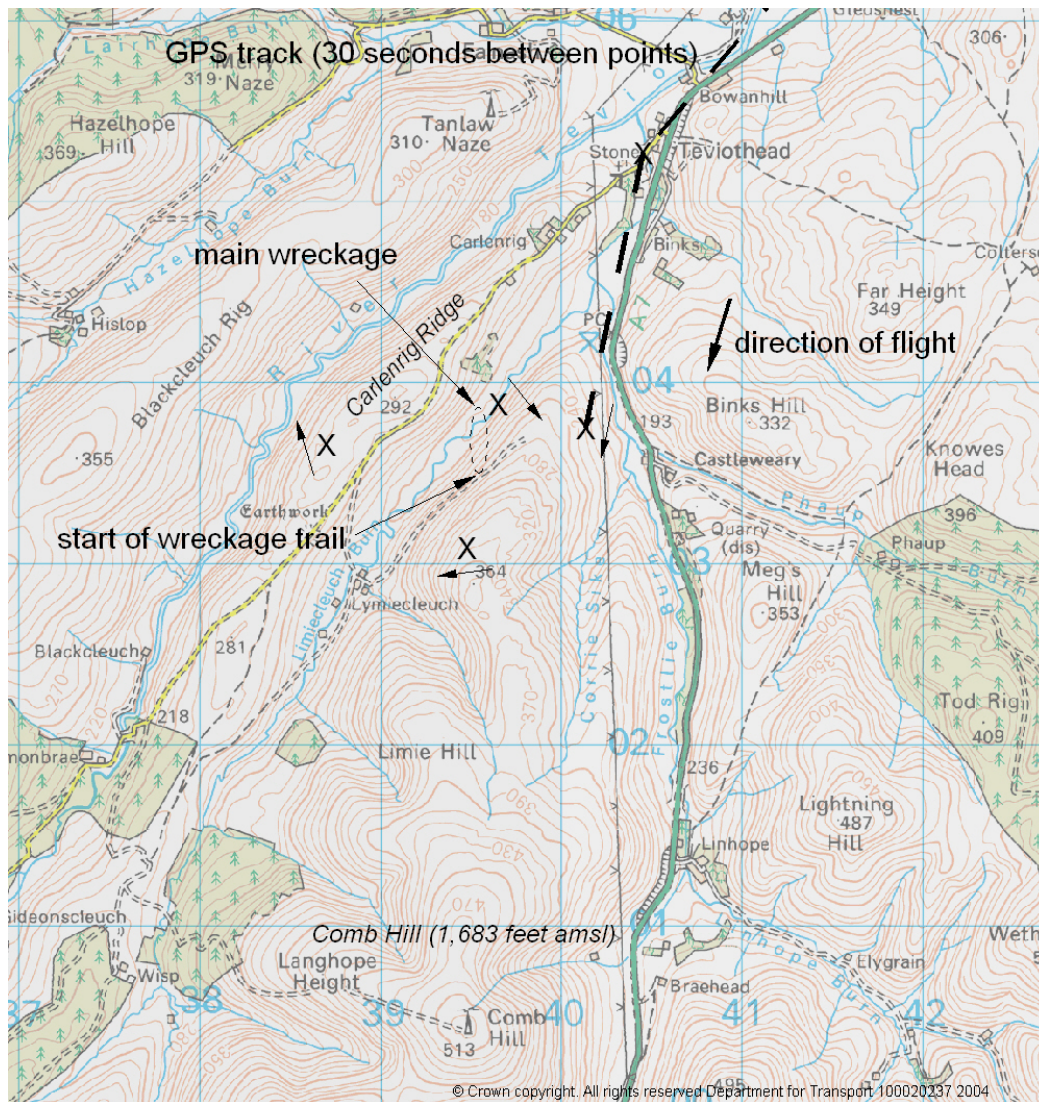
Figure 1

The helicopter was fitted with a Global Positioning System (GPS) navigation system that recorded the time, position, groundspeed, track and GPS altitude every 30 seconds during the flight. The GPS recorded data was downloaded at the AAIB and converted to heights above mean sea level (amsl) and Ordnance Survey Grid; the last part of the route is shown at Figure 1.

The GPS data showed that approximately 1 nm south of Teviothead, where the A7 road turns south, the aircraft's ground speed reduced to 98 kt. Over the next 30 seconds the aircraft climbed from around 1,500 feet to 2,400 feet; an average rate of climb of 1,800 feet per minute. In this time it turned right through 32° and the ground speed reduced to 50 kt. Over the next 30 seconds the GPS altitude increased approximately 200 feet to about 2,600 feet, the right turn continued through a further 83° and the ground speed increased to 86 kt. At the final data point, timed at 1004 hrs, the GPS altitude had decreased about 150 feet to approximately 2,450 feet, the right turn had continued through a further 130° and the ground speed had increased to 120 kt. No further data points were recorded.

Final GPS track of G-OUEL and wreckage site location

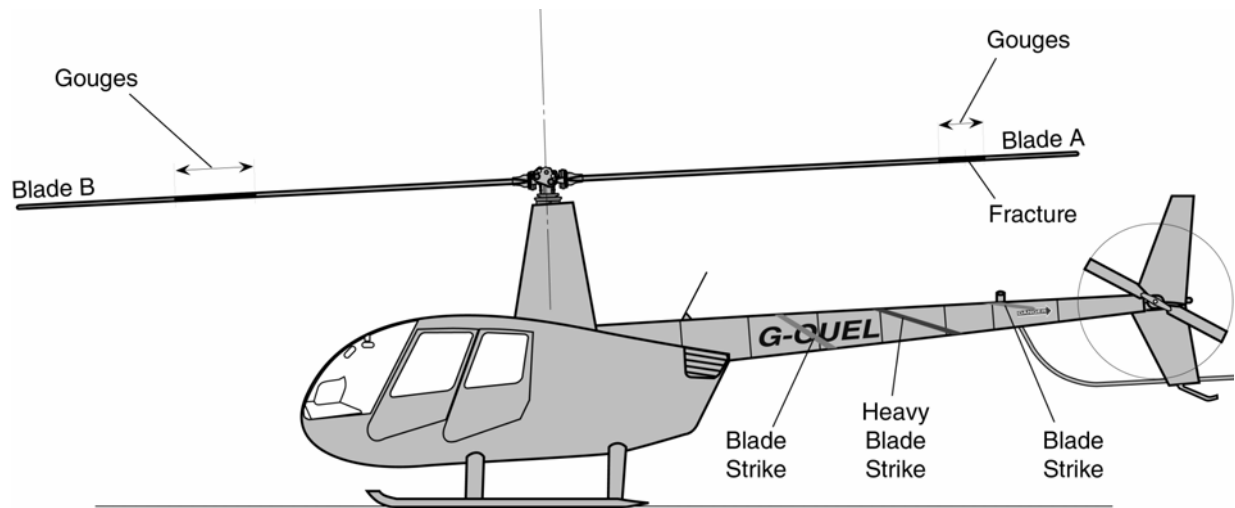
Figure 5

It was clear from markings and damage characteristics that the tailboom had sustained three strikes from MR blades on its left side (Figure 5). One of these strikes, around mid-way along the tailboom, had been particularly heavy. The strikes had separated the boom into 7 major parts and a large number of smaller fragments. Severe localised flattening damage to the TR driveshaft and the TR control rod in the area of the heavy tailboom strike was also indicative of a MR blade strike.

G-OUEL - Main rotor blade and tailboom marks

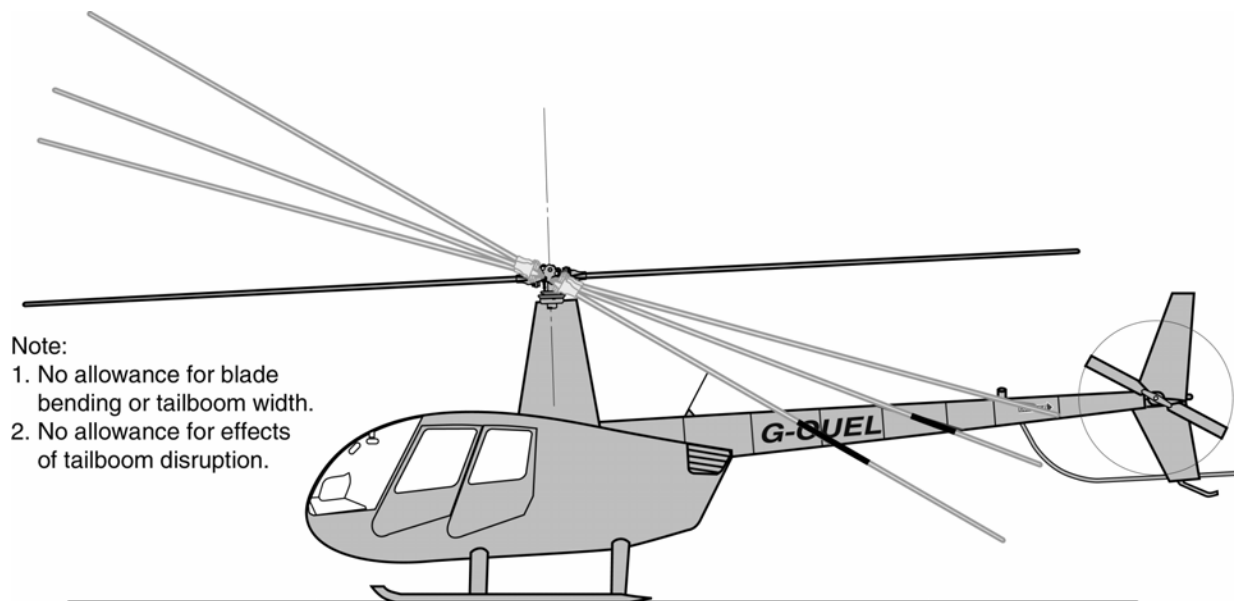
Figure 6

It was apparent from wreckage markings and distribution that G-OUEL's tailboom had suffered several strikes by the MR blades and that most the tailboom had detached in-flight as a result and subsequent ground impact was inevitable. The absence of ground marks from the MR blades together with the lack of appreciable ground impact damage to the blade leading edges indicated that the rotor had stopped, or very nearly so, by the time the helicopter reached the ground. The ground impact, made with substantial vertical speed, was non-survivable. Extensive destruction of the helicopter in the ground fire meant that insufficient evidence was available for all details of the in-flight break-up sequence to be positively determined.

Schematic of possible main rotor blade strikes on tailboom
