Beechcraft Baron B55, N55BN, 31 January 1996

AAIB Bulletin No: 5/96 Ref: EW/G96/01/09 Category: 1.2

Aircraft Type and Registration:Beechcraft Baron B55, N55BN

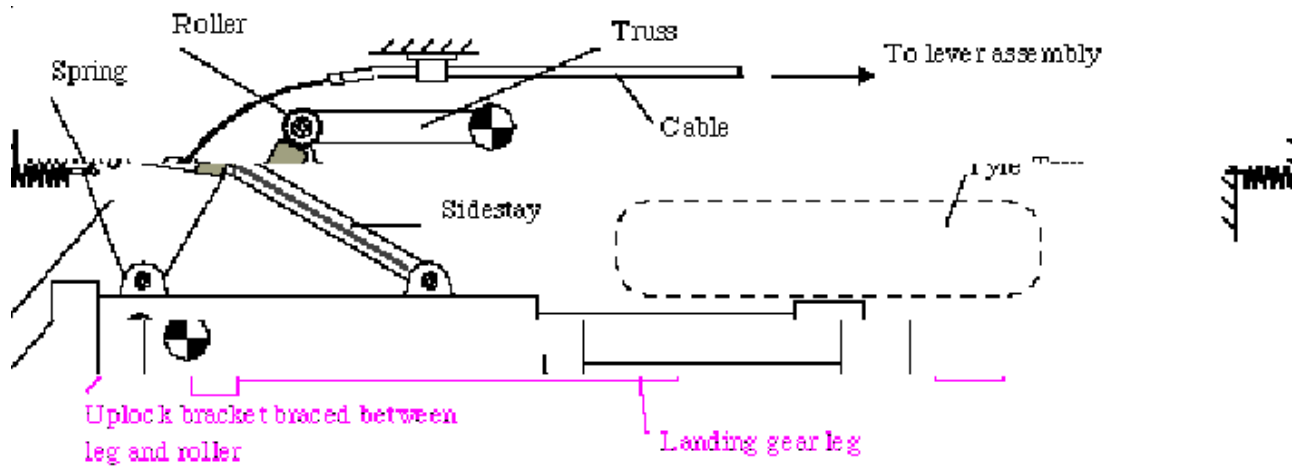
GEAR RETRACTED

which is connected, via rigid rods, to each of the main gear trusses. These are in turn connected to sidestays on the gear legs, and incorporate a roller assembly. The uplock consists of a bracket assembly which operates by forming a geometric brace between its mounting on the gear leg, and the roller. The bracket is connected to the gear bay structure by a spring, the tension of which opposes a cable linking the bracket to the gear operating motor lever assembly. The system is designed such that the cable is under tension when the gear is retracted. When the gear is selected down, the first effect of the motor lever assembly is to relax the cable tension. This results in the spring tension moving the uplock bracket away from the roller, thus allowing movement of the truss/sidestay assembly, and in consequence, extension of the gear. The principle of operation is shown in the attached diagram.

Following the accident, the uplock was found jammed in the locked position, and the gear operating rod had buckled as a result of compressive overload. During subsequent investigation, it was noted that the roller had seized, although the absence of any wear patterns on the roller surface did not indicate that this had been the sole source of the problem. In addition, it was found that the bolt hole in the uplock bracket, which forms the pivot on the gear leg, was worn. This had resulted in some freeplay in the uplock bracket, which could have interfered with its engagement with the roller. However there was no evidence, in the form of witness marks, that this had actually occurred. Finally, it was observed that the cable seemed somewhat stiff in operation, which, coupled with a slightly weak spring, may have contributed towards a reluctance for the uplock to release.
