No: 7/92

Ref: EW/C92/4/2

Aircraft Type and Registration: Piper PA-28-140 Cherokee, G-AYIO
No & Type of Engines: 1 Lycoming O-320-E2A piston engine
Year of Manufacture: 1970
Date & Time (UTC): 7 April 1992 at 1554 hrs
Location: Horseshoe Hill, near Consett, County Durham
Type of Flight: Private
Persons on Board: Crew - 1 Passengers - None
Injuries: Crew - Fatal Passengers - N/A
Nature of Damage: Aircraft destroyed
Commander's Licence: Private Pilot's Licence
Commander's Age: 52 years
Commander's Flying Experience: 74 hours (of which 20 were on type)
Last 90 days - 11 hours
Last 28 days - 4 hours
Information Source: AAIB Field Investigation

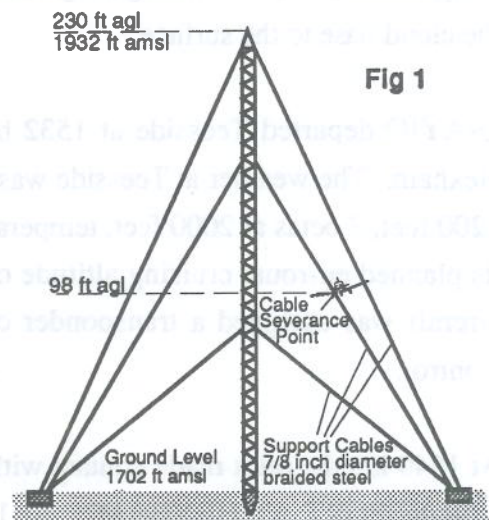
Wreckage and site examination showed that the aircraft had collided with the support cables of a radio mast, Muggleswick Radio Station Tower. The tower is 1702 feet amsl on undulating moorland and stands 230 feet agl. It is supported by twelve guy cables, in four orthogonal sets of three cables, with each set anchored in the ground approximately 100 feet from the base of the tower (Figure 1). Each cable is of multistrand braided steel of 7/8 inch overall diameter.

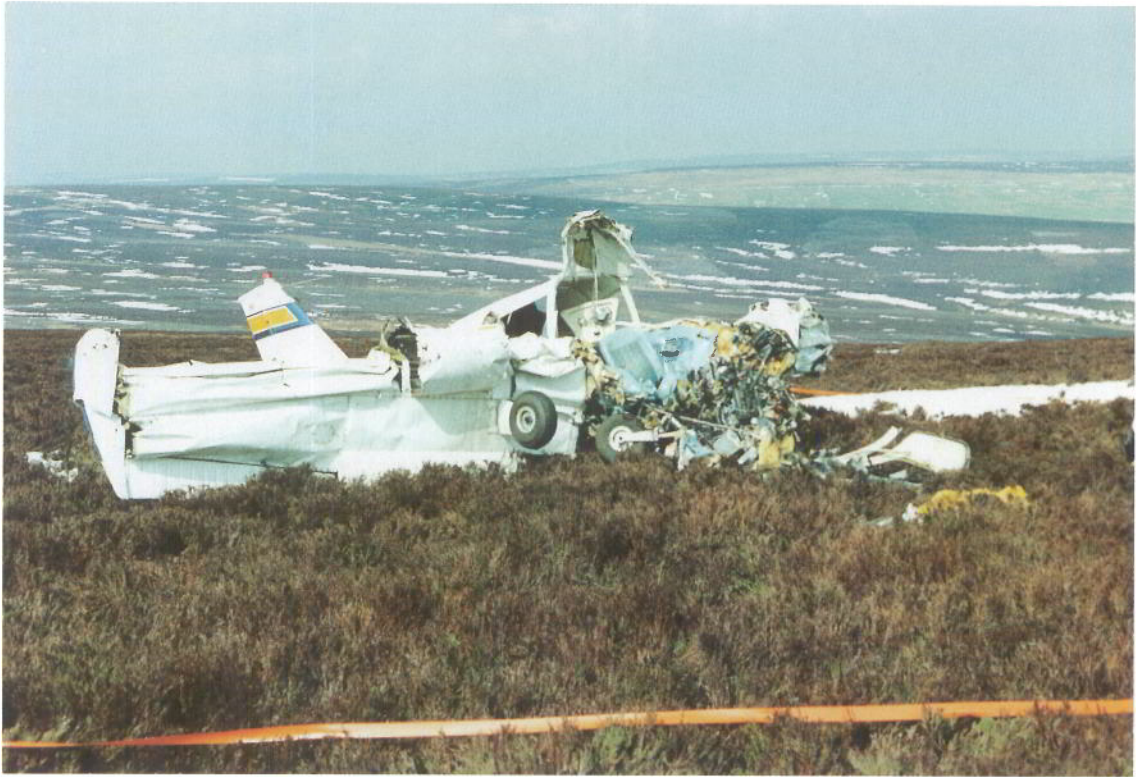
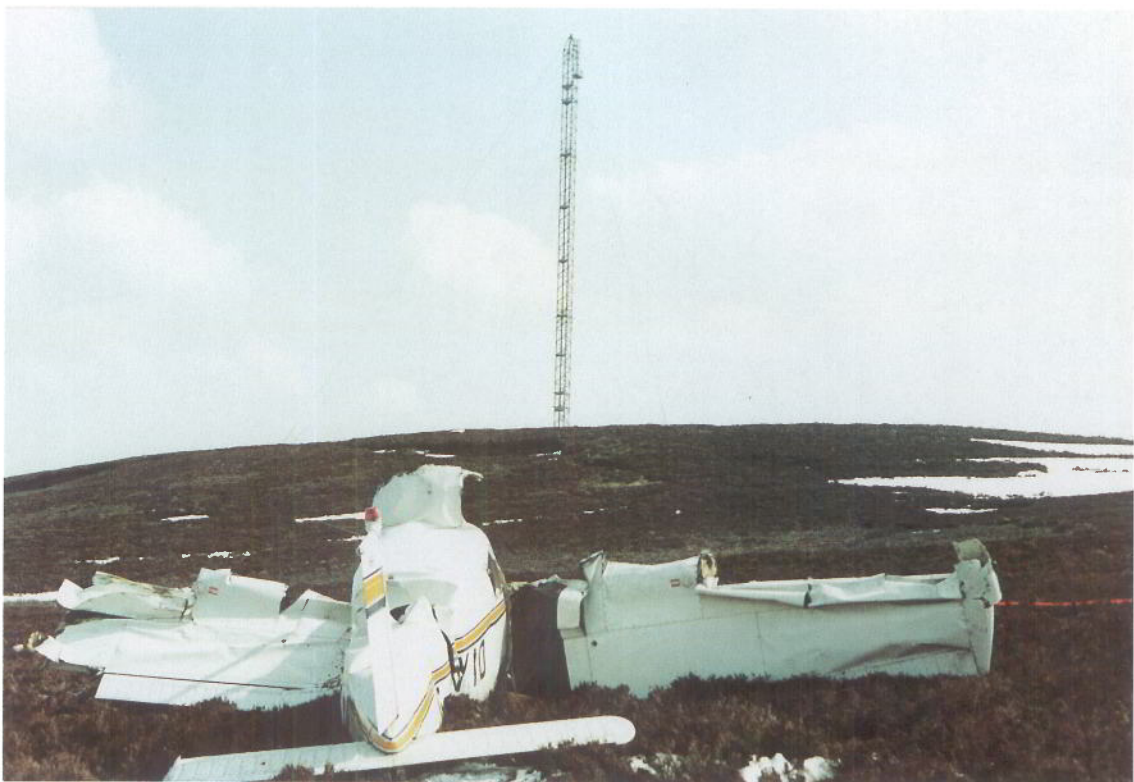
G-AYIO ACCIDENT SITE

The aircraft subsequently struck the ground 230 metres west of the point of major cable impact and approximately 150 feet below the level of this impact (Figure 2). The ground was of wet peat with a covering of heather. At ground impact the aircraft was heading approximately 080°T, *ie* almost towards the mast and was pitched nose down and descending at around 70° to the horizontal. Ground impact caused severe damage to the engine and forward fuselage, including the forward cabin area, gross longitudinal crushing of the leading edges of the wings and buckling of the rear fuselage. There was no fire.
