**INCIDENT**

<b>Aircraft Type and Registration:</b>	Bombardier DHC-8-402 (Q400), G-JEDW
<b>No &amp; Type of Engines:</b>	2 Pratt & Whitney Canada PW150A turboprop engines
<b>Year of Manufacture:</b>	2004
<b>Date &amp; Time (UTC):</b>	20 October 2005 at 0810 hrs
<b>Location:</b>	Leeds Bradford International Airport
<b>Type of Flight:</b>	Public Transport (Passenger)
<b>Persons on Board:</b>	Crew - 4                      Passengers - 60
<b>Injuries:</b>	Crew - None                      Passengers - None
<b>Nature of Damage:</b>	'Runway touched' sensor fairing abraded
<b>Commander's Licence:</b>	Airline Transport Pilot's Licence
<b>Commander's Age:</b>	44 years
<b>Commander's Flying Experience:</b>	4,150 hours (of which 200 were on type) Last 90 days - 126 hours Last 28 days - 42 hours
<b>Information Source:</b>	AAIB Field Investigation

**Synopsis**

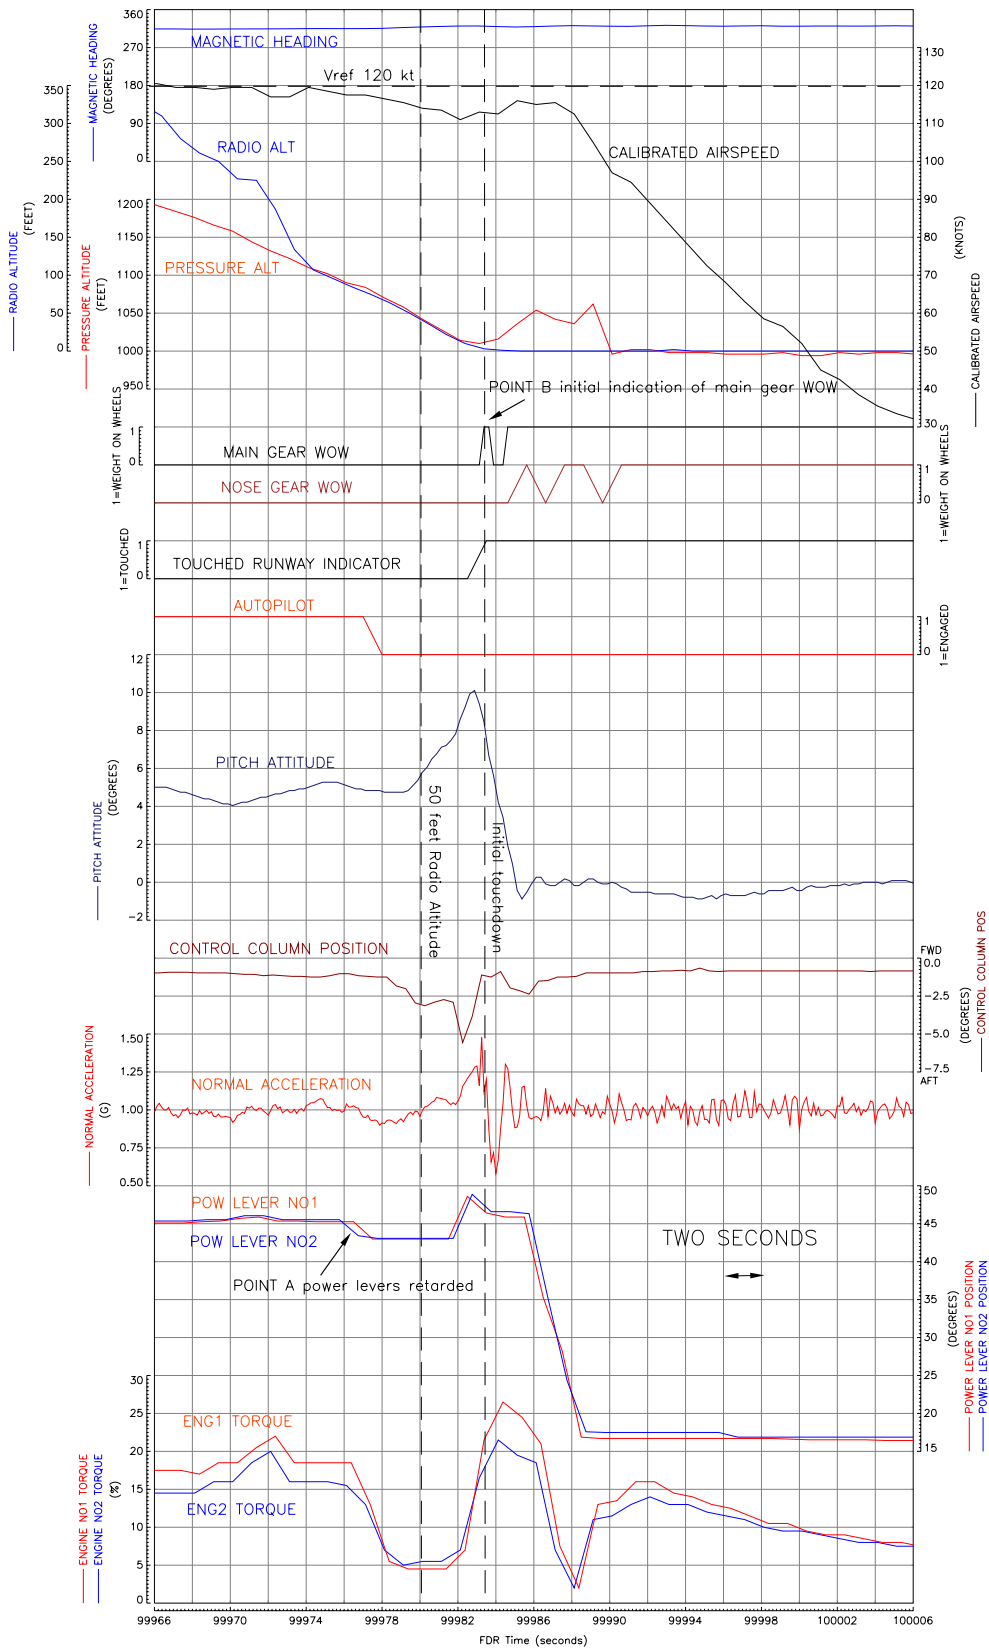
**Figure 1**  
Salient FDR Parameters  
Incident to G-JEDW on 20 October 2005

Recorded parameters indicated that the aircraft continued to descend as it tracked both the ILS glideslope and localiser signals. At about 130 feet agl, the airspeed was approximately 120 kt and the left and right engine torques were approximately 16 % and 18 % respectively. At 75 ft agl, the autopilot disconnected. Almost coincident with this, both power levers were retarded slightly (Figure 1 Point A) and both the engine torques and airspeed started to reduce. Shortly afterwards the commander said "DON'T PULL THE POWER BACK... YOU PULLED ALL THE POWER BACK..."

Two seconds later, at 50 ft agl and 115 kt airspeed, the aircraft started to flare. By this time both engines had stabilised at about 5% torque. Two seconds later, at 25 ft agl, with the pitch attitude approximately 7.5° nose

up and the airspeed at 113 kt, both power levers were advanced and the engine torque started to increase. The pitch attitude continued to increase to approximately 10° before reducing slightly to 9.4°, at which time a normal acceleration value of about 1.47g was recorded. This was coincident with the main gear weight on wheels parameter indicating that the aircraft had touched down (Figure 1 Point B). Almost simultaneously, the master and 'touched runway' warnings were recorded.

After the initial touchdown the aircraft momentarily became light before the main gear finally remained in a 'weight on wheels' condition. Shortly afterwards, the nose gear touched down and the aircraft oscillated in pitch slightly before settling, as evidenced by the pitch attitude and nose gear 'weight on wheels' parameters. The aircraft then began to decelerate. As it vacated the runway the crew advised ATC that they had a warning indicating that the aircraft tail may have touched the runway. The aircraft taxied to a stand where, at approximately 0820 hrs, the engines were shutdown.
