<b>Aircraft Type and Registration:</b>	Vickers-Supermarine Spitfire PR.XI, G-PRXI (PL983)	
<b>No &amp; Type of Engines:</b>	1 Rolls-Royce Packard Merlin 266 piston engine	
<b>Year of Manufacture:</b>	1944	
<b>Date &amp; Time (UTC):</b>	4 June 2001 at 1455 hrs	
<b>Location:</b>	Near Rouen, Vallee de Seine Airport, France	
<b>Type of Flight:</b>	Private (aerial display)	
<b>Persons on Board:</b>	Crew - 1	Passengers - N/A
<b>Injuries:</b>	Crew - 1 (Fatal)	Passengers - N/A
<b>Nature of Damage:</b>	Aircraft destroyed	
<b>Commander's Licence:</b>	Private Pilot's Licence	
<b>Commander's Age:</b>	56 years	
<b>Commander's Flying Experience:</b>	1,926 hours (of which about 48 were on type)	
<b>Information Source:</b>	See below

*The following is an account of an accident that occurred in France and which was subject to an investigation by the Bureau d'Enquetes et d'Analyses pour la Securite de l'Aviation Civile (BEA) and the French judiciary. The AAIB were asked to conduct and oversee a strip inspection of the Rolls-Royce Packard Merlin engine on their behalf. The findings of this examination are considered sufficiently important that they should be promulgated within the United Kingdom, at

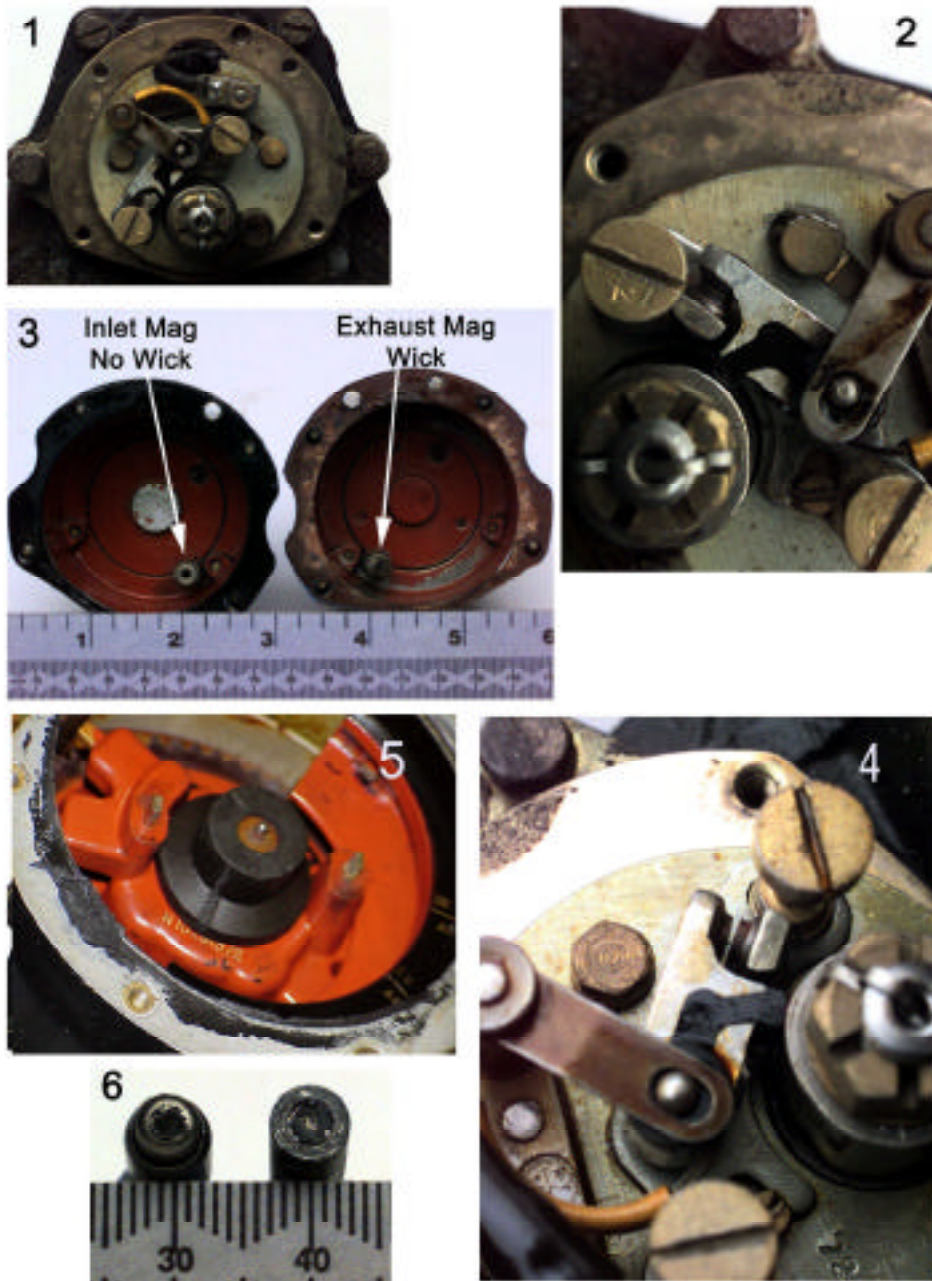
Figure 2

On the right magneto, there was a considerable degree of oil/grease contamination around the points but the wick, which conducts oil from a reservoir in the cap to lubricate the cam, was missing (see Figure 2, photograph 3). The points gap appeared to be excessive (about 0.018 inches). However there was also a small 'nib' caused by spark erosion which probably reduced the effective gap to about 0.015 inches (Figure 2, photograph 4). Turning the magneto by hand did not result in any spark.

On the left magneto, it could be seen that the points had closed up almost completely such that, even on the lobe of the cam, there was no appreciable points gap (Figure 2, photographs 1 & 2). The wick was present but was dry. In both cases the reservoirs were completely devoid of oil. Turning by hand did not produce a spark.

The right magneto did not produce any sparks at any RPM. This was initially thought to be due to the oil contamination. It, too, became abnormally hot during the few minutes that it was running.

The right magneto was the first to be examined. After removal of the main cover plate, it was noted that the rubber insulator (manufacturer's Part Number (PN) N72791, RAF PN 37A10941) over the central spindle appeared to have evidence of electrical tracking down one side (a line of degraded rubber, Figure 2, photograph 5). The decision was made to replace it with a serviceable insulator and repeat the rig test. The magneto performed satisfactorily with the new item, but still got hot as before. Further strip examination revealed that a grease retention plate was missing from the assembly and that this was responsible for the oily deposits found throughout the magneto. The BBMF personnel were also of the opinion that the grease used was not of the type they knew as approved for use in this application.

It is recommended that the Civil Aviation Authority should issue a letter to all operators of Rolls-Royce Merlin powered aircraft, equipped with Rotax magnetoes, recommending that the insulator, P/No N72791, be replaced at magneto overhaul. In addition, the letter should draw the attention of operators to the following recommendations made by Rolls-Royce plc:

1. Magneto overhaul on low utilisation engines should be accomplished at about half the generally accepted 500 hour engine overhaul life.
2. A magneto inspection should be performed on all Merlin engines within 50 hours/one year, and thereafter at yearly intervals, which should include visual checks of:
  - a) Points setting, condition and function
  - b) Insulator condition
  - c) Correct lubrication
  - d) Anti-tracking paint condition
  - e) Other apparent faults and signs of deterioration
3. A once-off check should be performed to ensure that copper inserts are used in the high-tension leads rather than aluminium or any other metal.
