AAIB Bulletin No: 7/94

Aircraft Type and Registration: Boeing 767-200 ER, Z-WPE

Date & Time (UTC): 10 March 1994 at 1819 hrs

Location: London Gatwick Airport

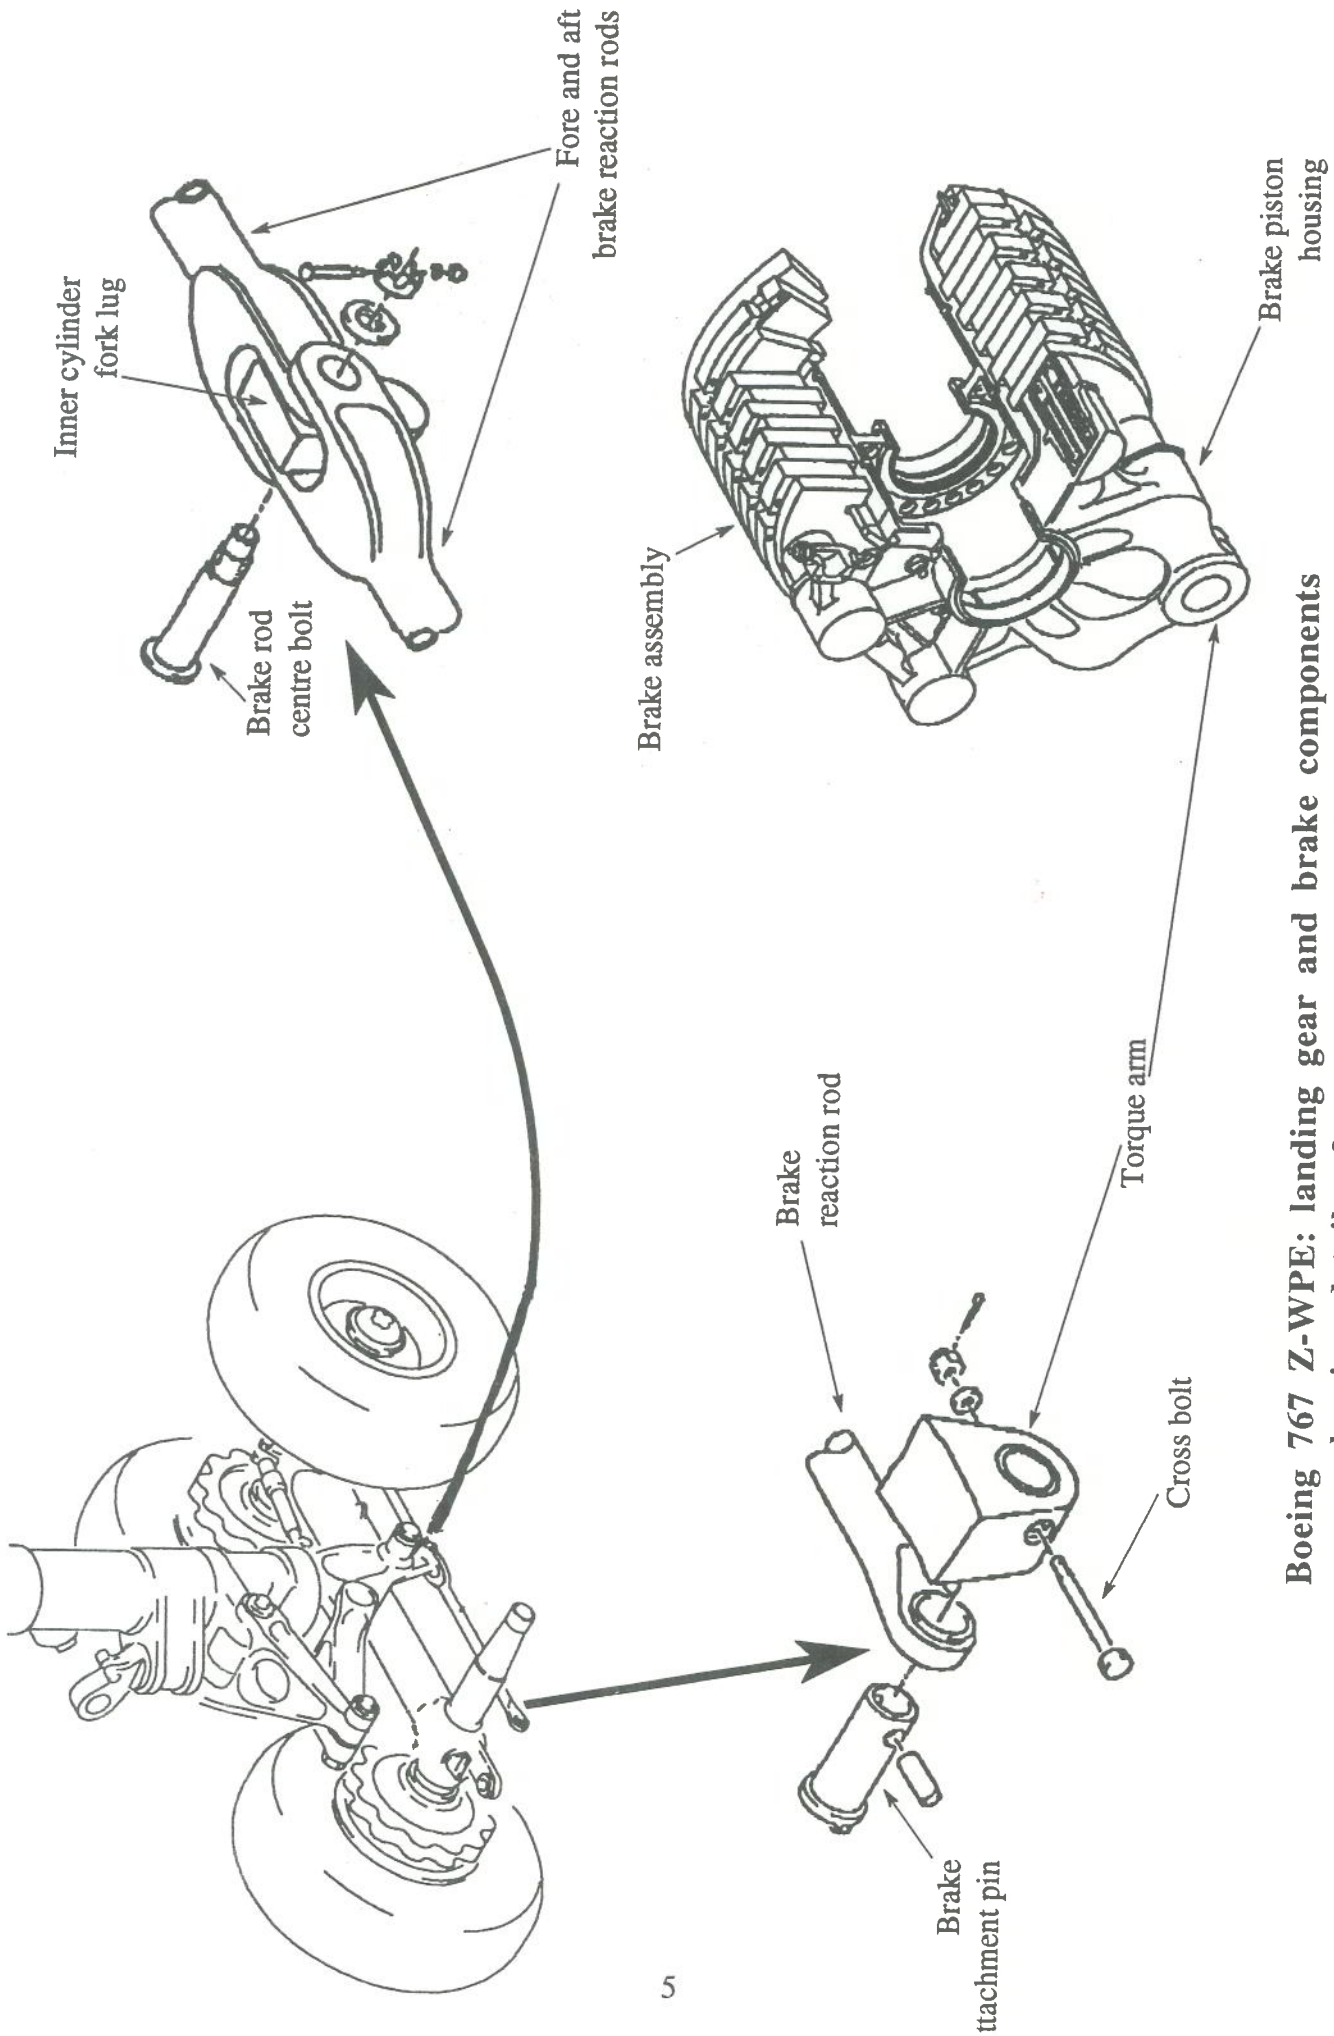
Figure 1

As found, No 3 tyre had completely deflated and No 7 had a slow leak. Hydraulic fluid was dripping from ruptured pipes on both landing gears. It was obvious that the brake reaction rods had detached from brakes No 2,4,6 and 8. These reaction rods prevent the entire brake assembly rotating with the wheel (see Figure 1) and thus disconnection allows pack rotation with the consequential pulling-apart of the brake hydraulic hoses which was clearly what had happened.

In all cases, the disconnection was due to the absence of the brake attachment pin which had apparently migrated out from the torque arm/reaction rod. All four had been recovered from the runway together with their associated retaining cross-bolts (which had broken), nuts and washers. The No 2 brake featured a broken torque arm on the brake pack as well, which was also recovered. Subsequent metallurgical examination of the failed components showed that overload failures of the cross-bolts had allowed the pins to migrate out; the broken torque arm must have occurred before the pin was completely disconnected.

Essentially, the phenomenon of brake reaction rod disconnection is, according to Boeing, due to 'squeal' vibration characterised by rotation deflection of the stationary brake components about the axle centrelines. This has manifested itself primarily as breakage of the cross-bolt and subsequent rapid migration of the attachment pin (as occurred on Z-WPE). A smaller number of cases involved failure of the brake rod centre bolt (which implies loss of braking on a tandem pair of wheels) and one recorded failure of the torque arm (as occurred on Z-WPE). Although simultaneous loss of a tandem pair of attachment pins has occurred before, this incident is the first in which four wheels have been affected, albeit on different landing gear bogies.

Boeing 767 Z-WPE: landing gear and brake components showing details of torque arm attachments

After the instances of cross-bolt failure described in AAIB Bulletin 4/94, the CAA imposed a performance penalty, and other interim measures, on the two affected British operators of the Boeing 767 by assuming a possible braking efficiency loss equivalent to two brake units. Meanwhile, Boeing issued two Service Bulletins, No's 767-32-A0116 and 767-32-A0126. The former detailed a programme of inspection and replacement of the centre bolt and bushing whilst the latter included inspection of the bushing and a modification to replace the brake attachment pin cross-bolt with a revised arrangement featuring a 'keeper' pin. Finally, Boeing issued Service Bulletin No. 767-32-A0125 which introduced a revised quick-disconnect hydraulic fitting arrangement to address another, non-associated, problem which had caused loss of individual wheel braking.

The FAA issued Airworthiness Directive (AD) 94-03-07 with an effective date of 18 February 1994 which mandated all three of the above Service Bulletins. It also included details of various performance penalty options should operators be unable either to comply with the AD inspection and modification requirements within the stipulated 60 days from the effective date or should defects be discovered which cannot be rectified within the compliance limitations detailed in the AD.

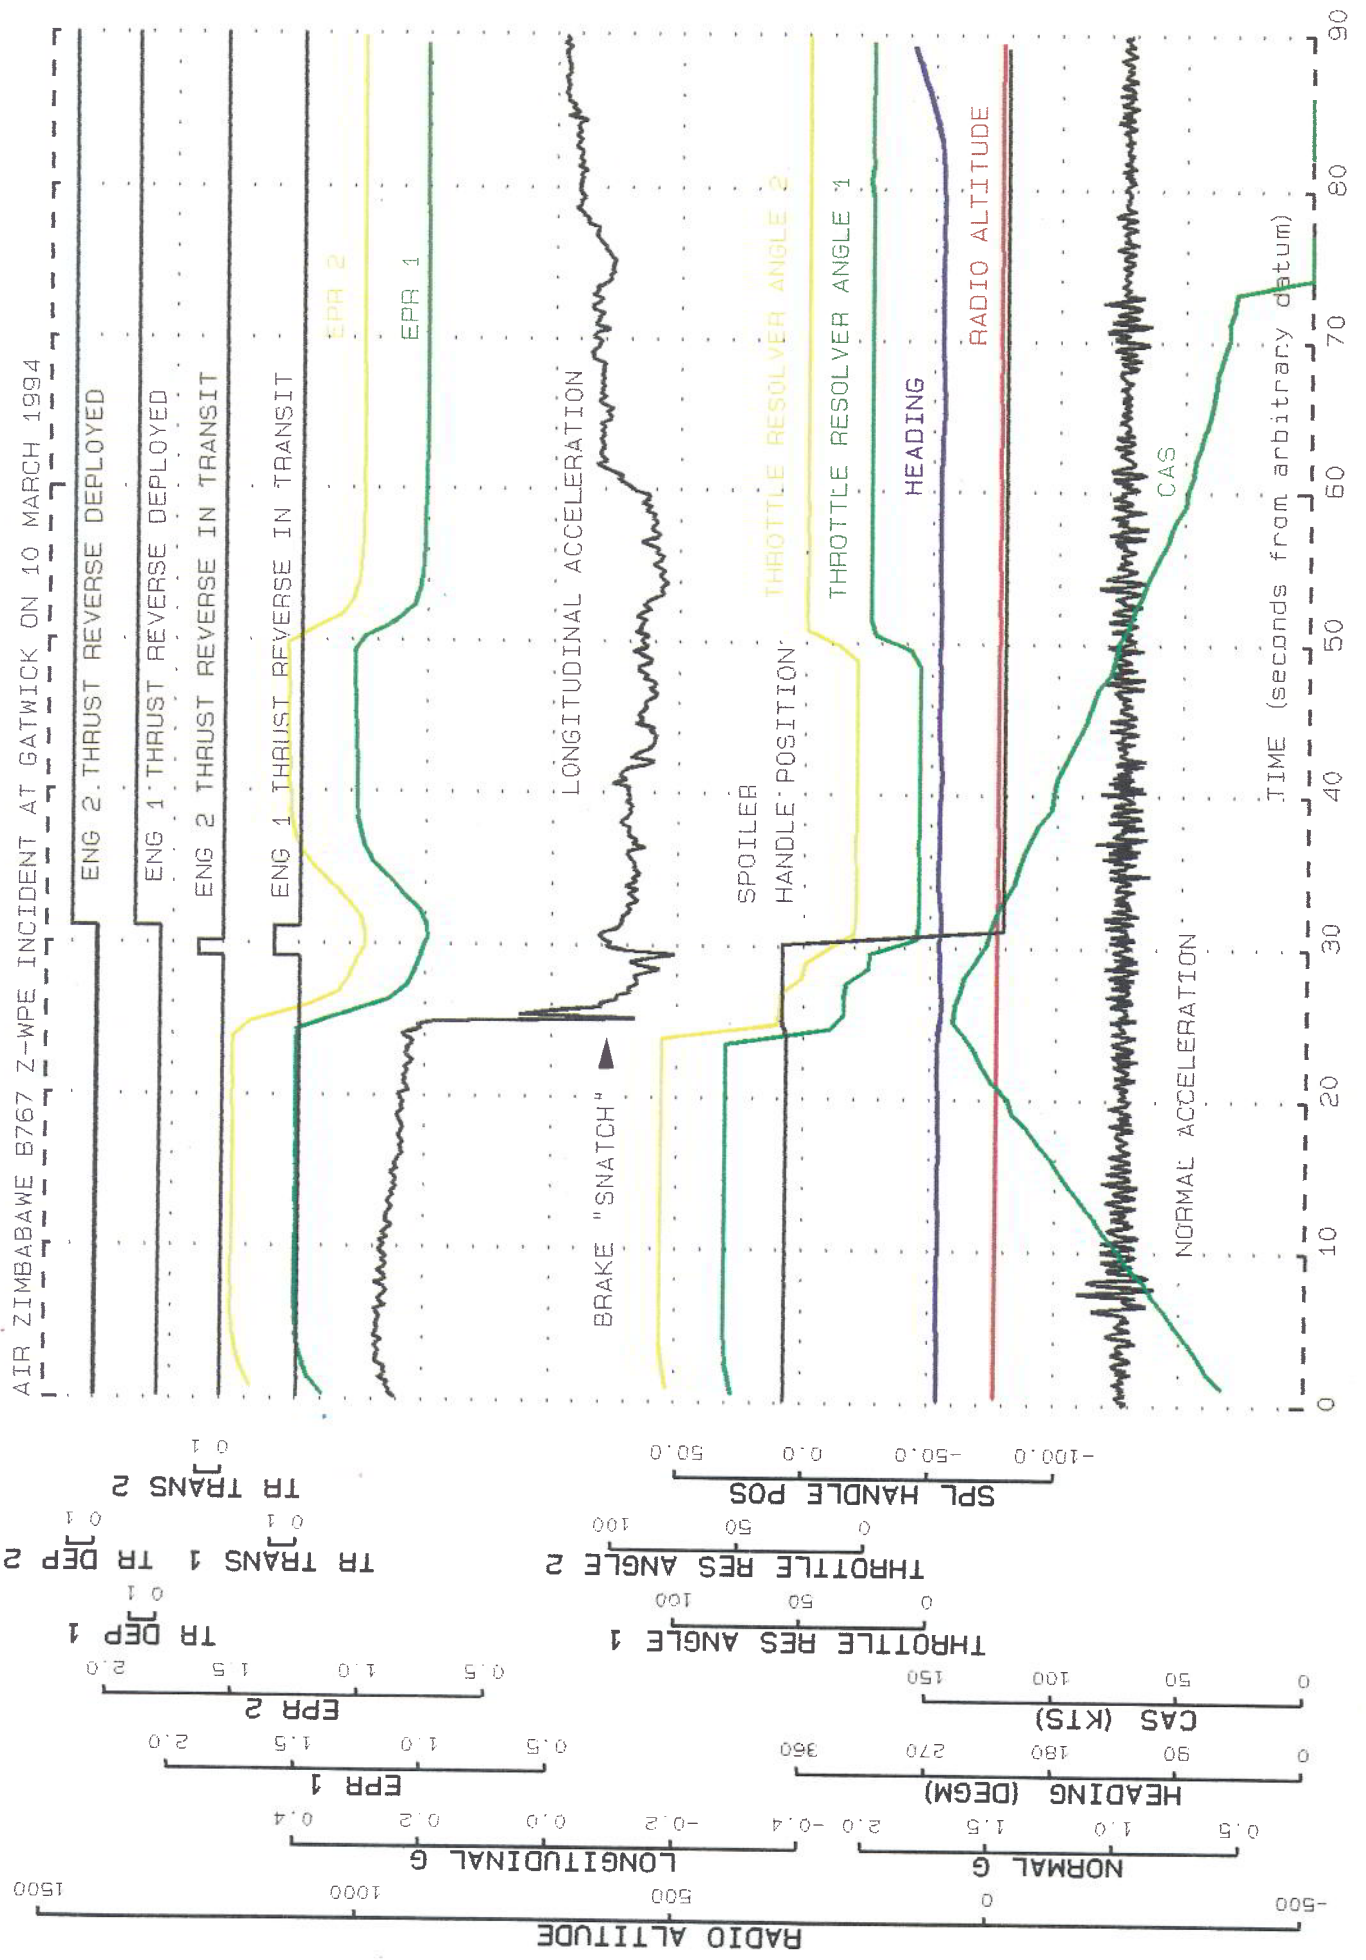
The Flight Data Recorder (FDR) was removed and replayed by AAIB. However, as the 30 minute Cockpit Voice Recorder would have overrun the period of the event, it was not removed or replayed. Figure 2 shows the relevant parameters from the FDR during the take-off run, the maximum speed reached was 141 kt when there was a spike in the longitudinal acceleration recording with a reduction in longitudinal acceleration of -0.314 g over 0.25 seconds. There was no recording of brake pressures on the FDR.

The 'spike' referred to above appears to be associated with brake reaction-rod disconnections inasmuch as it also featured in the previous incidents described in the AAIB Bulletin. However, they have also been noted to a greater and lesser extent on aircraft which have not suffered a failure. British Airways have indicated that they are involved in a research programme which seeks to identify such events, which they believe are a form of brake snatch, from routine FDR replays.
