AAIB Bulletin S3/2012

SPECIAL

ACCIDENT

Aircraft Type and Registration:	EC225 LP Super Puma, G-REDW
No & Type of Engines:	2 Turbomeca Makila 2A1 turboshaft engines
Year of Manufacture:	2009 (Serial no: 2734)
Date & Time (UTC):	10 May 2012 at 1114 hrs
Location:	20 nm east of Aberdeen
Type of Flight:	Commercial Air Transport (Passenger)
Persons on Board:	Crew - 2 Passengers - 12
Injuries:	Crew - None Passengers - 2 (Minor)
Nature of Damage:	Damage to be assessed following salt water immersion
Commander's Licence:	Airline Transport Pilot's Licence
Commander's Age:	To be advised
Commander's Flying Experience:	To be advised
Information Source:	AAIB Field Investigation

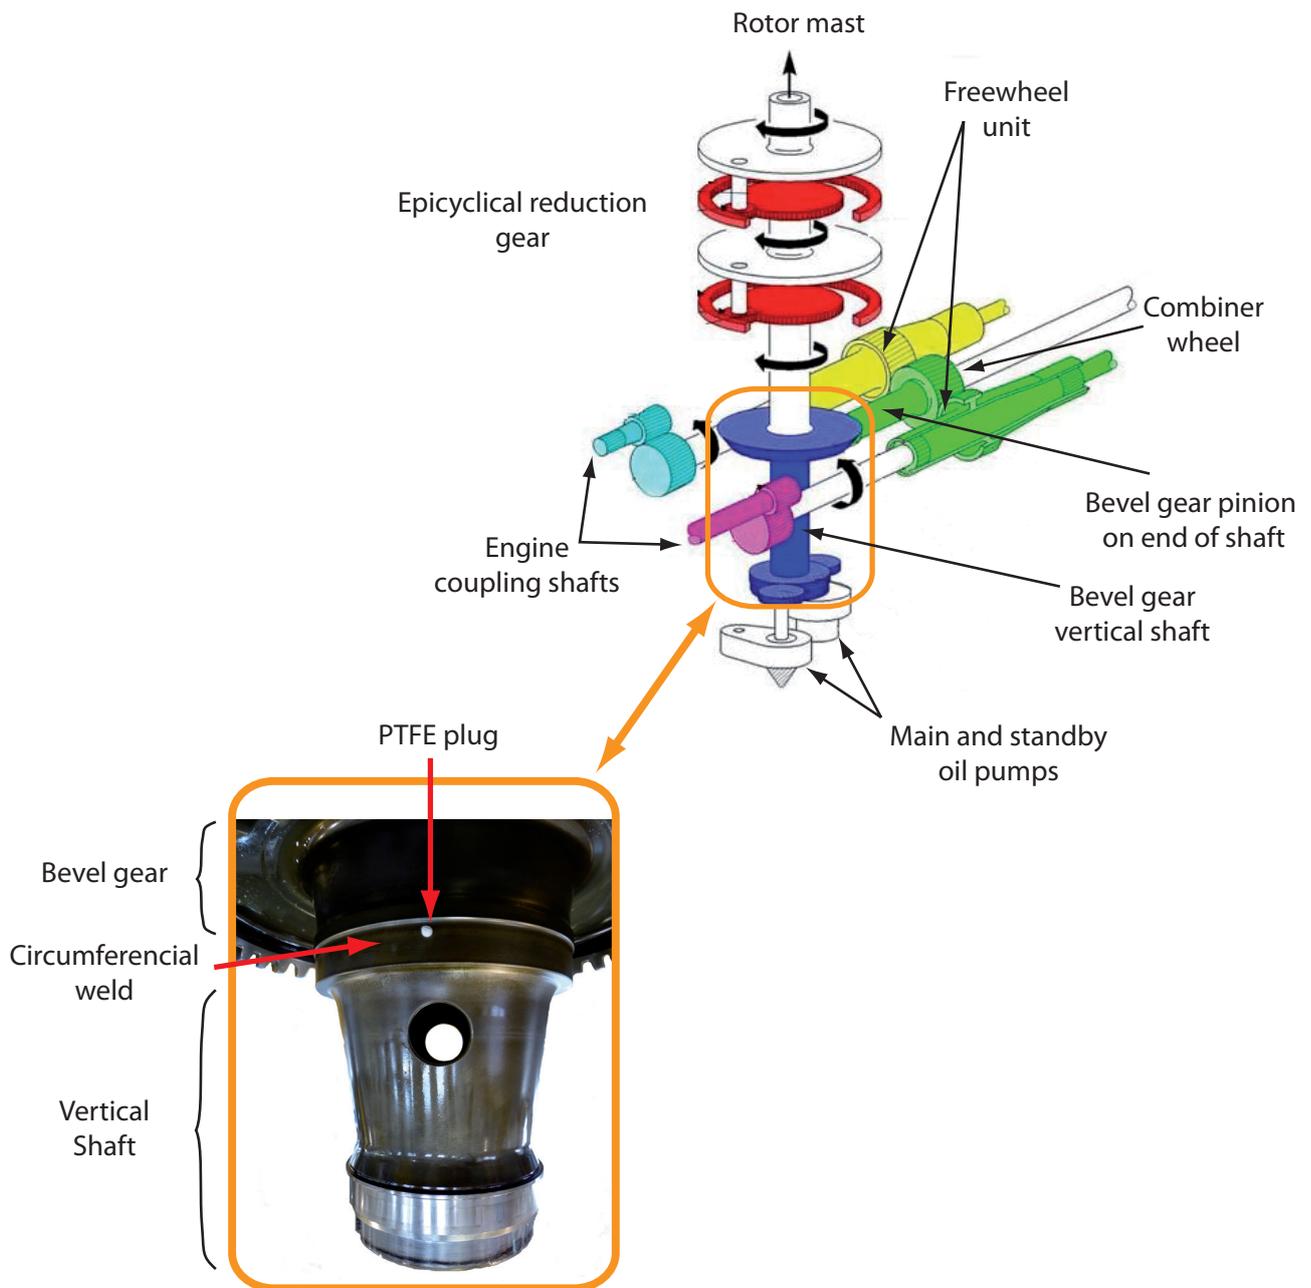
Figure 1

The MGB transmits power from the engines to the main rotor. The power from the engines is transmitted to the bevel gear through the combiner wheel and bevel gear pinion. The majority of this power is then transmitted upwards into the epicyclical reduction gear module. Two pinion gears, mounted at the bottom of the bevel gear vertical shaft, drive the main and standby oil pumps. The power train through the gearbox is illustrated at Figure 1.

MGB power train

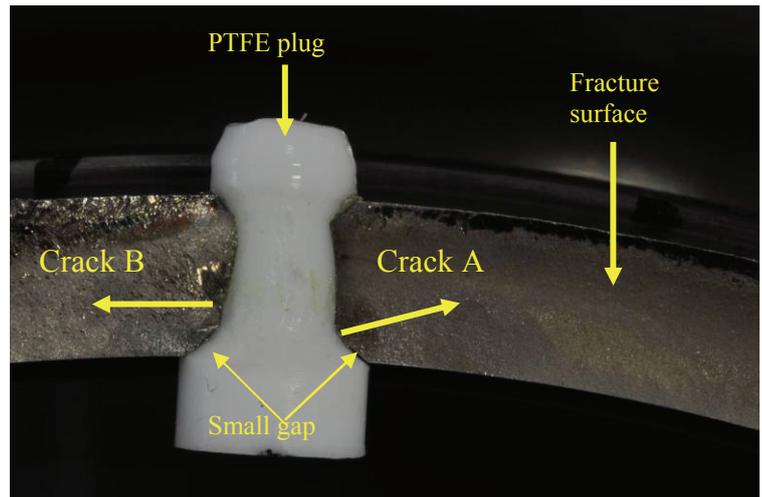
Figure 2

Examination of the fracture surface on both parts of the bevel gear vertical shaft revealed the presence of three cracks, identified as 'A', 'B' and 'C' (see Figure 2). Cracks 'A' and 'B' started from the 4.2 mm diameter hole in the weld and there was evidence of beachmarks

and striations along both cracks, which are indicators of a fatigue failure. Crack 'A' was 336 mm long² and extended for approximately 250° around the circumference of the shaft. This crack appeared to have initiated from a small corrosion pit, approximately 60 µm deep, on the inner countersink. Crack 'B' was 106 mm long and extended for approximately 80° around the circumference. This crack appeared to have initiated at a small defect in the internal surface of the hole. Crack 'C' was 42 mm long and extended for approximately 30° around the circumference. One end of this crack joined Crack 'A' and the other end ran under Crack 'B'. While there were striations on the surface of Crack 'C', there was no evidence of any beachmarks.

4.2 mm diameter hole in the weld

It was established that when the PTFE plug is fitted in the hole, with a $90^{\circ}\pm 1^{\circ}$ countersink, a small annular gap (approximately 0.37 mm x 0.05 mm in cross-section) can remain between the plug and the side of the countersink (see Figure 2).

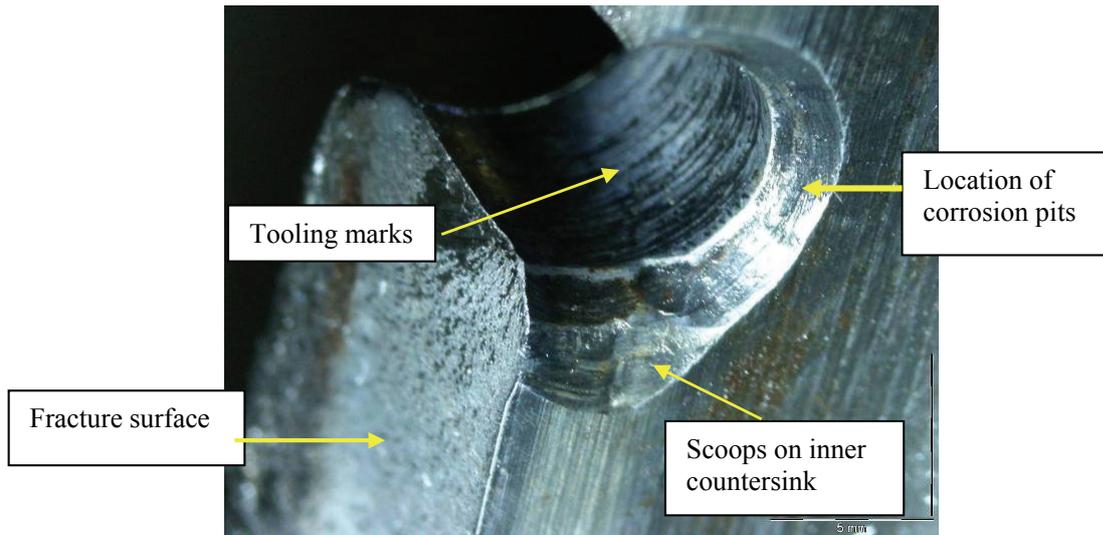
Figure 3

The diameter of the 4.2 mm hole was within the design specification. However, there was evidence of tooling marks and, what appeared to be, a spiral scratch that ran along the length of the hole. The geometry of the inner and outer countersinks was found to be outside the design specifications and there were a number of 'scoops' in the inner countersink (see Figure 3). There were patches of very small corrosion pits around the inner countersink, in the area where there is a gap (crevice) between the PTFE plug and the countersink. These corrosion pits were only initially detected using a scanning electron microscope.

Condition of the 4.2 mm hole and countersink
