AAIB Bulletin No: 9/94

Ref: EW/C94/1/2

Aircraft Type and Registration:	Bell 206B JetRanger, G-BODW	
No & Type of Engines:	1 Allison 250-C20 turboshaft engine	
Year of Manufacture:	1972	
Date & Time (UTC):	15 January 1994 at 0849 hrs	
Location:	Luton Airport, Bedfordshire	
Type of Flight:	Private (Pleasure)	
Persons on Board:	Crew - 1	Passengers - None
Injuries:	Crew - 1 Fatal	Passengers - N/A
Nature of Damage:	Aircraft damaged beyond economical repair	
Commander's Licence:	Private Pilot's Licence (Helicopters)	
Commander's Age:	45 years	
Commander's Flying Experience:	50 hours (of which 9 hours were on type) Last 90 days - 40 hours Last 28 days - 9 hours	
Information Source:	AAIB Field Investigation

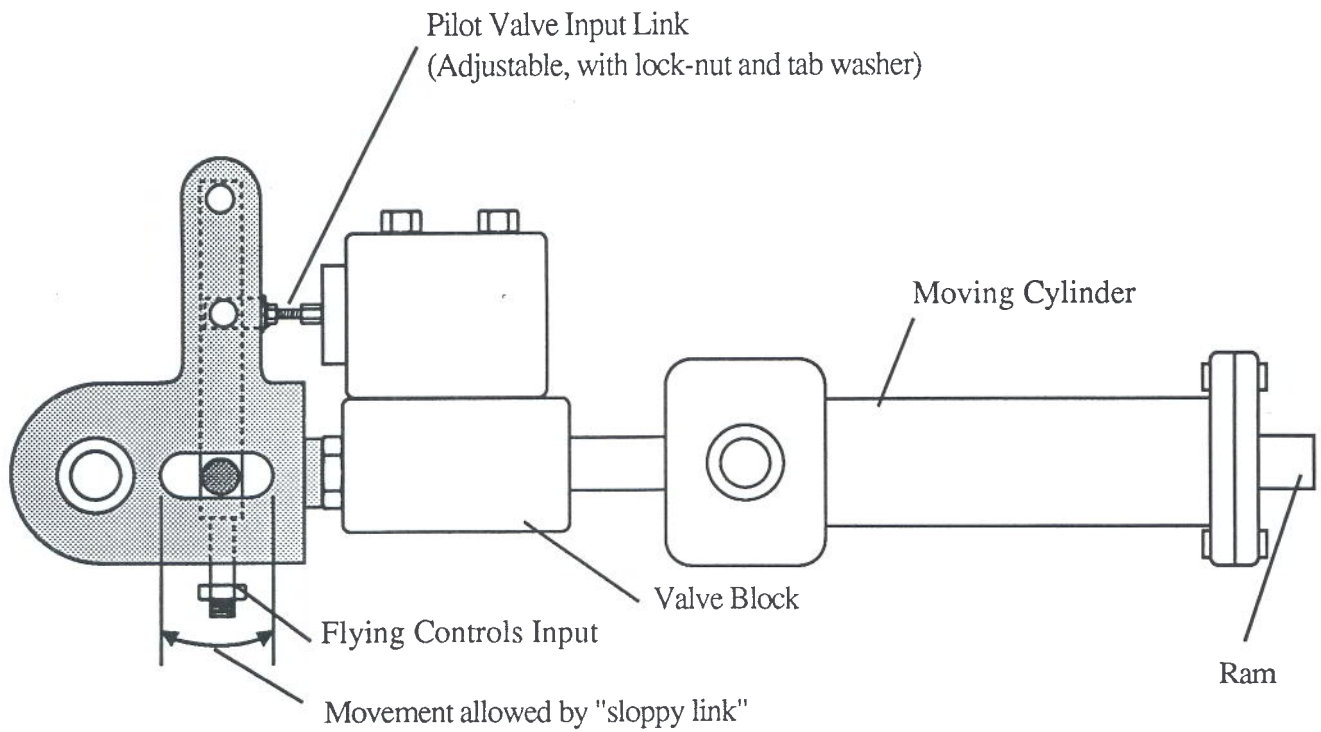
Examination of the flying control system revealed no evidence of pre-impact failure or disconnection of any of the linkages. Apart from the fluid spillage from the reservoir, the hydraulic system was intact, and was able to be functioned after being connected to a hydraulic rig. The yaw and cyclic actuators appeared to function normally; however, movement of the collective lever appeared to be slow in the down direction in comparison to the rate at which it could be moved upwards. Neither the actuators, nor the cradle in which they were mounted, had suffered any impact damage that could have accounted for this anomaly. Accordingly, all four actuators were removed from the airframe and taken to an overhaul agent for test and strip examination. No faults were found with the yaw and cyclic actuators. However, the fault on the collective actuator was confirmed in that the unit was comparatively slow in the ram extending, ie down collective direction. Examination revealed that the problem was due to the pilot valve input link not being centralised within the 'sloppy link' that was attached to the airframe flying controls (see Figure 1). This resulted in the pilot valve link bottoming out at one end of the sloppy link before it had achieved the full valve open position. The fact that the full orifice area was not available produced the sluggish movement in one direction. The valve input link, which is

adjustable, had been secured with a tab washer which was still in position. In addition, a 'tell-tale' paint mark was still intact, suggesting that the valve had not moved in service since its last overhaul in the US, approximately 1,865 aircraft hours prior to the accident. It was found that the pilot valve input link needed to be adjusted 0.013 inch to produce satisfactory operation of the actuator.

Subsequent to this investigation, the aircraft manufacturer indicated that, following accidents, they had encountered instances of apparently mis-rigged pilot control valves on actuators. This is thought to originate from slight yielding in the valve linkage arising from high reaction loads being generated in the flying control linkages.

FIGURE 1 Diagrammatic representation of collective actuator, showing principle of sloppy link

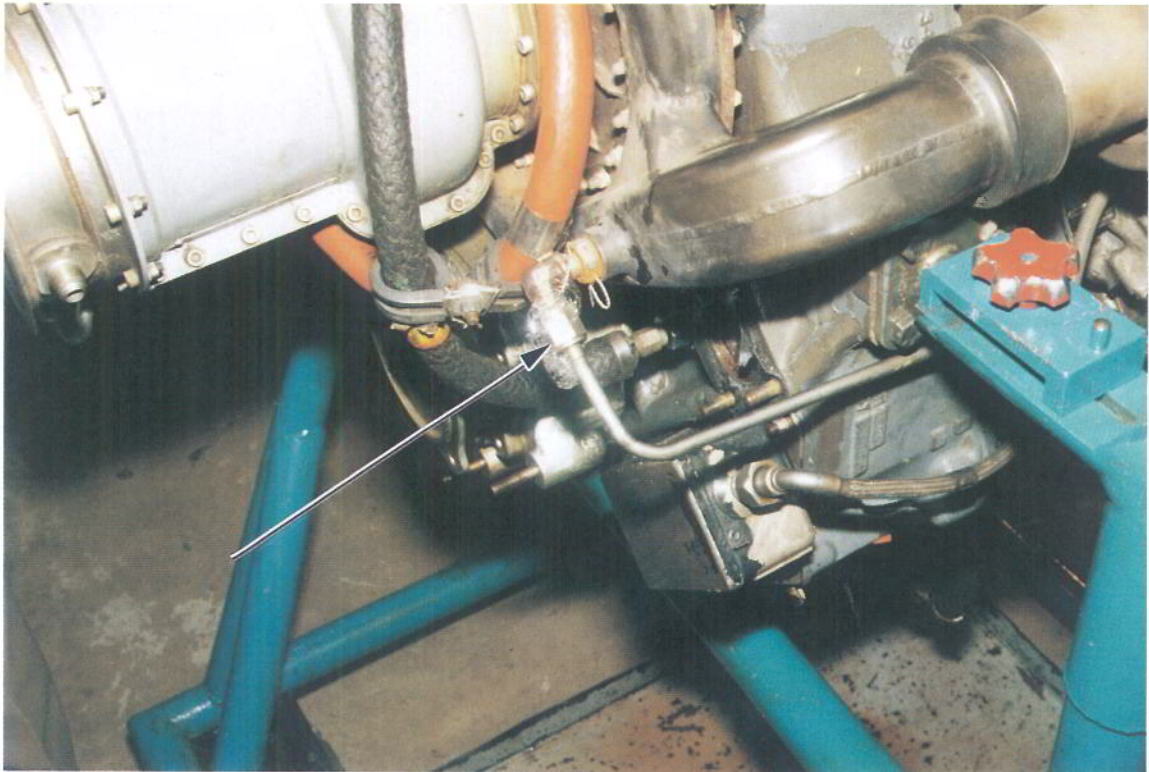
Before engine disassembly began, it was found that a pipe running between the compressor diffuser scroll and PT governor was slightly loose. This was traced to a loose nut (of a type known as a 'B' nut), at the union of the pipe with the diffuser scroll. The purpose of the pipe is to supply a reference compressor pressure, P_C , to the fuel control components. In the event that the pipe becomes disconnected, there will be a complete loss of engine power; the gas generator will run down to sub-idle and even flame out. The nut could be turned under firm finger pressure, although the engine manufacturer specifies an assembly torque of 80 to 120 lb ins for this and similar unions on the engine. It was established that the union was leaking by disconnecting the P_C pipe at the PT governor and blowing air into it; bubbles appeared after soap solution was applied to the union (see Figure 2). Most of the 'B' nuts on the engine had no 'torque paint' applied to provide an indication of loss of torque during inspections, although a white, crumbling residue was visible on a few. Such residue was found on the loose union, and the two halves of the mark were misaligned by approximately $1/16$ inch, ie only a small rotational movement. It was later noted that the application of 80 lb ins of torque caused realignment of the marks and also eliminated the leak. The P_C pipe is normally disconnected at the compressor scroll whenever a compressor wash is carried out. The aircraft records indicated that this was last accomplished on 2 October 1993, approximately 30 operating hours before the accident.

The engine was run at ground idle for five minutes before the union of the P_C line with the scroll fitting was loosened. It was noted that considerably more rotation, approximately two flats, had to be applied to the 'B' nut in order to obtain a leak. However, apart from a tiny increase in turbine outlet temperature, and a similar decrease in gas generator RPM (N1), the engine operated normally, and continued to do so when it was accelerated to take-off power.

The engine was run to cruise power, and the nut was backed off a long way, giving a considerable air leakage. Once again, there was virtually no effect on the operation of the engine. It was also found that the engine could be slam accelerated to take-off power from ground idle with the nut in this position. Only when the pipe was physically disconnected did the N1 stabilise at a sub-idle RPM and could not subsequently be accelerated.

FIGURE 2 Location of B nut on compressor diffuser scroll, showing soap bubbles from leaking air

94-26 It is recommended that the FAA take action to require some form of positive locking of the 'B' nuts on the compressor delivery pressure (P_C) sensing line on all Allison 250 Series engines, to prevent the loosening of such nuts and consequent sudden loss of engine power.

94-27 It is recommended that the CAA and the FAA consider a requirement for the fitting of safety valves to the P_C sensing lines on all aircraft equipped with Allison 250 Series engines, in order to eliminate the need to remove and reattach the P_C line to the compressor diffuser during compressor washes.
