**ACCIDENT**

<b>Aircraft Type and Registration:</b>	Slingsby T.51 Dart 15 Glider, BGA1166	
<b>No &amp; Type of Engines:</b>	None	
<b>Year of Manufacture:</b>	1964	
<b>Date &amp; Time (UTC):</b>	30 August 2006 at 1750 hrs	
<b>Location:</b>	Sutton Bank, near Thirsk, Yorkshire	
<b>Type of Flight:</b>	Private	
<b>Persons on Board:</b>	Crew - 1	Passengers - None
<b>Injuries:</b>	Crew - 1 (Fatal)	Passengers - N/A
<b>Nature of Damage:</b>	Aircraft destroyed	
<b>Commander's Licence:</b>	Silver C gliding certificate	
<b>Commander's Age:</b>	54 years	
<b>Commander's Flying Experience:</b>	412 hours (of which 1:17 were on type) Last 90 days - 3:56 hours / 23 flights Last 28 days - 1:04 hours / 4 flights	
<b>Information Source:</b>	AAIB Field Investigation, assisted by the British Gliding Association

**Synopsis**

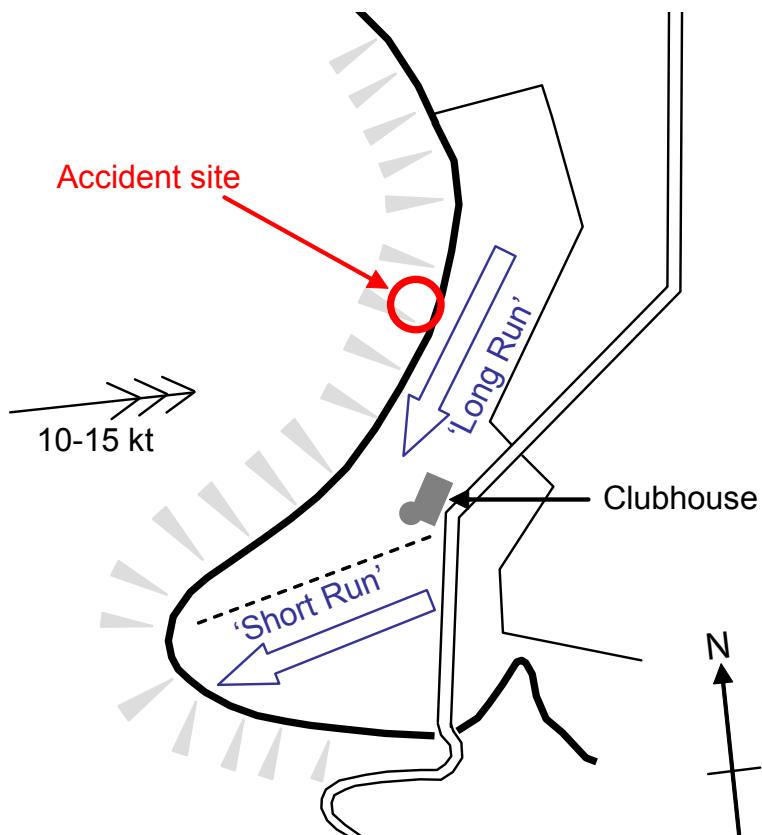
**Figure 1**

On the day of the accident the site was operating to a standard configuration of takeoffs and landings, according to the prevailing wind. This configuration was promulgated at a routine briefing, given by the club duty instructor on the morning of the accident. In this configuration, launches and landings were both being made on the 'short run', with a secondary landing area available on the 'long run', see Figure 1.

Gliding site showing main and secondary landing areas

on the main landing area. On the penultimate traverse southwards, the glider flew approximately down the centre of the secondary landing area at between 100 and 150 ft; witnesses were surprised and concerned when the glider did not land, but instead turned northwards again on its final traverse along the ridge line. During this time the glider descended to a very low height, probably less than 50 ft above the ridge, and appeared to be flying very slowly with an unusually nose-high pitch attitude.
