**ACCIDENT**

<b>Aircraft Type and Registration:</b>	Piper PA-32R-300 Cherokee Lance, G-BSYC	
<b>No &amp; Type of Engines:</b>	1 Lycoming IO-540-K1G5D piston engine	
<b>Year of Manufacture:</b>	1977	
<b>Date &amp; Time (UTC):</b>	5 April 2008 at 0948hrs	
<b>Location:</b>	Cairn Gorm, Cairngorms, Scotland	
<b>Type of Flight:</b>	Private	
<b>Persons on Board:</b>	Crew - 1	Passengers - None
<b>Injuries:</b>	Crew - 1 (Fatal)	Passengers - N/A
<b>Nature of Damage:</b>	Aircraft destroyed	
<b>Commander's Licence:</b>	Private Pilot's Licence	
<b>Commander's Age:</b>	45 years	
<b>Commander's Flying Experience:</b>	Approximately 440 hours (of which at least 126 were on type) Last 90 days - not known Last 28 days - not known	
<b>Information Source:</b>	AAIB Field Investigation

**Synopsis**

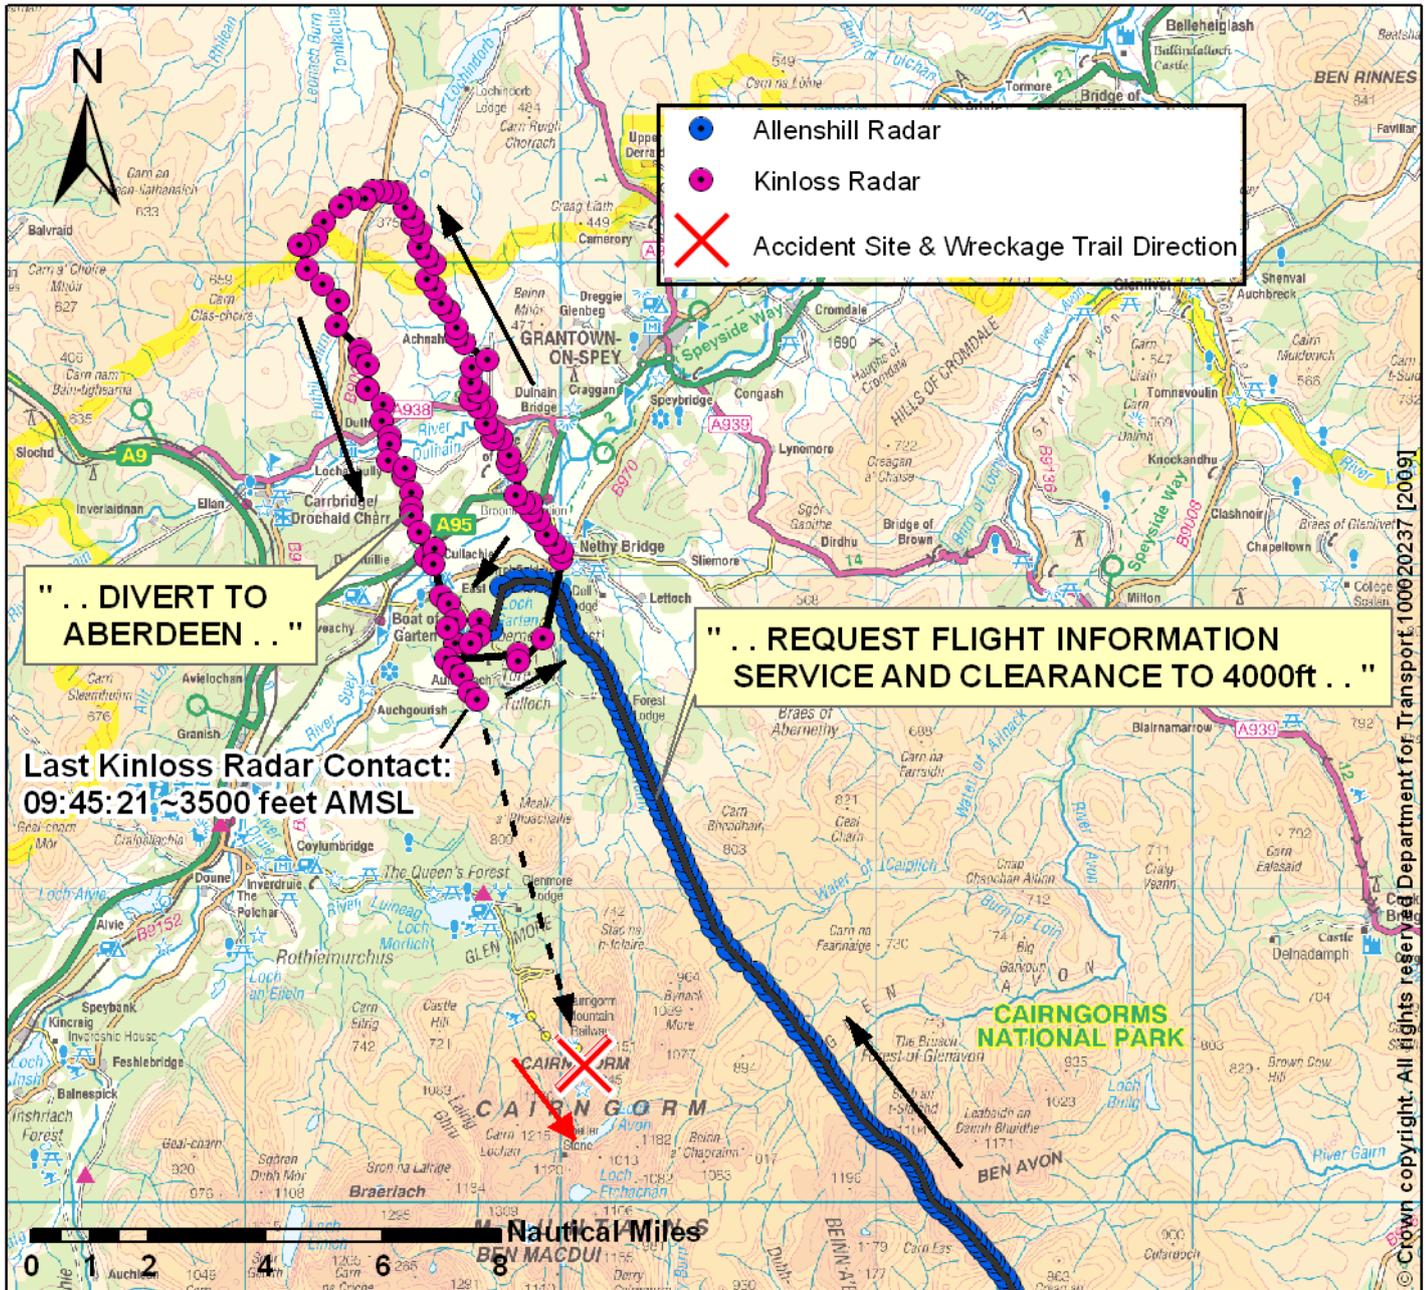
Figure 1

G-BSYC radar track near Cairn Gorm and location of accident site

The Kinloss radar track shows that the aircraft continued the left turn through a full 360° as it levelled just below 4,000 ft, before continuing to track in a north-north-westerly direction for a further eight nautical miles. The aircraft then turned left through 90° and, after another two nautical miles, to the left again on a track back towards Cairn Gorm (elevation 4,085 ft amsl), 15 nm ahead. After five nautical miles (09:44:00 hrs), the pilot reported severe weather, some icing and his intention to divert to Aberdeen.

Kinloss lost contact with the aircraft at 09:45:21 hrs, by which time the aircraft had descended to an altitude of 3,500 ft, with Cairn Gorm seven nautical miles ahead. Playback of the Inverness radar recording showed that contact was lost at around the same time and position. The average ground speed over the last eight nautical miles of the track was approximately 168 kt.

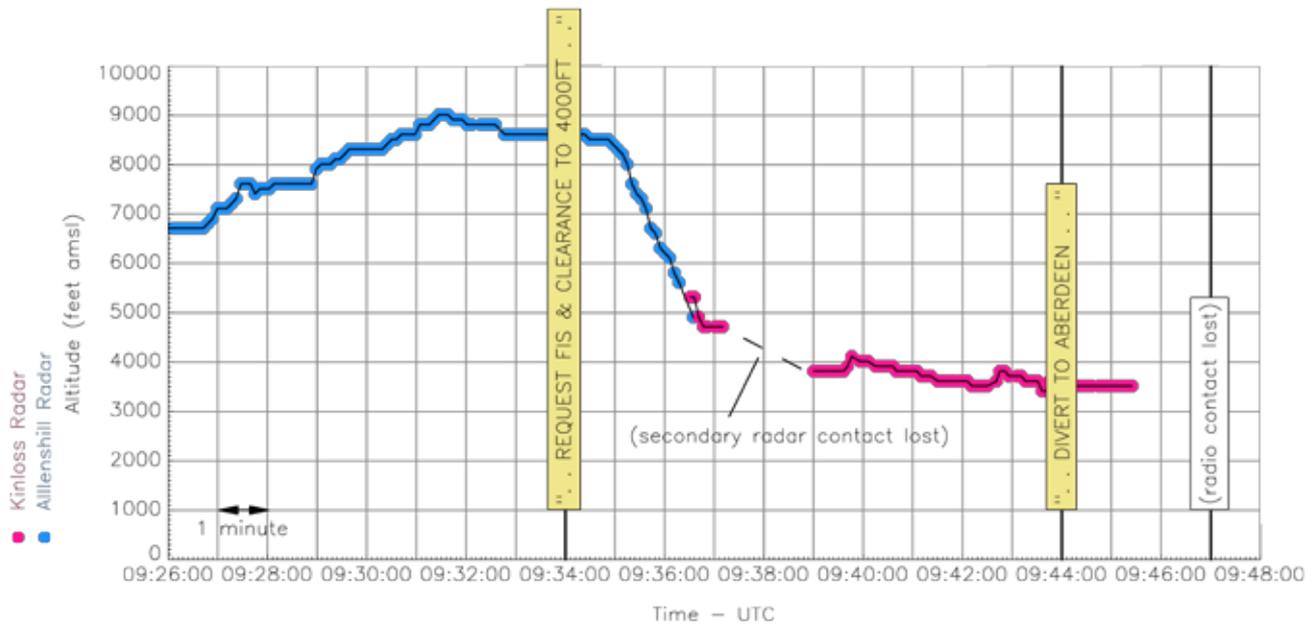
**Figure 2**

climbed from an altitude of 6,700 ft<sup>2</sup> to 9,000 ft (see Figure 2). Two and a half minutes after reaching 9,000 ft, the pilot requested clearance to descend to 4,000 ft, beginning the descent one minute later. As the aircraft passed through 7,000 ft, it started a turn to

the left through almost 180° during which it descended a further 2,000 ft. Allenshill radar lost contact in the process, but at 09:36:30 hrs the aircraft's progress was picked up by the radar at RAF Kinloss<sup>3</sup>.

G-BSYC Mode C altitude (corrected to Inverness QNH of 1021 mb)
