No:12/88

Ref: EW/G88/07/13

**Aircraft Type and Registration:** Cessna 310G, G-XITD

CESSNA 310G, G-XITD  
PORT LANDING GEAR COLLAPSE

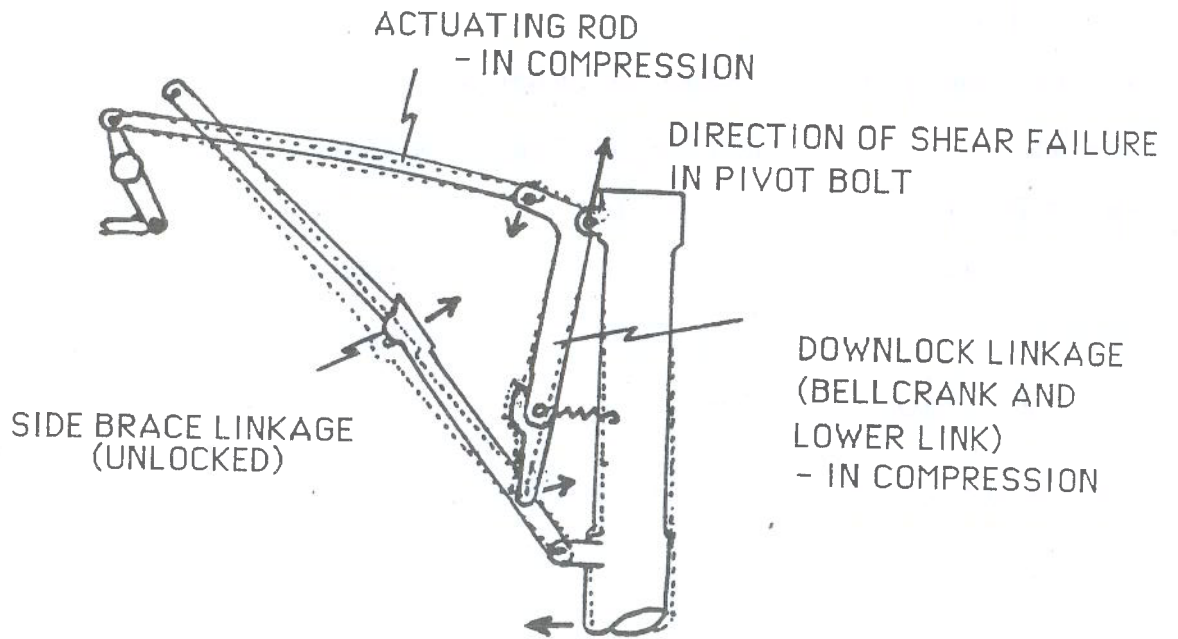
AAIB carried out a visual inspection of the landing gear. The downlock bellcrank (See Fig) had become detached at its pivot point on the mainleg and at its connection to the lower link of the over-centring downlock assembly.

The bolt at the bellcrank pivot had been sheared at two locations by transverse loads between the bellcrank and its attachment lugs on the mainleg. One of these failures was in pure shear and the other in combined shear and bending with some secondary surface damage on the fracture face. Neither fracture showed any sign of there having been a pre-existing defect. This evidence is typical of overload failure in shear, the bolt failing at the first location in pure shear and then at the second location, once the bolt has been partially liberated, in combined bending and shear. The bolt from the lower end of the bellcrank was not recovered but damage in the bellcrank hole showed that the bolt had been present when subjected to violent twisting and off-centre loads. Again, there was secondary damage to the lugs on the lower link but no evidence of any pre-existing metallurgical defect was found. Given the amount of distortion associated with the lower link failures it would appear that this area of failure was secondary to the pivot failures.

The actuating rod attached to the top end of the bellcrank had bent in a fashion typical of compressive collapse. The actuating rod damage and pivot bolt failures were consistent with the system having sustained landing loads without the main side brace being over-centred and locked while the downlock itself was in a locked condition.
