ACCIDENT

Aircraft Type and Registration:	Silence Twister, G-MRJP	
No & Type of Engines:	1 Jabiru 2200A piston engine	
Year of Manufacture:	2011 (Serial no: LAA 329-14972)	
Date & Time (UTC):	14 January 2014 at 1455 hrs	
Location:	Launton, Oxfordshire	
Type of Flight:	Private	
Persons on Board:	Crew - 1	Passengers - None
Injuries:	Crew - None	Passengers - N/A
Nature of Damage:	Damage to propeller, landing gear, wings and fuselage	
Commander's Licence:	Airline Transport Pilot's Licence	
Commander's Age:	57 years	
Commander's Flying Experience:	20,000 hours (of which 4 were on type) Last 90 days - 160 hours Last 28 days - 48 hours	
Information Source:	Aircraft Accident Report Form submitted by the pilot and additional inquiries by the AAIB

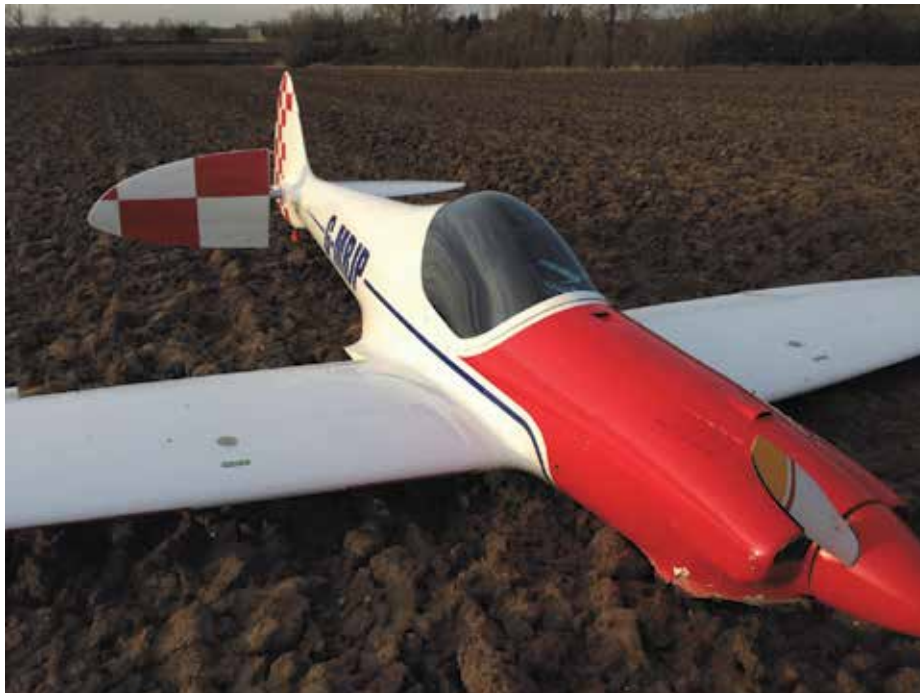
Figure 1

The aircraft was flying at about 1,500 ft, following minor maintenance, when the pilot heard a loud bang accompanied by vibration and a yaw and roll to the right. The aircraft was damaged in the subsequent forced landing but it was clear that the deriggleable right tailplane had rotated through 90° in-flight. Wear in the guide tube of the tailplane locking pin was found to have led to improper routing of the pin which had not engaged with the locking spigot.

As he evacuated the aircraft, the pilot saw that the right tailplane had rotated through 90° about its mainspar (Figure 1).

G-MRJP after landing showing right tailplane rotated through 90°

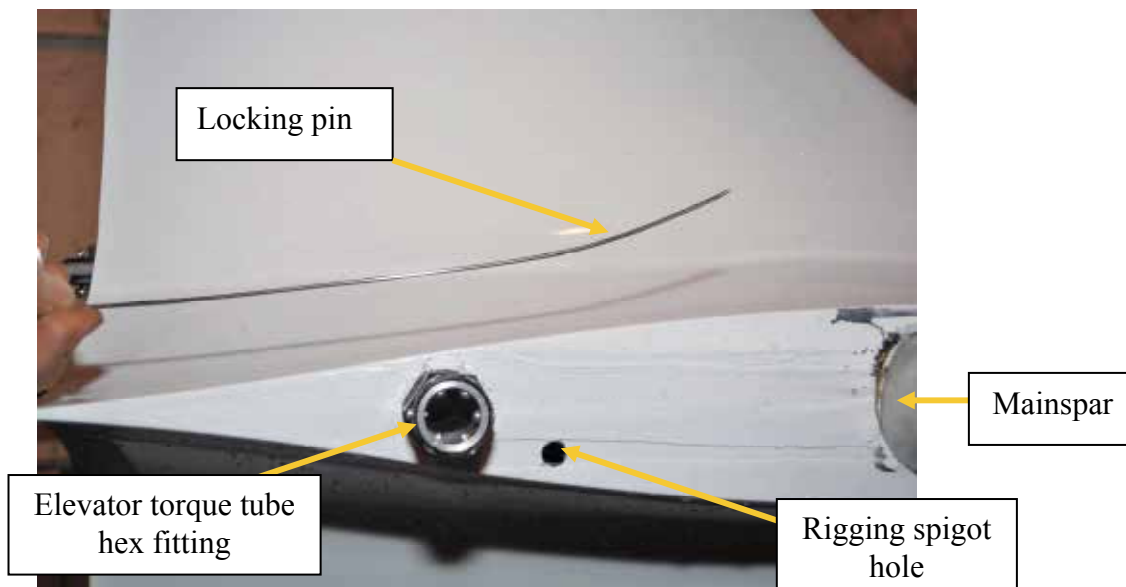
Figure 2

The Twister has fully demountable tailplanes. Each is slid onto the tubular mainspar and, when pushed fully home, the elevator torque tube engages in its hexagonal drive and a rigging spigot enters a hole in the fuselage (Figure 2). To lock the tailplane laterally, a wire locking pin is inserted into a plastic guide tube in the rear fuselage and pushed home. The final part of its travel inserts the pin through a hole in the rigging spigot, preventing lateral movement of the tailplane.

In the case of G-MRJP, the locking pin had missed the hole in the rigging spigot because it had exited the guide tube through a hole before reaching the end. The hole had been worn in the tube because it had been rubbing on the elevator torque tube. The unlocked tailplane had then migrated spanwise, disengaging the hexagonal elevator drive and allowing the tailplane to rotate about the main spar. The aircraft had previously been derigged to conduct minor maintenance and, when subsequently reassembled, had been independently inspected by two people without spotting that it not been properly locked.

View of rear fuselage showing tailplane/elevator attachment features. The locking pin has been withdrawn completely. Note that the pin is angled upwards as it and the guide tube have to pass under the elevator torque tube. (Photo courtesy LAA)

The Light Aircraft Association (LAA) acted quickly on learning of this accident and wrote to all Twister owners explaining the known circumstances and advocating a physical pull check on the tailplanes to ensure the locking pin has engaged in the spigot. They also published an item in their magazine *Light Aviation* (February 2014), repeating the letter and giving additional photographs and details as well as advising that their design team would be looking to see whether improvements needed to be made.
