No: 9/91

Ref: EW/A344

Aircraft Type and Registration: Concorde 102, G-BOAE

Nature of Damage: Portion of lower rudder lost, superficial damage to tailcone

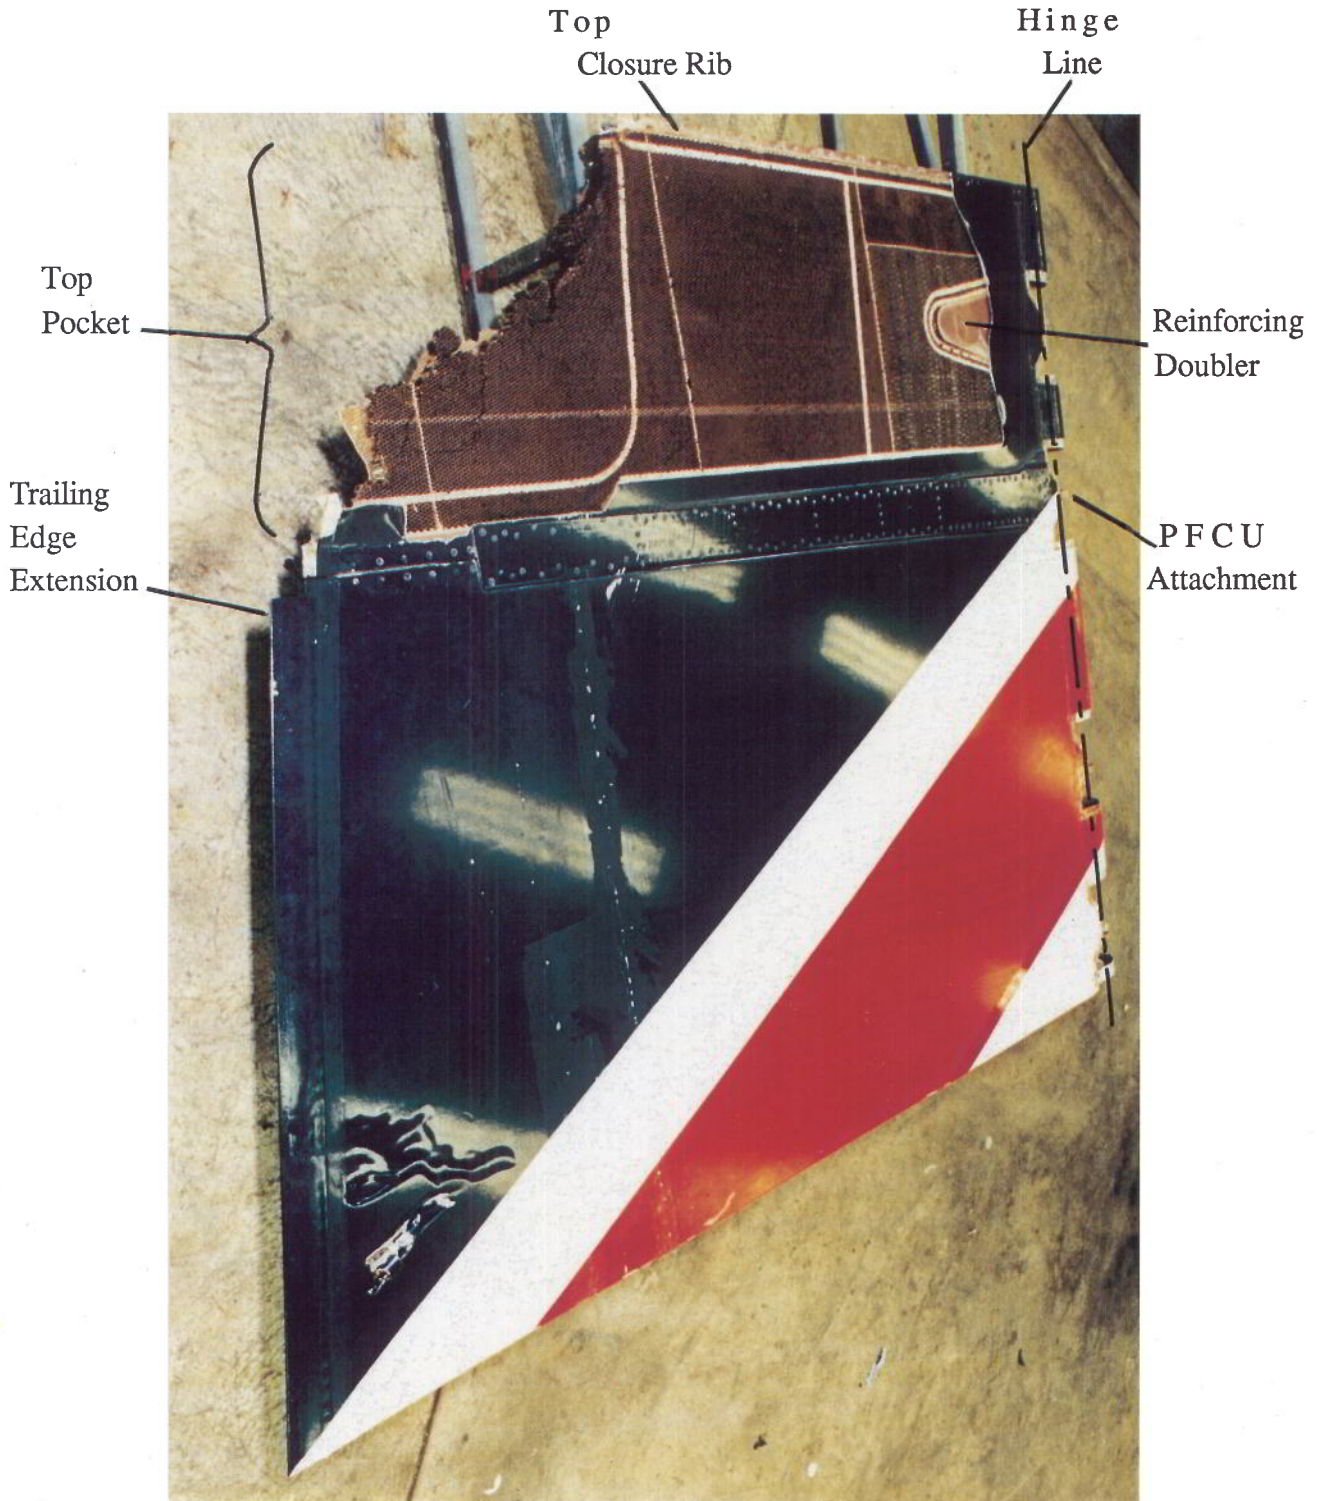
Concorde 102 , G-BOAE
Lower Rudder VW25
(Right side)

The Concorde aircraft has two independent rudders, an upper and a lower, each operated by a dual acting PFCU. Each rudder is of aluminium skinned honeycomb construction and is composed of two structurally separate "pockets", one above the re-inforced attachment rib for the PFCU and one below. The failure in G-BOAE occurred in the top pocket of the lower rudder (see Photograph); a triangular area was lost from the aft end of the pocket bounded by almost all the trailing edge, the rearmost 23" of the top closure rib and, on the left skin, a ragged diagonal tear which showed signs of bending reversals in its failure. Also, most of the skin on the right side was lost forward to about seven inches aft of the leading edge spar.

It was unclear as to whether the lost rudder structure and skin had detached in one or more pieces but it did appear, and was later confirmed from metallurgical examination, that the major piece of skin on the right side, with or without the trailing edge triangle of rudder, had detached in one piece with a progressive clockwise failure around its periphery. The failure of its attachment to the flange of the top closure rib started at the aft end and progressed forwards. The skin then tore downwards towards its bottom edge, this fracture line being unaffected by a bonded doubler at the top hinge location, and hinged about a line parallel to the bottom edge at a change of thickness. It finally tore along this line and pivoted, leading edge downwards, about some remaining attachment at the aft end, leaving some circular arc scoring on the adjacent skin as it did so.

The most likely interpretation of the other peripheral evidence is that as the skin panel swung downwards one corner penetrated the lower rudder near its bottom aft corner, causing the panel to pivot again about that point and slam onto the tailcone. There were edge markings on the tailcone and some scoring evidently made by rivets of the same pitch as those along the top edge of the skin panel. It was also apparent that the panel had been pressed down onto the tailcone leaving extensive smearing of blue paint on the white tailcone and local inward deformation of the tailcone skin, indicative of high
