Boeing 737-800, 5B-DBX

AAIB Bulletin No: 6/2004	Ref: EW/G2003/11/11	Category: 1.1
INCIDENT		
Aircraft Type and Registration:	Boeing 737-800, 5B-DBX	
No & Type of Engines:	2 CFM 56-7 turbofan engines	
Year of Manufacture:	2003	
Date & Time (UTC):	14 November 2003 at 2326 hrs	
Location:	Manchester Airport, Manchester	
Type of Flight:	Public Transport (Passenger)	
Persons on Board:	Crew - 7	Passengers - 188
Injuries:	Crew - None	Passengers - None
Nature of Damage:	Damage to left upper winglet of the Boeing 737 and the right wing tip of a Boeing 767 (G-OBYC)	
Commander's Licence:	Airline Transport Pilot's Licence	
Commander's Age:	36 years	
Commander's Flying Experience:	8,200 hours (of which 515 were on type)	
	Last 90 days - 211 hours	
	Last 28 days - 67 hours	
Information Source:	Aircraft Accident Report Form submitted by the pilot plus a report from Manchester Airport

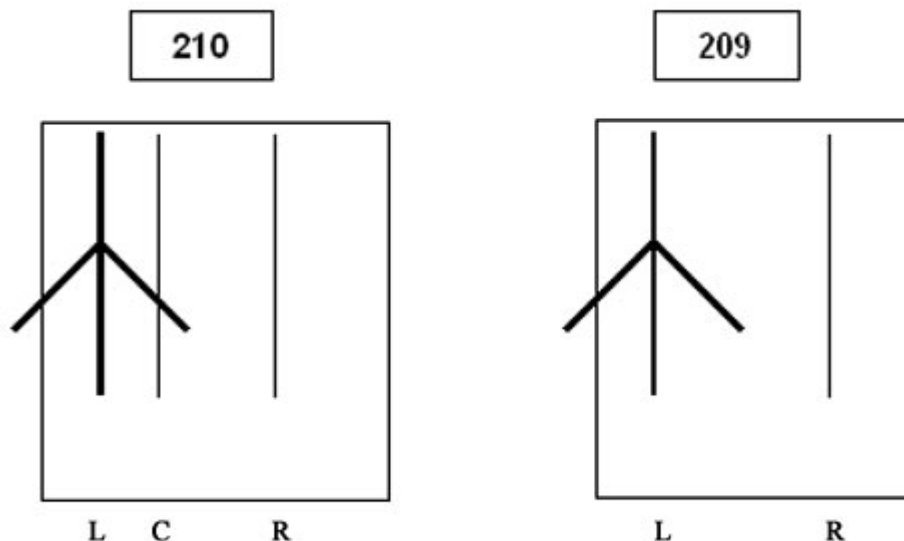
Figure 1

When the Left Centreline of each stand is occupied, this effectively blocks the use of all other centrelines. It should be noted that only this combination is allowed, ie 210C could not operate if 209L is used. Typically, maximum aircraft size for both 209L and 210L is the Boeing 757 (B757). It is also relevant that a Boeing 737-800H variant, that is a B737 with winglets has a greater wingspan than other B737 variants, and as such is treated as a B757 for the process of stand allocation.

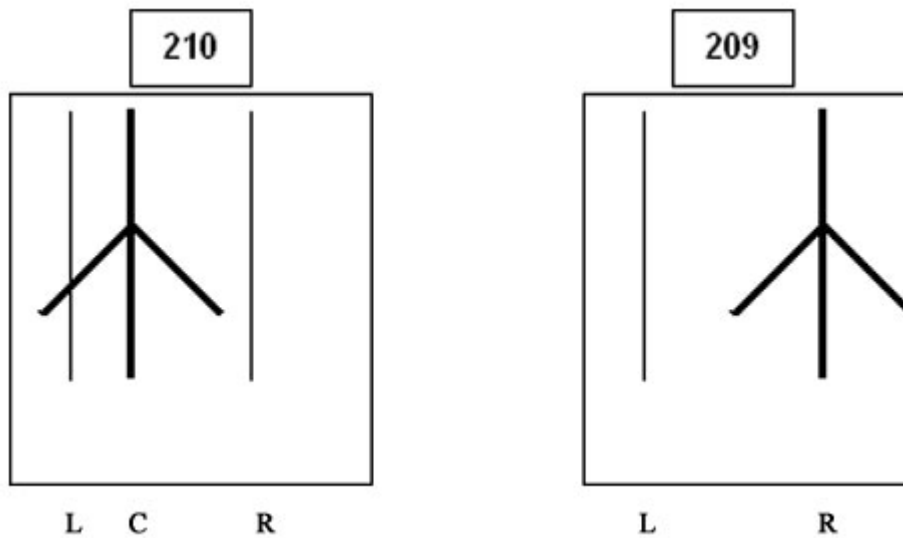
Figure 2

When the even-numbered stand centreline is occupied, eg 210C, then the adjacent odd-numbered stand's right centreline should be used, eg 209R. Should 209L be used, then there is a compromise of wingtip clearance with Stand 210. Typically, the maximum aircraft size for 209R is a B737 (without winglets) and for 210C it is a Boeing 767 (B767).

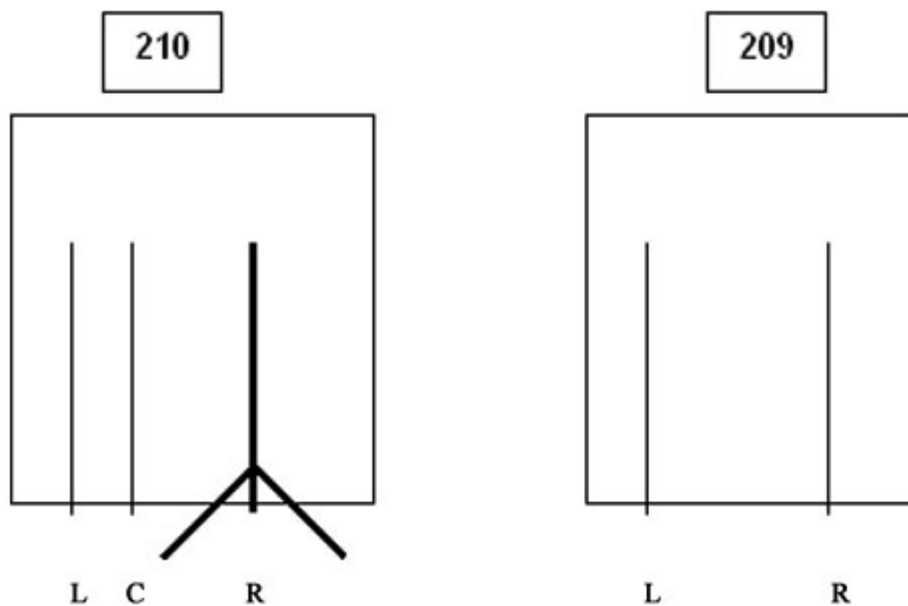
Figure 3

The final example shows the use of the even-numbered stand right centreline, which could be utilised by a wide body aircraft, such as a Boeing 747 (B747). This would effectively close both stands and only Stand 210R could be occupied.
