S1/2002 - Bombardier Challenger CL-600-2B16, N90AG

AAIB Bulletin No: S1/2002	Ref: EW/C2002/1/2	Category: 1.1
Aircraft Type and Registration:	Bombardier Challenger CL-600-2B16, N90AG	
Serial Number:	5414	
Year of Manufacture:	1999	
Date & Time (UTC):	4 January 2002 at 1207 hrs	
Location:	Birmingham International Airport	
Type of Flight:	Private (FAR Part 91)	
Persons on Board:	Crew - 2	Passengers - 3
Injuries:	Crew - 2 Fatal	Passengers 3 Fatal
Nature of damage:	Aircraft destroyed	
Commander's Licence:	FAA Airline Transport Pilot's Certificate	
Commander's Flying Experience:	Approximately 10,000 hours (of which about 500 were on type)	
Information Source:	AAIB Inspector's Investigation

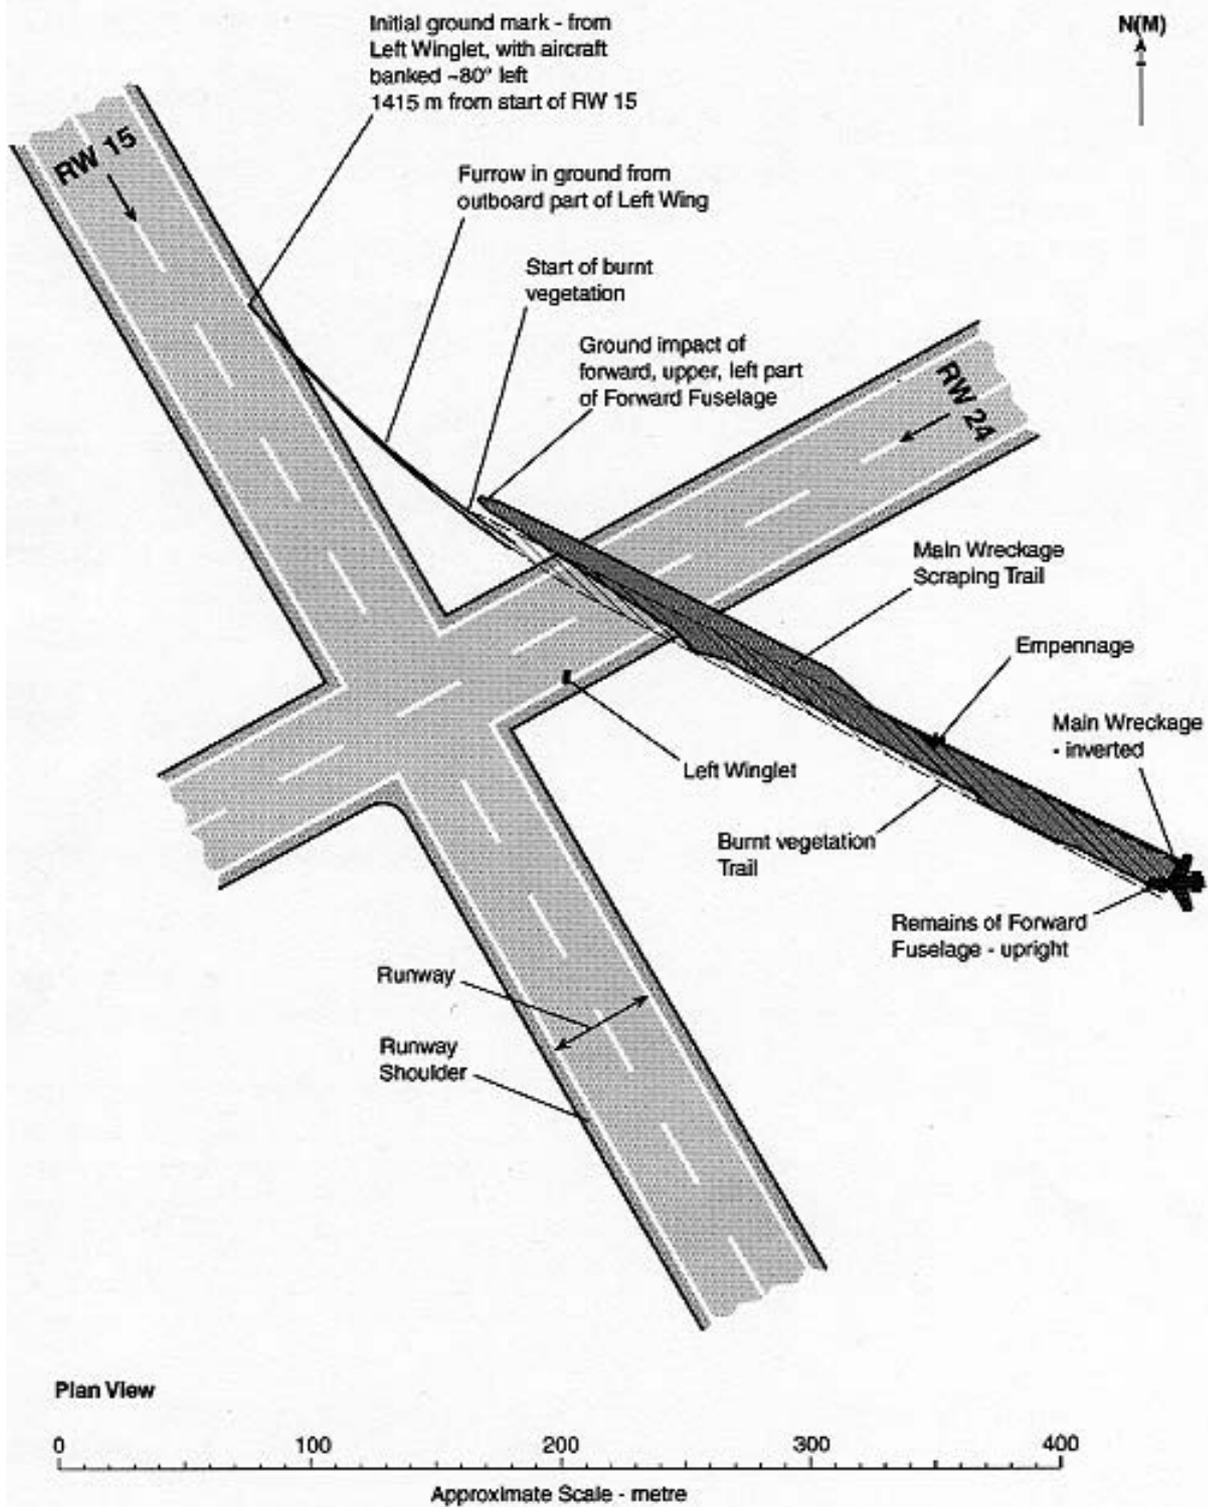
Figure 1

Witness marks indicated that, following lift-off, N90AG first made ground contact with its left winglet. Initial contact had been onto the tarmac-surfaced left shoulder of the runway, approximately 1,415 metre along the 2,605 metre runway (Figure 1). The runway marks and wreckage damage characteristics showed that the aircraft had been banked approximately 80° left at this point and had been descending at a comparatively low rate.

After initially tracking 10-15° left of the runway heading, the winglet scraped across the left edge of the shoulder onto the grass-covered ground adjoining the runway. Ground contact became progressively heavier, causing the outboard part of the left wing to progressively deform and break-up, while the aircraft continued to roll to the left. After the left wing had scraped for a total of 120 metres, fuel released from the ruptured wing tank ignited. At the same time, the forward, upper, left part of the fuselage contacted the ground heavily. This caused severe damage to the upper portion of the forward fuselage, structural severance of the forward fuselage at the front of the wing centre section and localised rupture of the right and centre wing fuel tanks. Shortly thereafter, horizontal stabiliser ground contact caused detachment of the fin from the fuselage and thus separation of the whole empennage.

The main wreckage, consisting of the wings and the centre and aft fuselage, slid inverted for approximately 320 metres from the fuselage ground contact point before coming to rest. The remains of the forward fuselage remained attached by cables and pipelines to the main wreckage, in approximately its normal relative position, but came to rest upright.
