ACCIDENT

| Aircraft Type and Registration: | Brandli Cherry BX-2, G-BXUX | |
| Location: | Clipgate Farm Airstrip, Canterbury, Kent | |

Synopsis

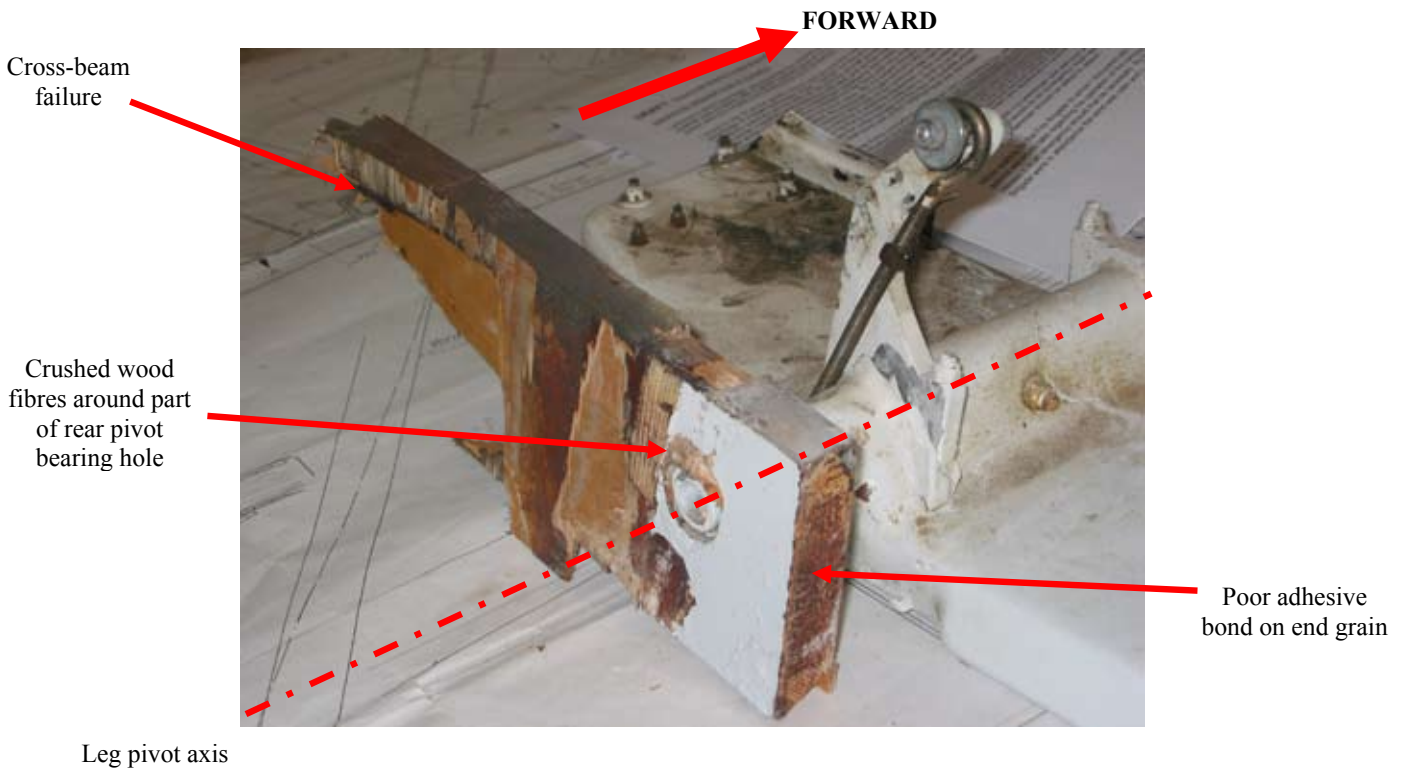
Figure 2 shows a partial reconstruction of the failed section of the crossbeam, with the rear pivot of the leg located in a wooden block at the outboard portion of the beam. It is apparent that the wood fibres around part of the circumference of the rear face of the locating

hole have been crushed by the bearing bush, to the extent that they are standing proud of the surface. This damage is consistent with the leg moving in a rearward and upward direction. It is likely that the crossbeam would need to be secure and in position in order to react the forces generated by the leg in damaging the bearing hole. If so, it follows that at least some of the damage to the hole preceded the beam failure. It should be noted that the crossbeam consisted not of a single plank of timber, but was in fact built up using square-section Sitka spruce strips, top and bottom, with facings made from ply. This was typical of the lightweight construction methods used throughout the aircraft.

Partial reconstruction of failed fuselage crossbeam and right main leg

Figure 2 also shows the undamaged end of the beam which had been bonded to structure within the wing root. The fact that the adhesive can be seen without any wood fibres attached is indicative of a poor bond. Furthermore, bonds on ‘end grain’ surfaces such as this are generally avoided in wooden structures. However, the plans for the aircraft did not show any carry-through structure that linked the beam with the wing root, suggesting that the beam end was intended to be stabilised by its bond with the cockpit floor, together with a filleted joint to a plywood panel on the cockpit sidewall. A photograph of the intact left side of the beam is shown in Figure 3. On the right side, the plywood panel had failed due to the aft movement of the crossbeam.
