ACCIDENT

Aircraft Type and Registration:	Schleicher ASW 24, G-CGDU	
No & Type of Engines:	N/A	
Year of Manufacture:	1991 (Serial no: 24118)	
Date & Time (UTC):	30 April 2012 at 1342 hrs	
Location:	Near Dunstable, Bedfordshire	
Type of Flight:	Private	
Persons on Board:	Crew - 1	Passengers - None
Injuries:	Crew - 1 (Fatal)	Passengers - N/A
Nature of Damage:	Aircraft destroyed	
Commander's Licence:	BGA Gliding Certificate	
Commander's Age:	65	
Commander's Flying Experience:	274 hours (of which 10 were on type) Last 90 days - 17 hours Last 28 days - 8 hours	
Information Source:	AAIB Field Investigation

Synopsis

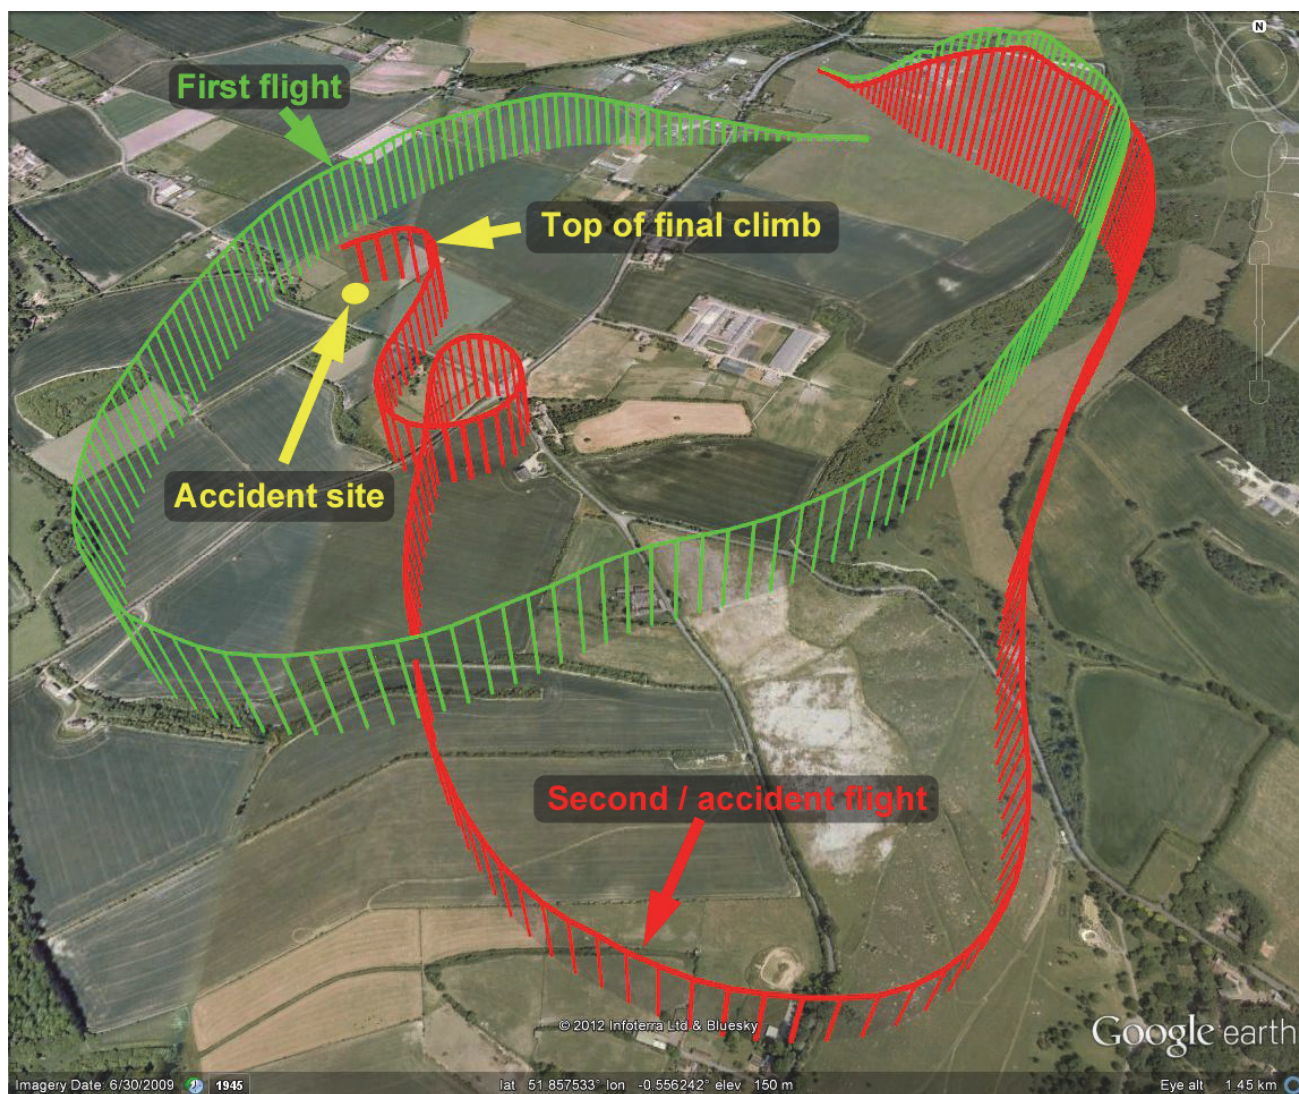
Figure 1

The Garmin GPSIII Pilot did not record any data but was used to pass GPS data to the iPAQ which recorded the GPS position and GPS altitude once per second. The iPAQ recorded both the first flight of the day and the subsequent accident flight (Figure 1). The recording of the accident flight stopped whilst in the air in the vicinity of the accident site, most likely due to the loss of buffered data when the iPAQ was damaged in the impact. This installation used a GPS antenna mounted on the glider.

The pilot had completed a flight in the morning, the profile of which was recorded on the iPAQ. He did not raise any issues regarding that flight, which appears to have been conducted safely. He did not execute any pull-up manoeuvre on the first flight.

The first (green) and second/accident (red) flights

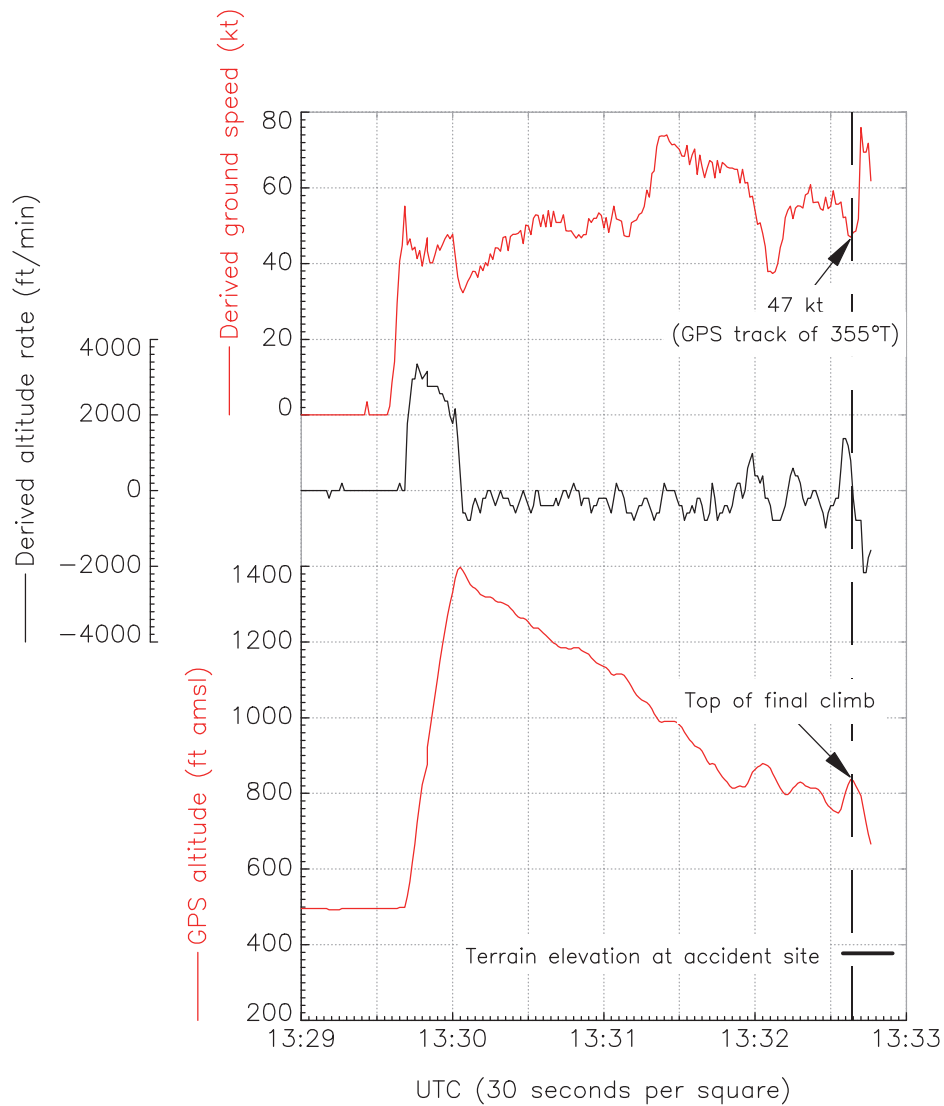
Figure 2 shows the iPAQ recorded GPS altitude data for the accident flight, as well as the derived altitude rate and derived groundspeed. The accident flight started at 1329 hrs and the recording ended approximately three minutes later.

On the accident flight, for a reason that was not determined, the pilot elected to execute a pull-up manoeuvre. A possible explanation is that he was exploiting an area of lift, in order to gain height. The GPS data show that the glider's groundspeed reduced to 47 kt as it reached the top of the pull up, at which point it banked to the left. The wind direction and strength was such that it would have produced a tailwind component of 10 kt or possibly greater, given the gusty conditions. This, in combination with the low groundspeed, indicates that the glider's airspeed

would have been close to, or possibly even below, the 1g stall speed of 37 kt for the given weight.

Recorded GPS altitudes and derived altitude rates and ground speeds for the accident flight, sourced from the iPAQ
