**ACCIDENT**

<b>Aircraft Type and Registration:</b>	Gemini Flash 2A, G-MWMS	
<b>No &amp; Type of Engines:</b>	1 Rotax 503 piston engine	
<b>Year of Manufacture:</b>	1990	
<b>Date &amp; Time (UTC):</b>	1 July 2009 at 1229 hrs	
<b>Location:</b>	Park Hall Country Park, near Weston Coyney, Stoke-on-Trent, Staffordshire	
<b>Type of Flight:</b>	Private	
<b>Persons on Board:</b>	Crew - 1	Passengers - None
<b>Injuries:</b>	Crew - 1 (Serious)	Passengers - N/A
<b>Nature of Damage:</b>	Extensive	
<b>Commander's Licence:</b>	National Private Pilot's Licence	
<b>Commander's Age:</b>	58 years	
<b>Commander's Flying Experience:</b>	180 hours (of which 0 were on type) Last 90 days - 0 hours Last 28 days - 0 hours	
<b>Information Source:</b>	AAIB Field Investigation

**Synopsis**

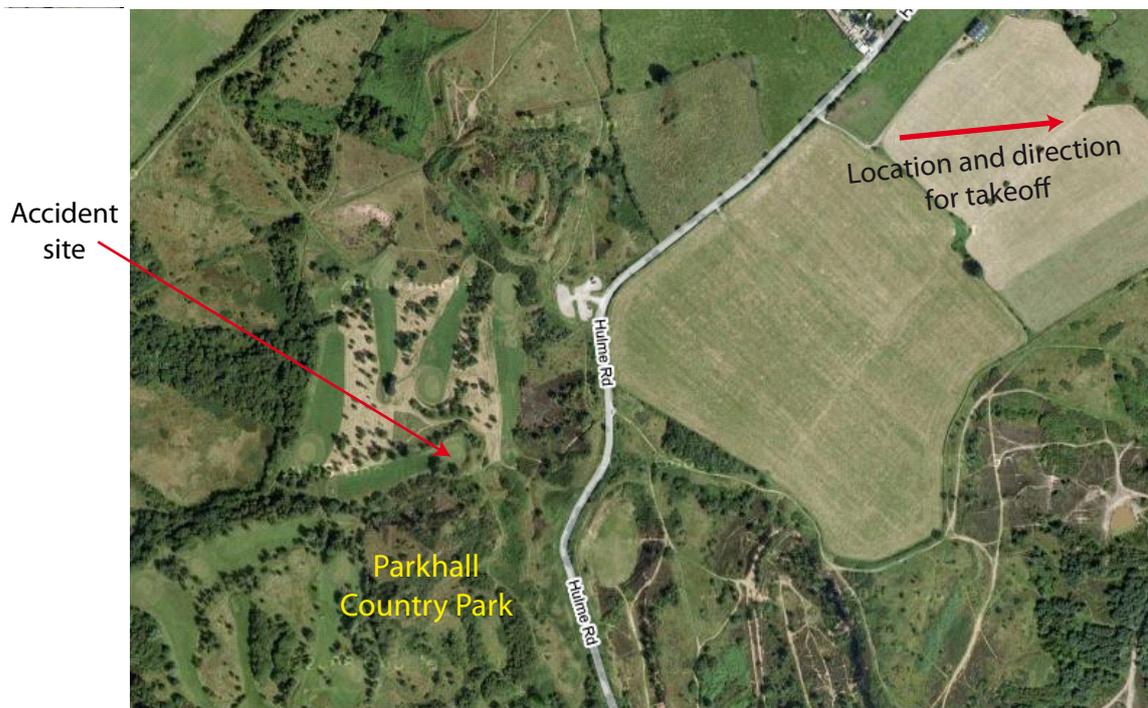
**Figure 1**

The field from which the aircraft departed had been recently mown, and measured approximately 200 by 100 m, see Figure 1. It was surveyed by

the Staffordshire Police Collision Support Unit. The aircraft had taken off in a direction that had 180 m of field available on a downward slope of approximately 6%.

The wreckage was located approximately 700 m from the field from which the pilot had taken off (Figure 1). The nose of the aircraft had struck a steep embankment a few metres from the third green on a municipal golf course. No damage or witness marks were found on the trees that were growing on the top of the embankment and it was concluded that the aircraft had struck the ground in a slightly nose-down attitude, without excessive roll, having been flying in approximately the same direction as the third fairway and towards the green, possibly attempting a forced landing.
