ACCIDENT

Aircraft Type and Registration:	Robinson R44 Astro, G-TATY
No & Type of Engines:	1 Lycoming O-540-F1B5 piston engine
Year of Manufacture:	1999
Date & Time (UTC):	16 September 2005 at 0855 hrs
Location:	Near Amersham, Buckinghamshire
Type of Flight:	Training
Persons on Board:	Crew - 1 Passengers - None
Injuries:	Crew - 1 (Serious) Passengers - N/A
Nature of Damage:	Severe disruption of fuselage, main and tail rotor blades, cockpit canopy and tail rotor drive shaft
Commander's Licence:	Student Pilot (Helicopters) Private Pilot's Licence (Aeroplanes)
Commander's Age:	59 years
Commander's Flying Experience:	224 hours (of which 31 were on helicopters) Last 90 days - 17 hours Last 28 days - 3 hours
Information Source:	AAIB Field Investigation

Synopsis

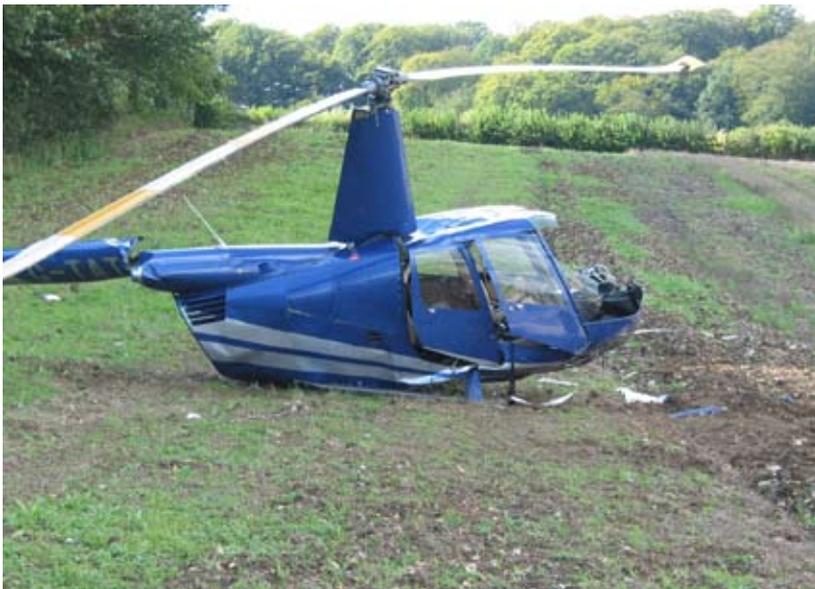
Figure 1

G-TATY, 16 September 2005

The aircraft was resting upright in the field with its nose facing in the direction of 000°(M). Both landing gear skids had collapsed and the forward section of the right skid had fractured. The transparent portions of the cockpit canopy had shattered and there was clear evidence that a main rotor blade had cut through the canopy and struck the instrument panel. The engine rpm instrument was found 50 metres from the main wreckage and had a main rotor blade imprint in its casing. The main rotor blades were relatively undamaged apart from the tips which had been bent rearwards and up as a result of ground impact. The tail boom had partially separated and was bent to the left. The lower vertical tail fin was bent in half and the tail rotor exhibited ground impact damage. One tail rotor blade had separated but was embedded in the ground within 2 metres of the tail rotor gearbox.

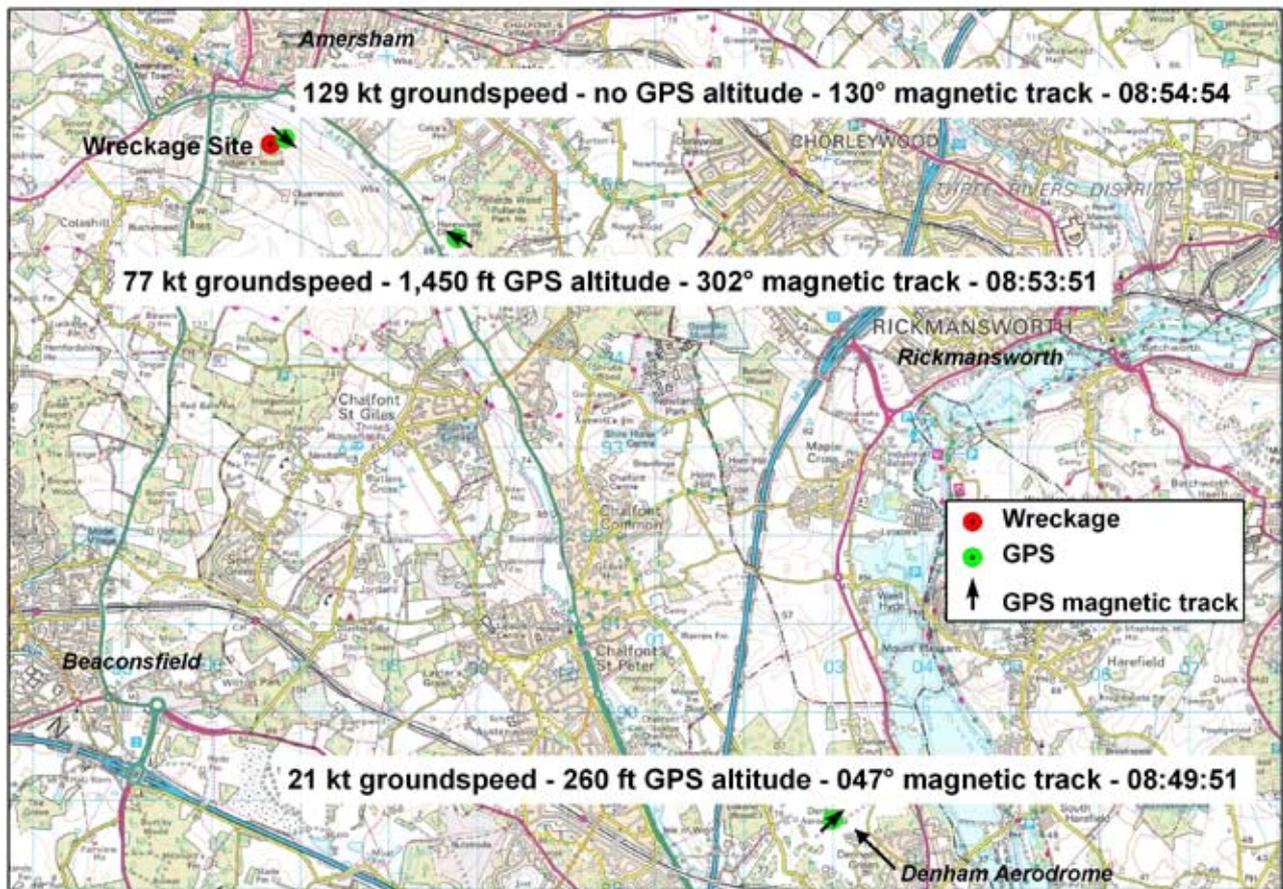
Figure 2

Recorded information was retrieved from G-TATY’s GPS equipment. The GPS memory was set to record waypoints, and their associated information, every four minutes. However, there was a gap of only one minute and three seconds between the last two points. This could have happened as a result of power being removed and then restored to the GPS at some time after the penultimate waypoint was recorded.

The recorded GPS waypoints are shown in Figure 2.

G-TATY recorded waypoints

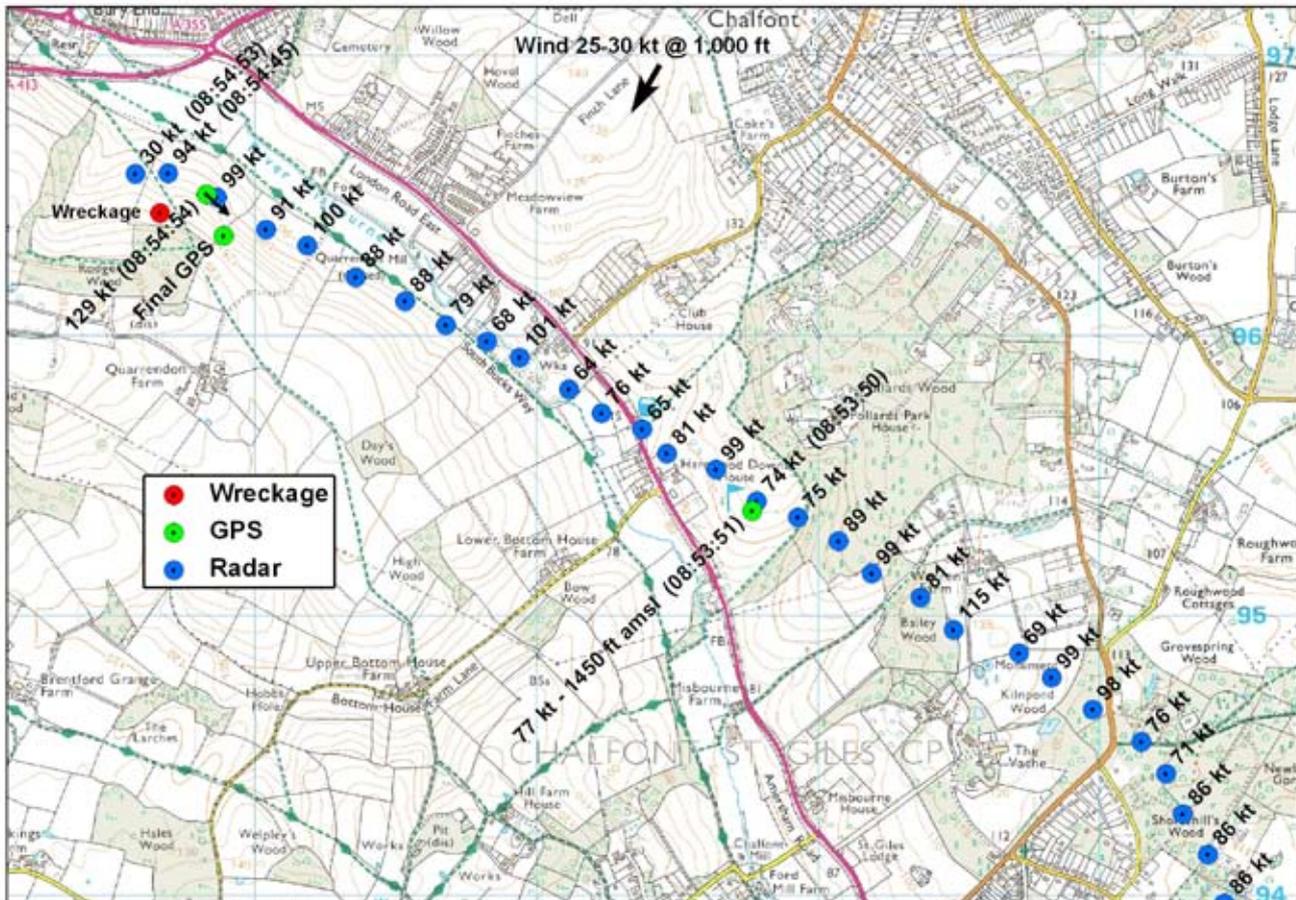
Figure 3

G-TATY radar recordings

However, the helicopter's GPS groundspeed of 129 kt at 0854:54 hrs was considered unreliable because it was not consistent with any of the witness statements, nor was it reflected in the recorded radar data, which is shown in Figure 3.

There was good correlation between the radar and GPS at 0853:51 hrs but less correlation at 0854:54 hrs.
